APPENDIX - A  
Morgan Brook Watershed Management Plan  
Bacteria Sampling Results - Morgan Brook Watershed

Appendix - B  
Morgan Brook Watershed  
Section 319 Nonpoint Source Management Program  
Track Down Survey Summary Table

**WEST HILL  
POND**

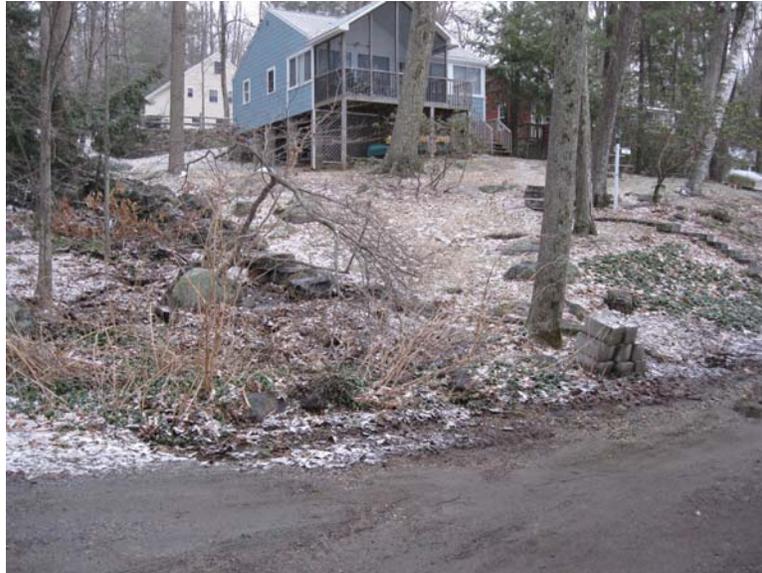
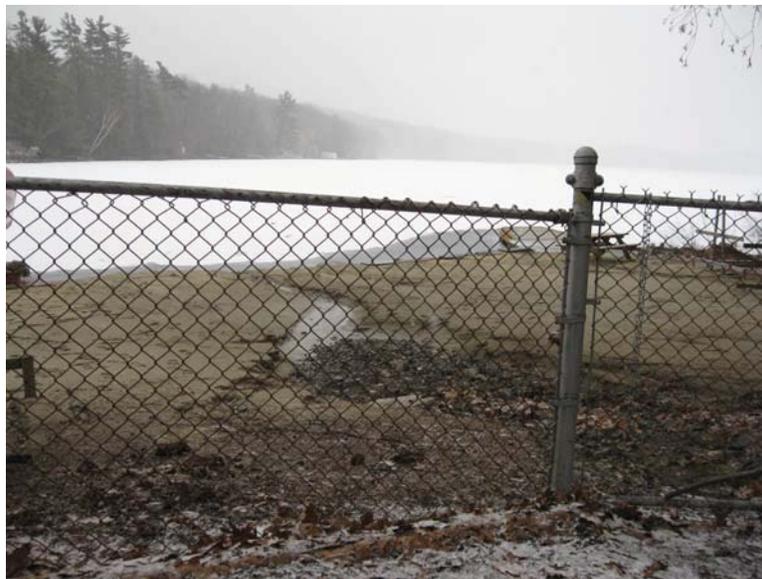
LAKE IMPACT ASSESSMENT: Moderate (2)

Inadequate sized CB on west side of road typically plugged or covered with leaves, overflow puddles in road and then erodes LAPOA beach.

Install a deep sump CB with “CL” top and hood, install new pipe under the road and to the pond, regrade road and construct an in pond basin. Provide Siltfence or filtrex sox during winter months along the beach front to reduce beach erosion.

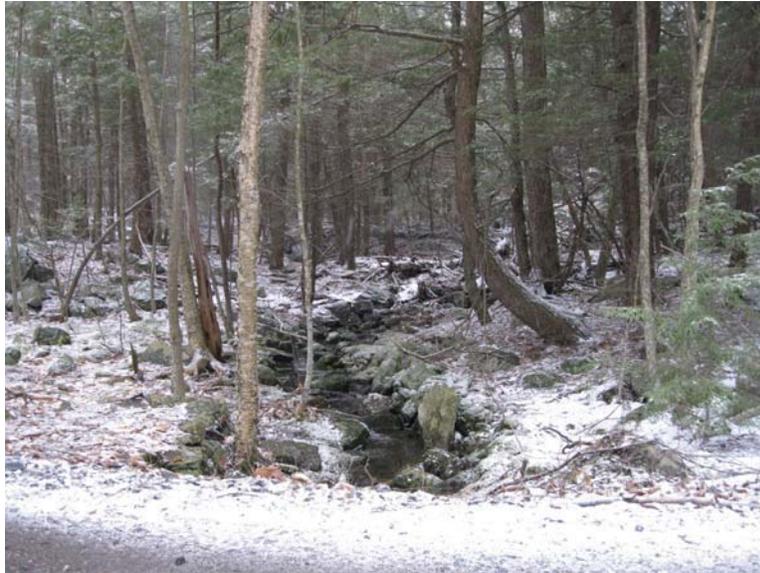
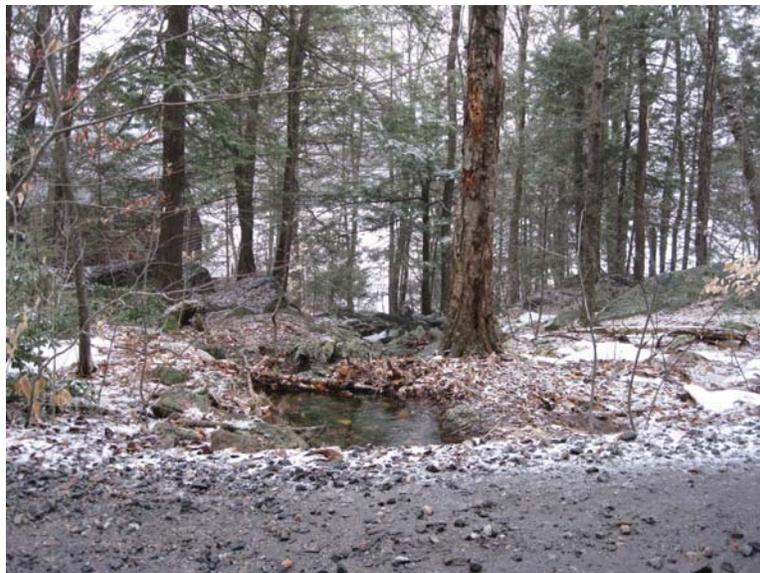
LAKE IMPACT ASSESSMENT: Low (3)

Stable drainage from undeveloped upland area.

Monitor and insure entrance to culverts is kept clear to prevent overtopping roadway.

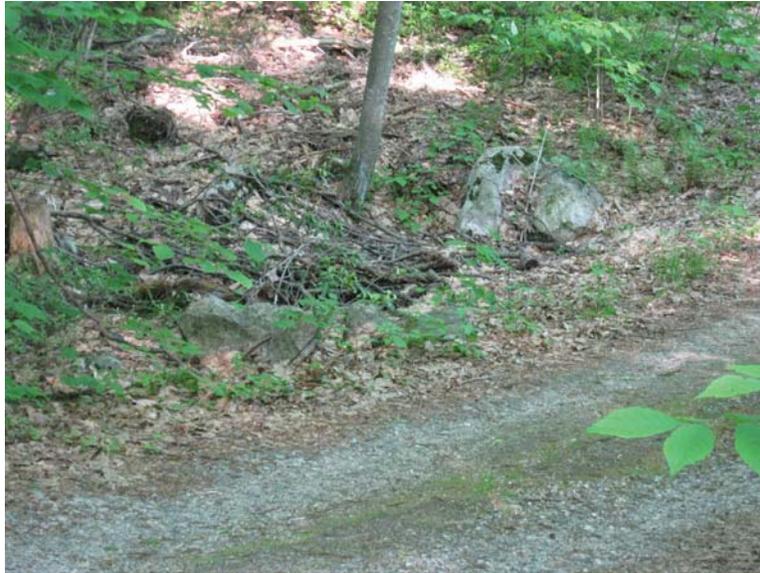
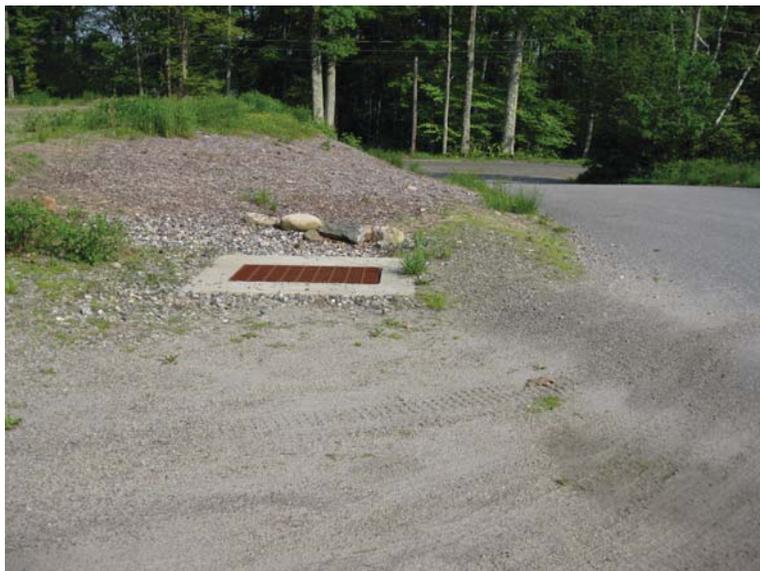
LAKE IMPACT ASSESSMENT: Low (3)

- A. Drainage from East side of road, crosses under several private drives and is used for deposition of landscape debris.
- B. Drainage from playing fields/parking area on west side of road is collected in CB's and piped to rock lined outlet area with level spreader.

- A. Discontinue practice of filling channel with debris and brush.  
Insure that culvert entrances and CB grates are kept clear.

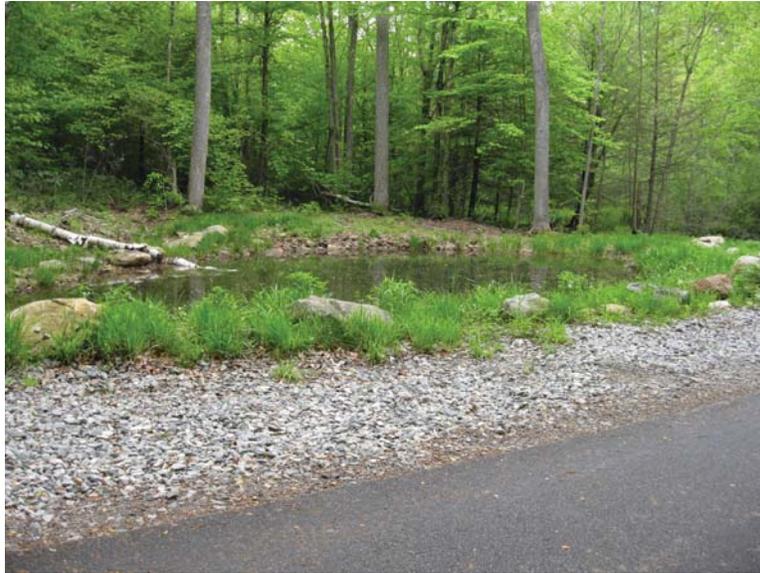
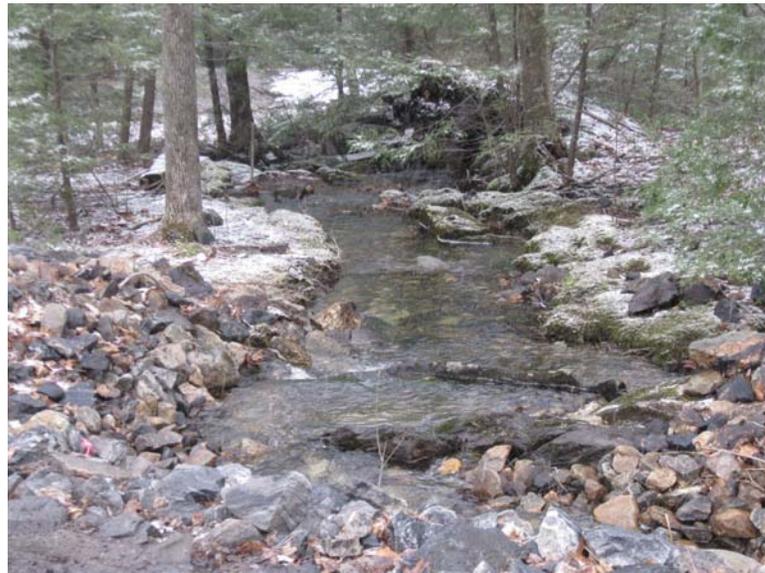
DRAINAGE AREA: 151.5 Ac.  
LAKE IMPACT ASSESSMENT: High (1)

The road was recently regraded and repaved to reduce roadside erosion and a settling pond for road runoff was created. A rock dam created to maintain a water levels in a large undeveloped wetland acts as a metering device to attenuate outflows and reduce erosion of banks below (east) of the road. Road regrading and paving appears to have significantly reduced erosion and sediment loads from road shoulders.

Clean roadside sediment pond as necessary and monitor rock dam for debris accumulation that would cause high water levels allowing brook to overflow and erode material.

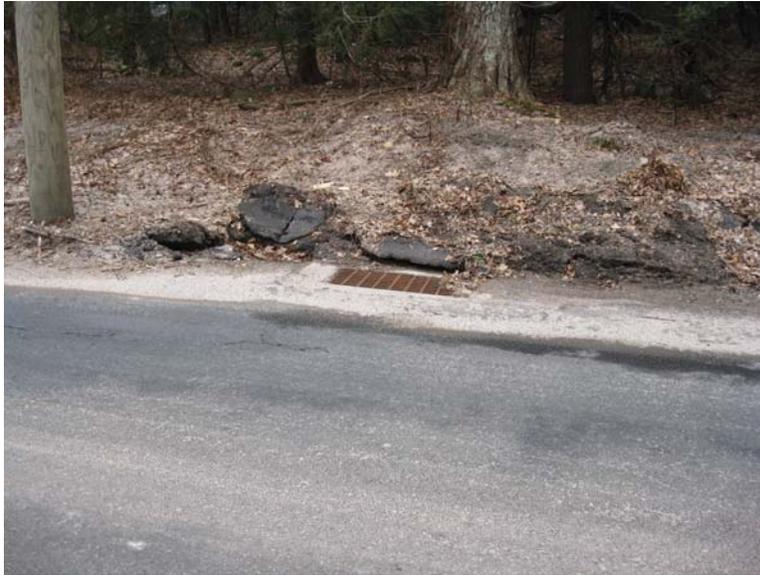
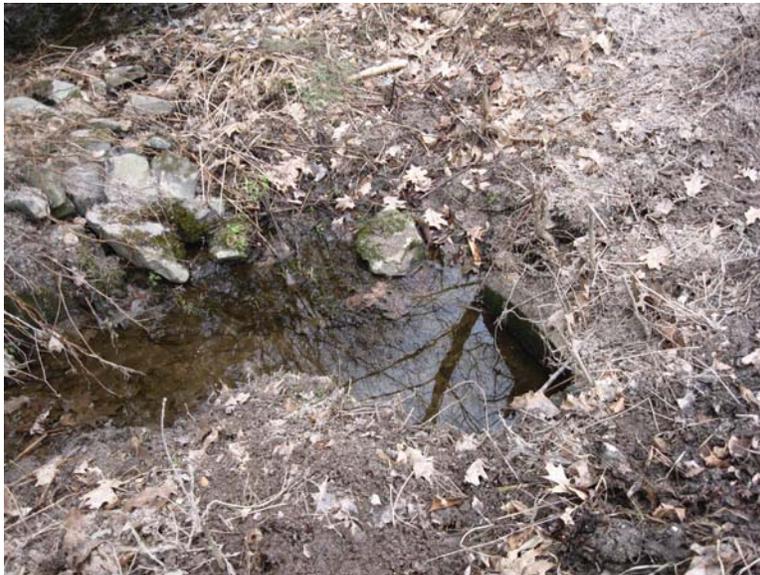
LAKE IMPACT ASSESSMENT: Moderate (2)

Roadside drainage through a Catch Basin (6) system into a wetland area on south side of West Hill Rd and then piped to outfall at edge of pond.

Install deep sump (2-ft min) catch basins. Regrade and vegetate roadside area to reduce exposed soil. Create a well maintained, vegetated roadside shoulder. Create roadside sediment basin for yearly cleaning. If unable to create a sediment basin (property rights or wetland issues) then install a large particle separator (equivalent of a septic tank) alongside or under the road. Particle separator could be installed on lake side of road at beginning of pipe to lake.

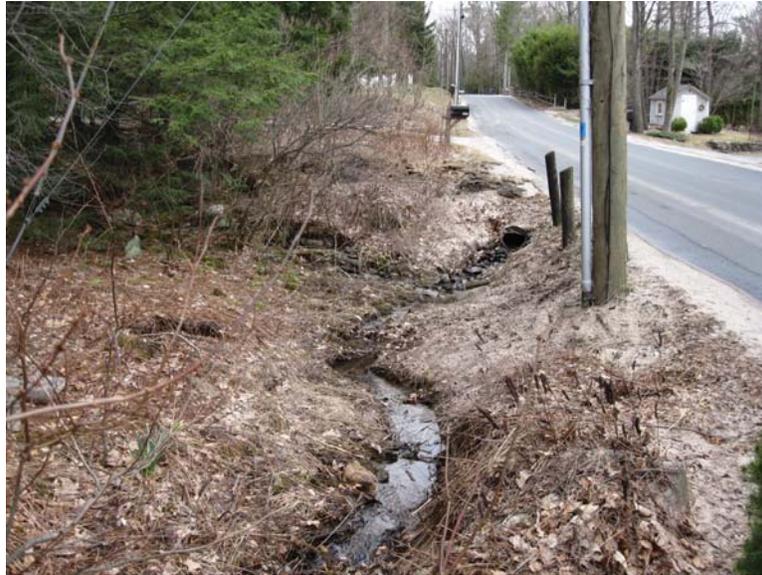
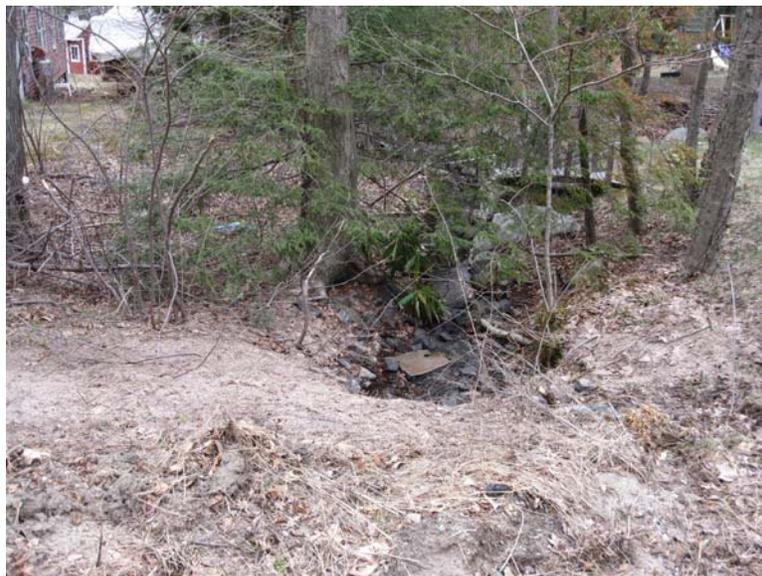
LAKE IMPACT ASSESSMENT: High (1)

Roadside drainage through a Catch Basin (4) system into a wetland area on south side of West Hill Rd and then culverted under the road to an open drainage to pond. End of brook is full of sediment and during high flows material is eroded into pond

Install deep sump (2-ft min) CB's. Regrade and vegetate roadside area to reduce exposed soil. Create roadside sediment basin for yearly cleaning. If unable to create sediment basin (property rights or wetland issues) then install a large particle separator (equivalent of a septic tank) alongside or under road. Amour or maintain vegetated roadside discharge points. Remove accumulated sediment adjacent to pond to prevent ponding of storm flows and erosion into lake.

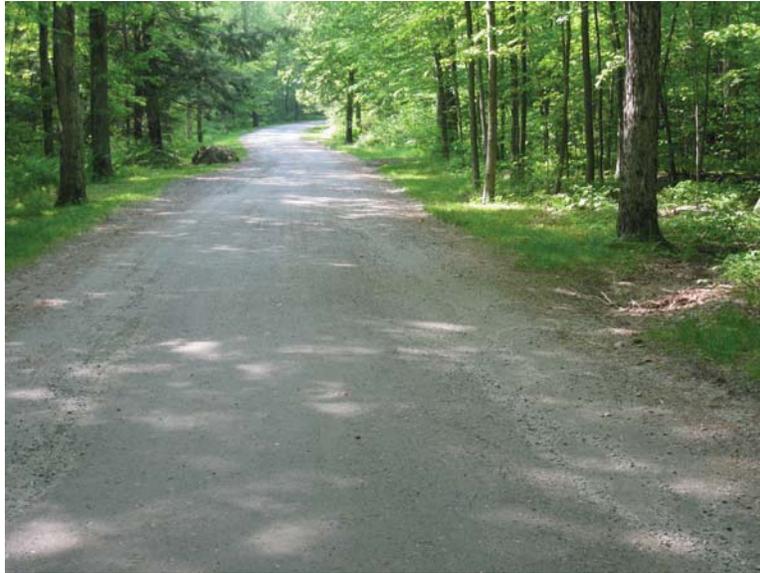
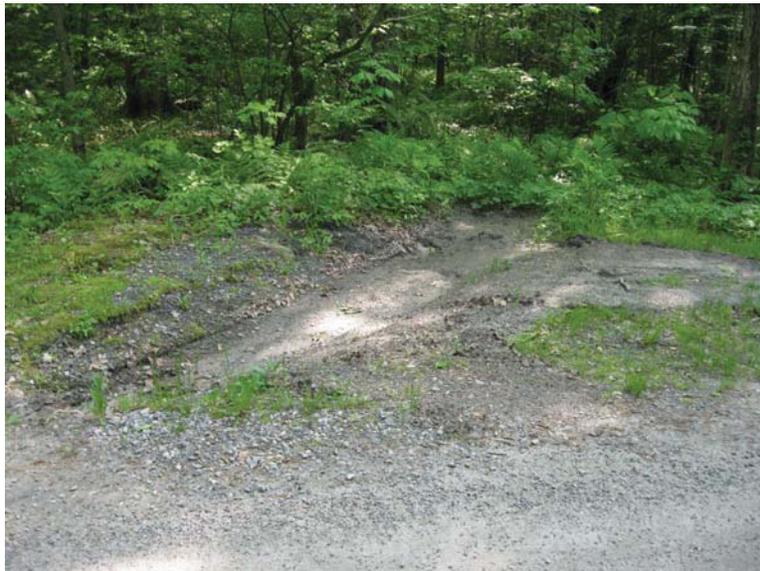
LAKE IMPACT ASSESSMENT: Low (3)

Drainage from the Brodie Park area, and an access road to the Town Beach and then through wetlands to the lake. The road has multiple discharge points which fill up with eroded road surface material. Outfall has deposits of sand covered with weedy/rush growth. Deposition can be eroded into pond during high flow events. The Beach area has a fine, silty sand which is easily eroded and drainage from parking area is directed over beach area.

Clean road discharge points and establish vegetation.  
Dredge deposited material from outfall and use boulders to establish an in pond sediment basin area at outfall which can be cleaned out as necessary.

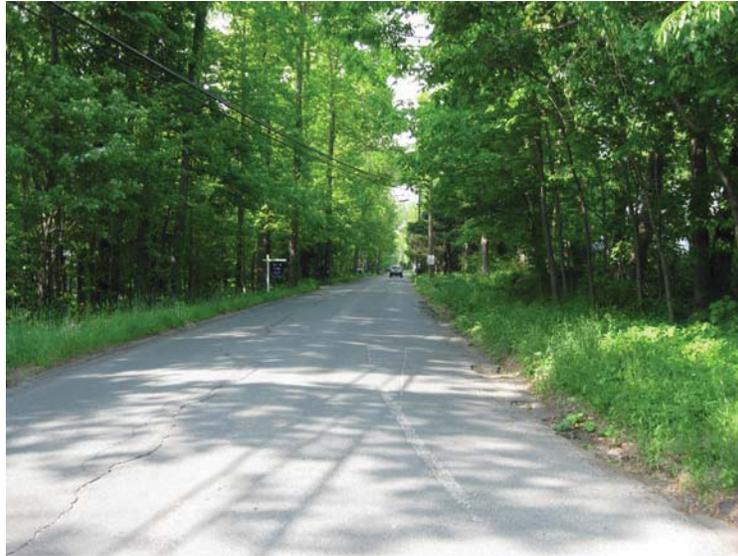
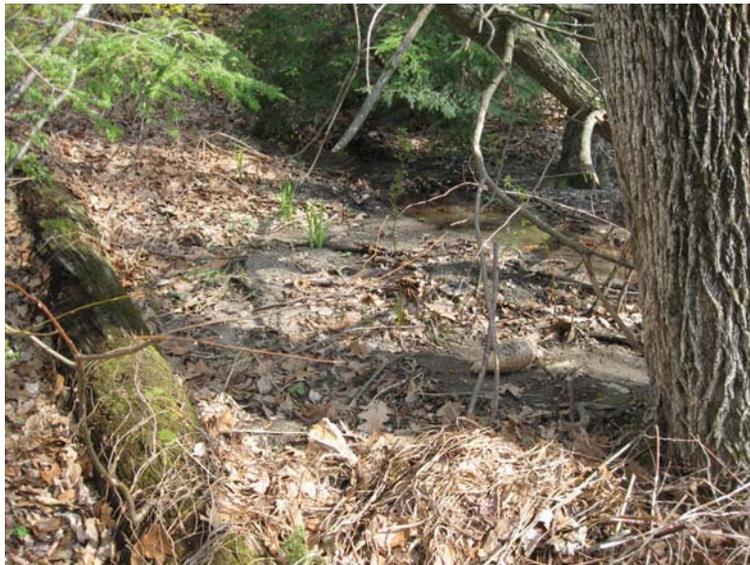
LAKE IMPACT ASSESSMENT: Low (3)

Multiple diagonal swales from upland area and roadside runoff enter a wetland area with no distinct outfall to lake. Some of the swales have areas of exposed or disturbed soil due to recent driveway construction. There are currently 9 catch basins along Niles Road. Drainage paths adjacent to Niles road are filled with road sand.

Stabilize areas of exposed soils

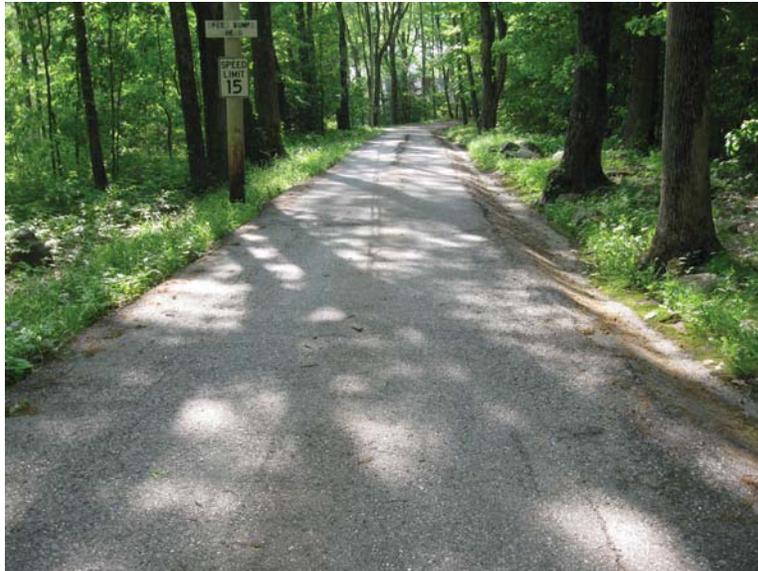
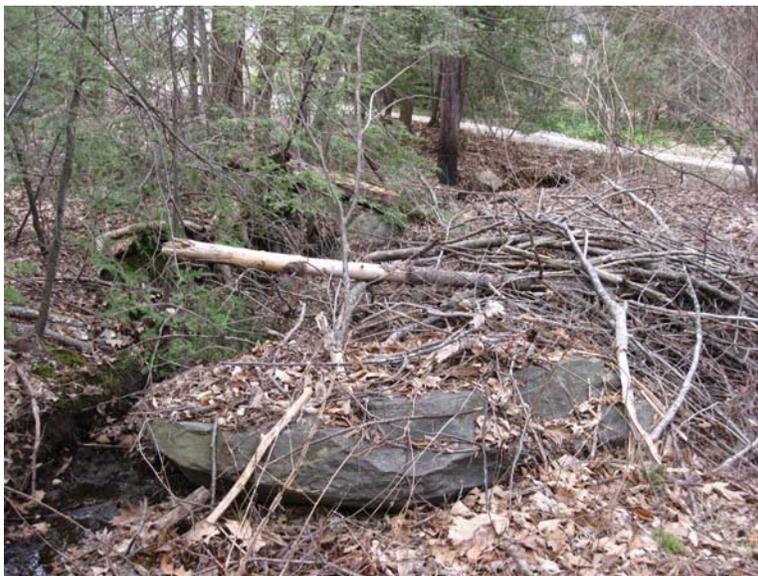
LAKE IMPACT ASSESSMENT: Moderate (2)

Paved access way with paved roadside swale and a very steep eroding channel at north end of development.

Maintain existing pavement and keep roadside area and ditch clean. Install 2 catch basins with deep sumps (to trap large particles) at the bottom of hill. Stabilize channel using rip rap and stone waterdrops (steppools). Keep channels clean to prevent dams from forming and allowing bypass erosion during high flows.

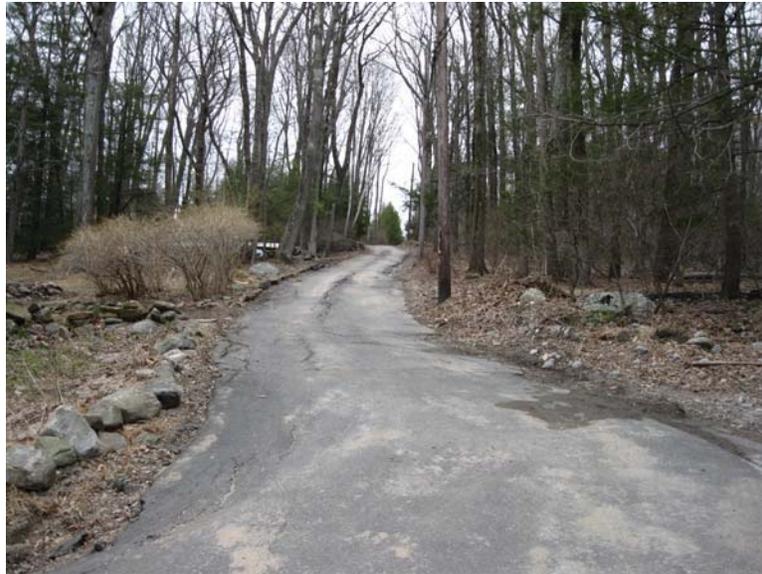
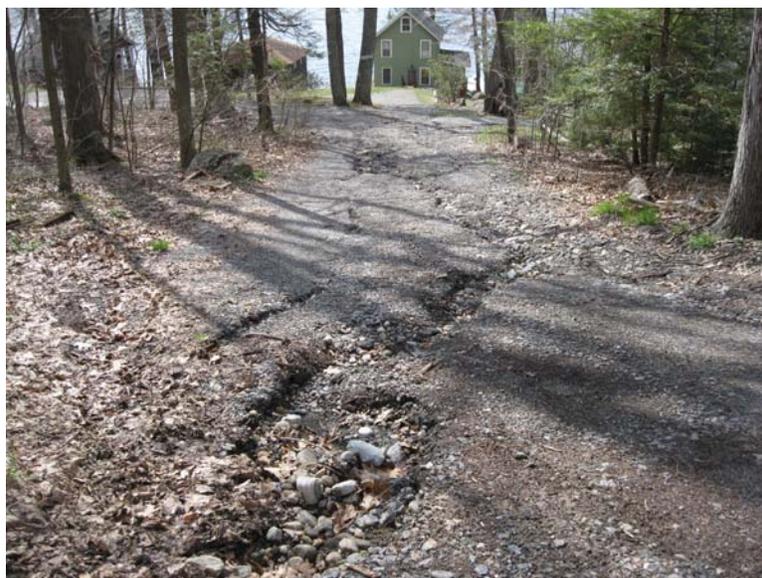
LAKE IMPACT ASSESSMENT: Moderate (2)

A paved road with roadside erosion and poorly maintained drainage paths. The lower portion of the access way is steep gravel with no drainage control.

Reconstruct roadway (existing paved and graveled portions 0.2 miles) to allow overland drainage from shoulders. The lower south section should be paved due to steepness. Improve and maintain existing drainage swales.

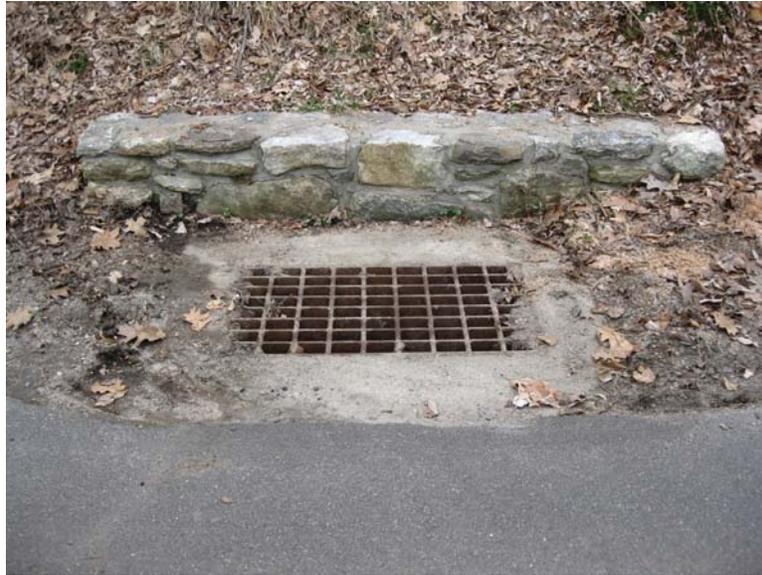
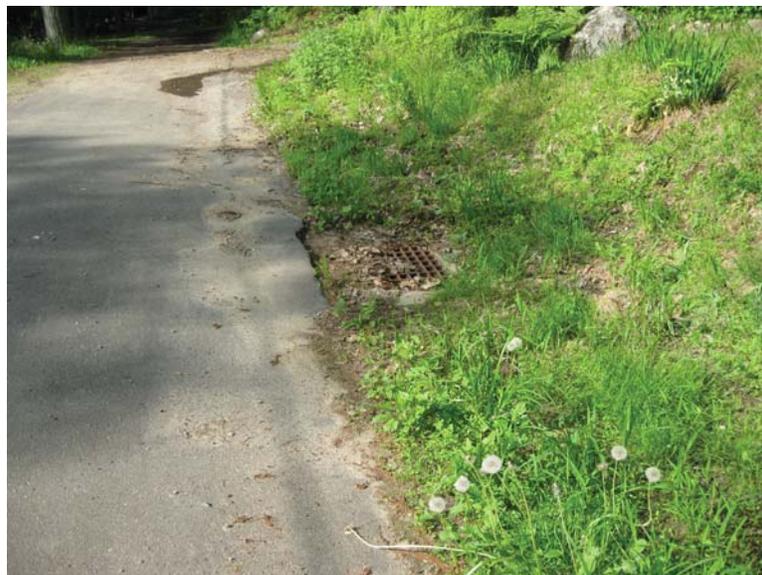
LAKE IMPACT ASSESSMENT: Low (3)

Residential area with light to moderated development, previously installed sediment catch basin that has not been maintained. Roadway appears to stay wet from hillside seepage.

Clean and maintain existing sediment catch basins or install deep sump basins  
Regrade road to drain to roadside swale and existing CB.

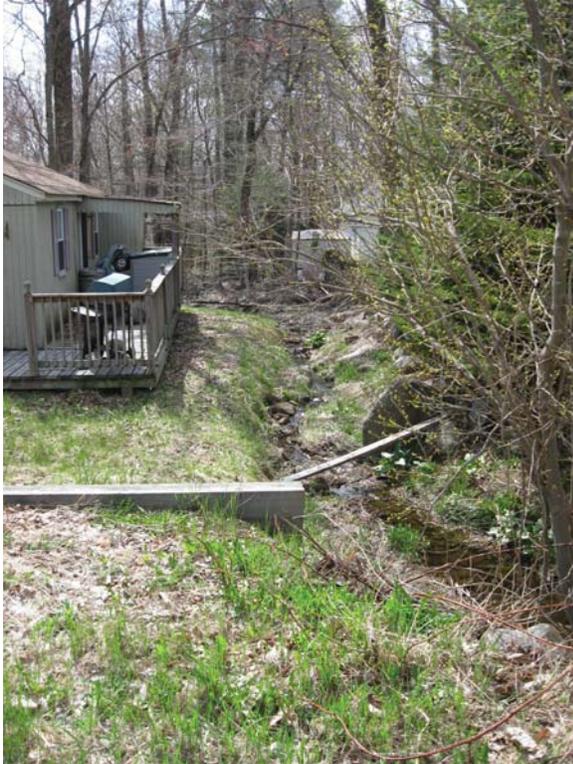
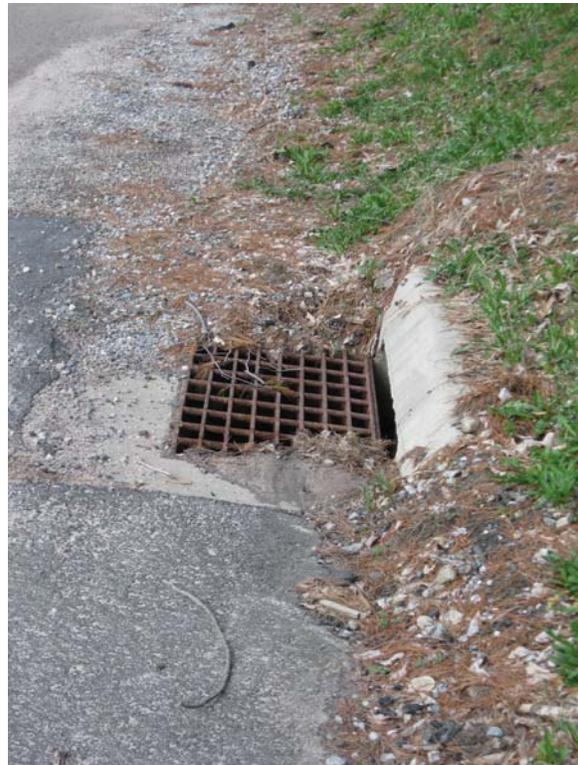
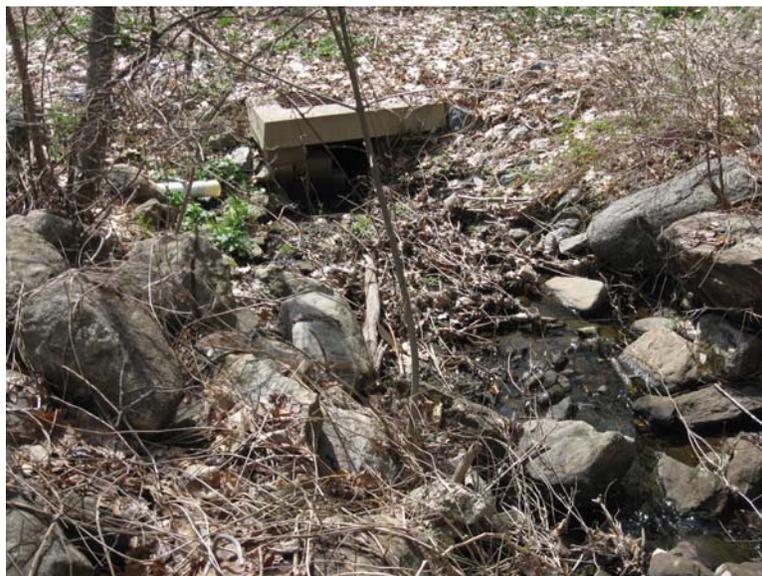
**INFLOW 14**

LAKE IMPACT ASSESSMENT: High (1)

Drainage is from a relatively densely developed residential area through a system of culverts and open channels. Most of the roads are gravel with poor shoulder drainage, allowing storm flows to erode roadway. Lower portion of the channel is blocked by debris, and has actively eroding areas.

Install deep sump catch basins or large particle separators Create roadside grassed channels or armor shoulders with 2-in stone. Remove debris and stabilize exposed channel banks

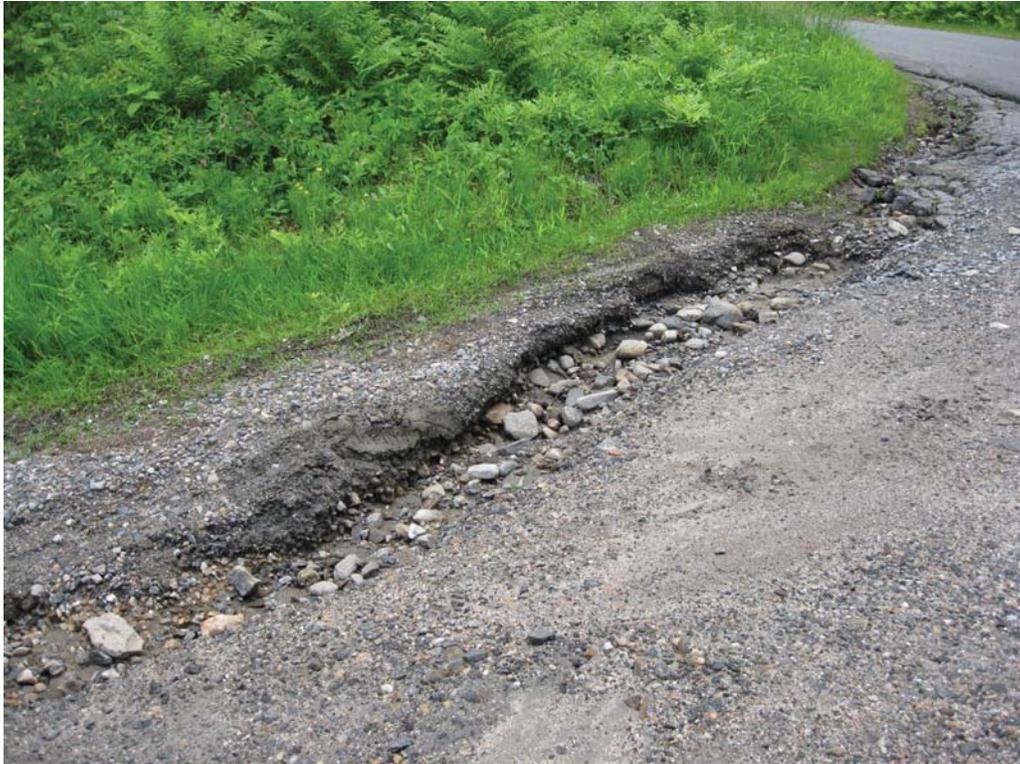
Eroded Shoulders - Install shoulder armor or create grassed swales.

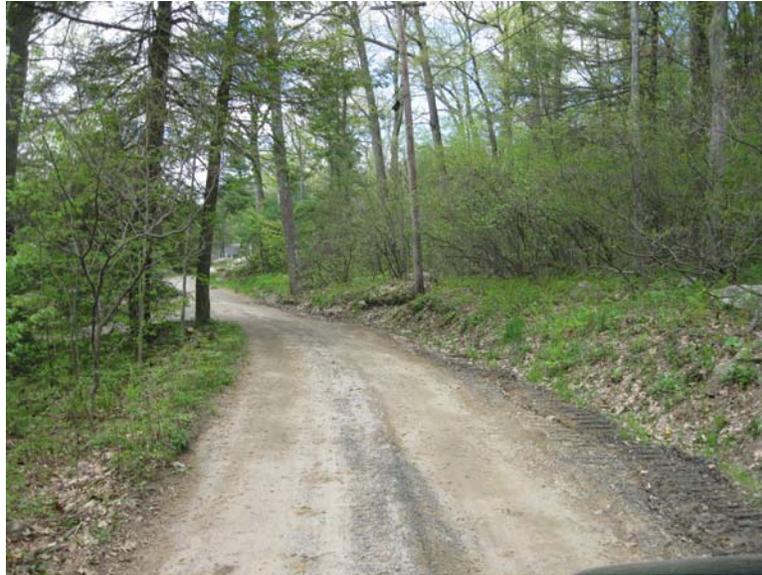
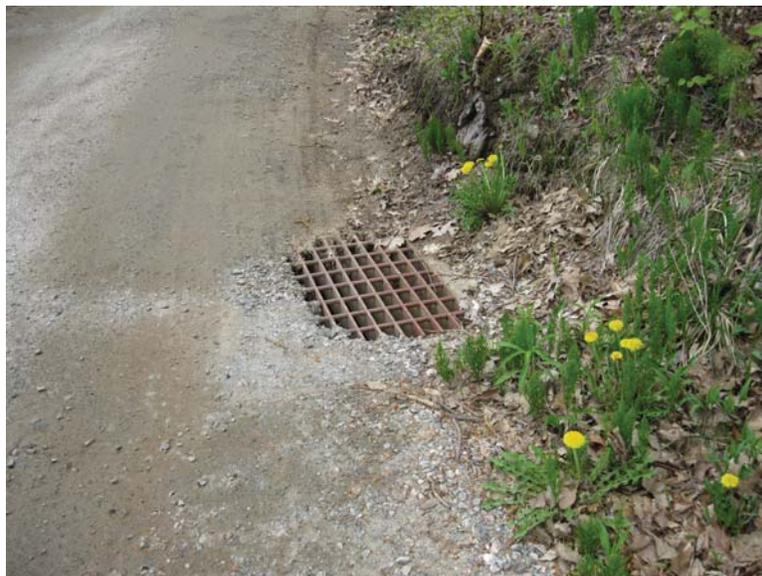
LAKE IMPACT ASSESSMENT: Low (3)

Gravel access way with eroding roadside swale, culverted under access way and discharges to an open ditch alongside cottage. Large impervious paved area from former parking area.

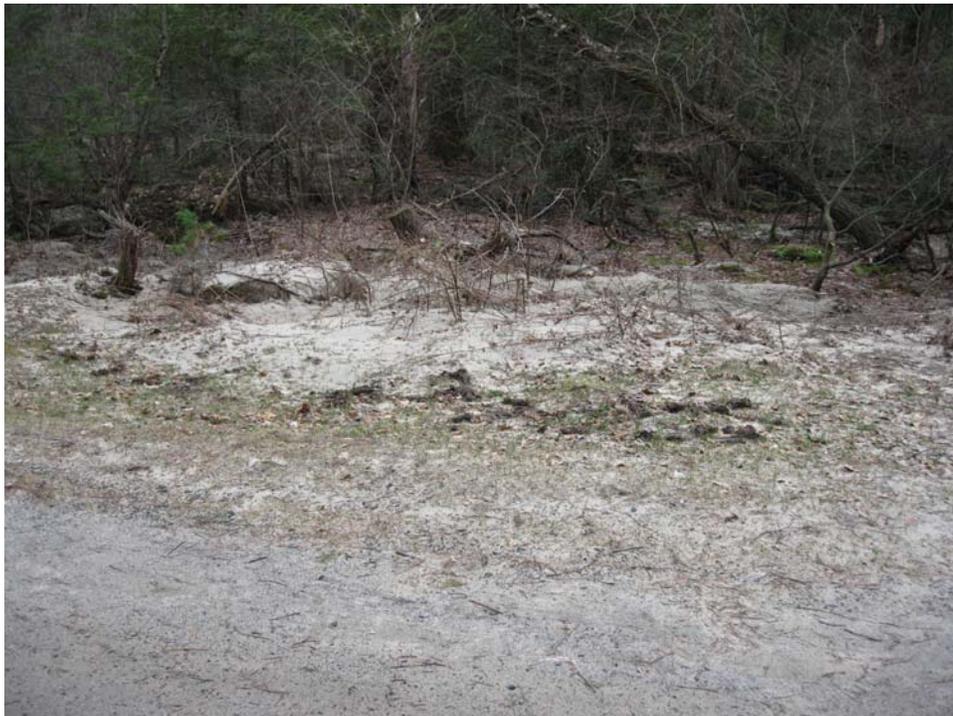
Wrong gradation of beach sand, allows erosion by both wind & water

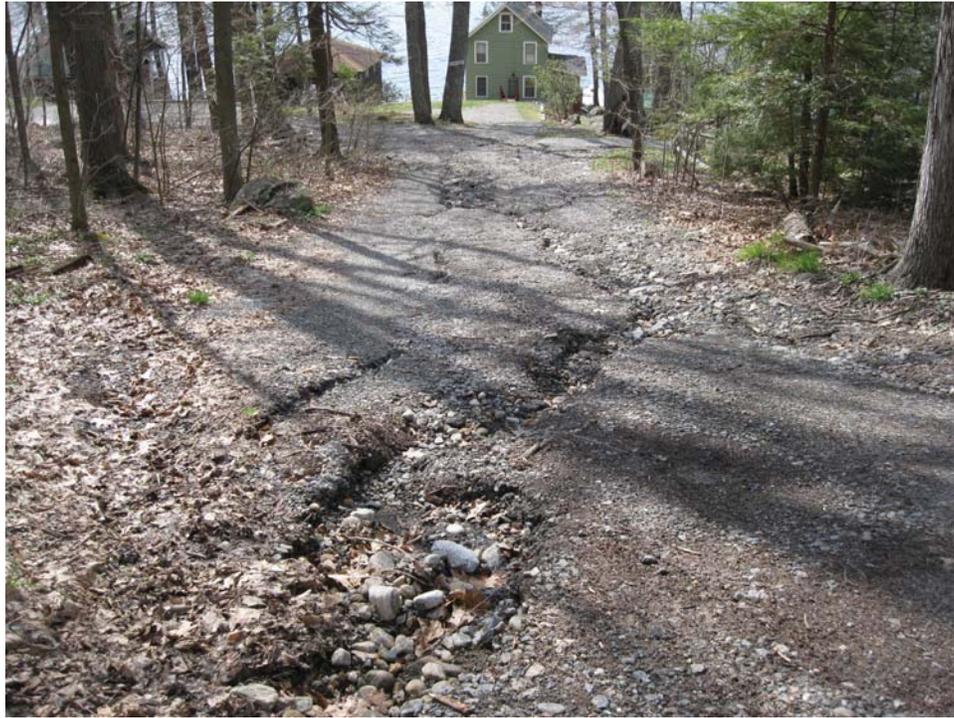
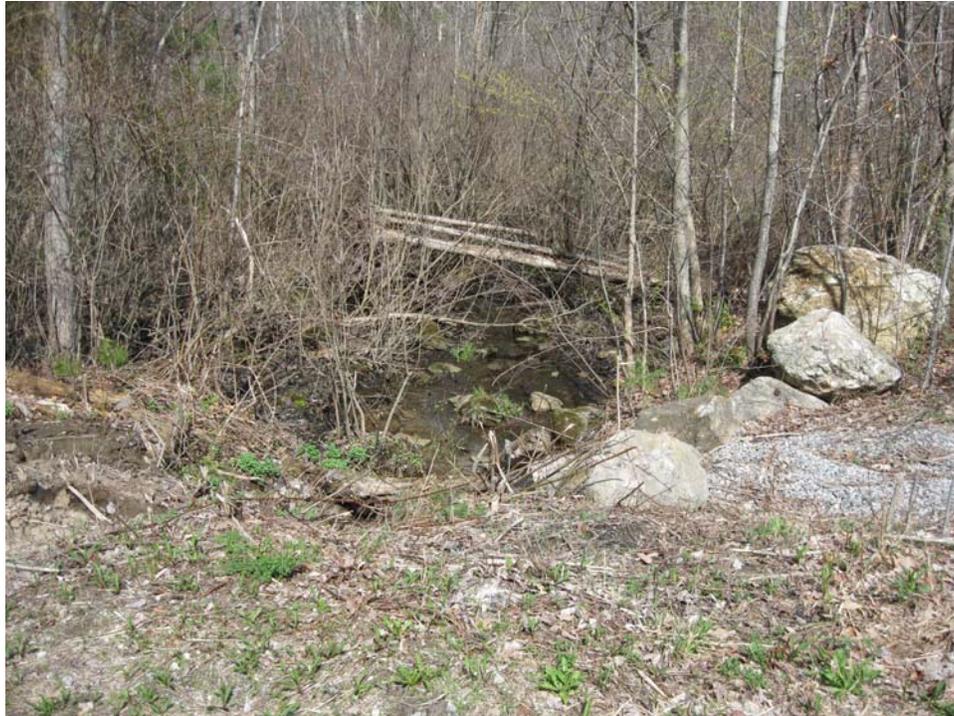
Improper grading and maintenance of drives and roads
