Blackledge River Habitat Restoration Project

Location: Colchester, Public property,
Salmon River State Forest

Completed: September 2004

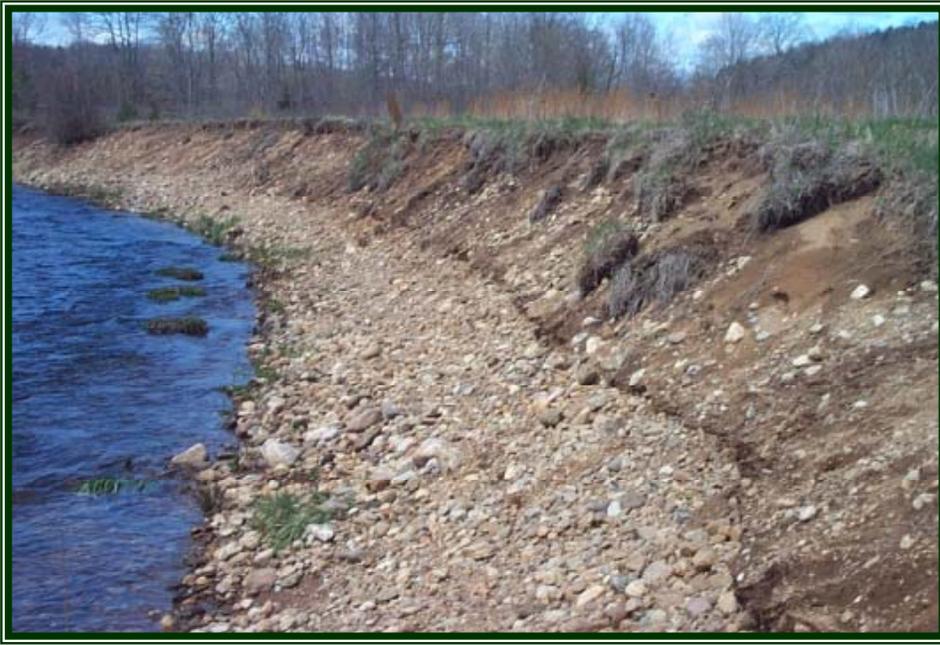
Approximately 710 feet of streambank along the lower Blackledge River had experienced channel instability and erosion. Based upon a review of aerial photographs, instability had been traced back to large flood events in 1973 and 1982. Within this stretch, an area approximately 440 feet in length was severely eroded causing a collapse of the streambank and degradation of instream aquatic and riparian resources. This lack of an extensive and stable root system contributed to significant quantities of sandy and coarse soils to erode and deposit downstream within the Blackledge River and Salmon River.

Streambank erosion prior to restoration efforts.

Design was based upon placing the subject reach of the river back into dynamic equilibrium, (condition where erosion/deposition are in balance) to effectively transport water and sediment. Approximately 440 linear feet of streambank was stabilized with a boulder rock toe up to the two-year storm elevation, erosion control fabric and live branch layering. At the top of the streambank, an upland vegetated riparian zone was restored with a variety of plants to establish a mixed hardwood forested riparian zone. A boulder J-hook structure was installed to deflect streamflow away from the stream bank and towards the stream's centerline. Several tree and rootwad structures were installed along the streambank to not only protect streambanks from erosion but to provide much needed large woody debris cover habitat for the resident fish community. Deep pool habitat was restored alongside the outside bank more than 200 feet in length.

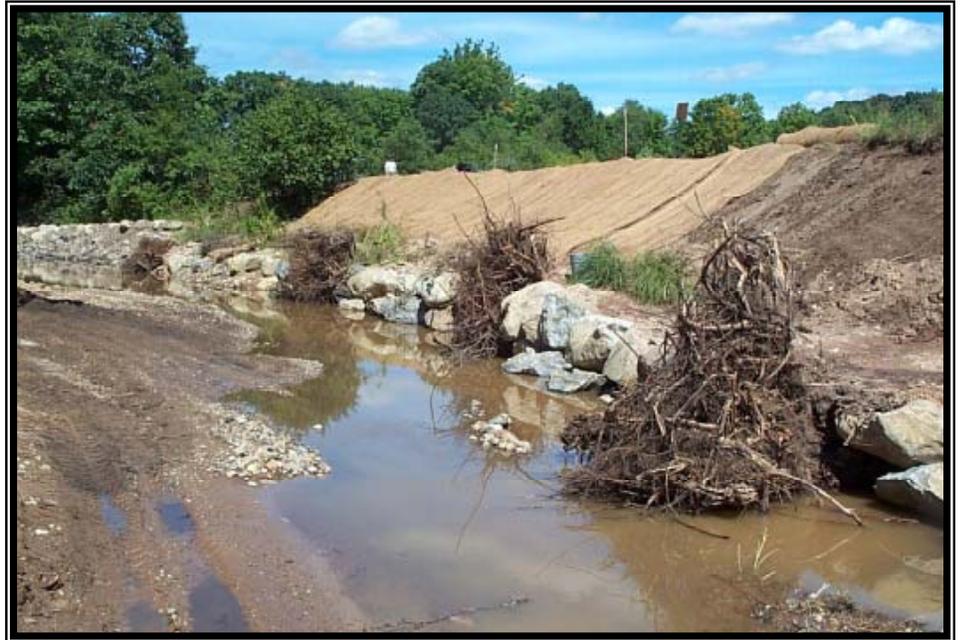
Boulder toe, rootwad and streambank stabilization treatments during construction.

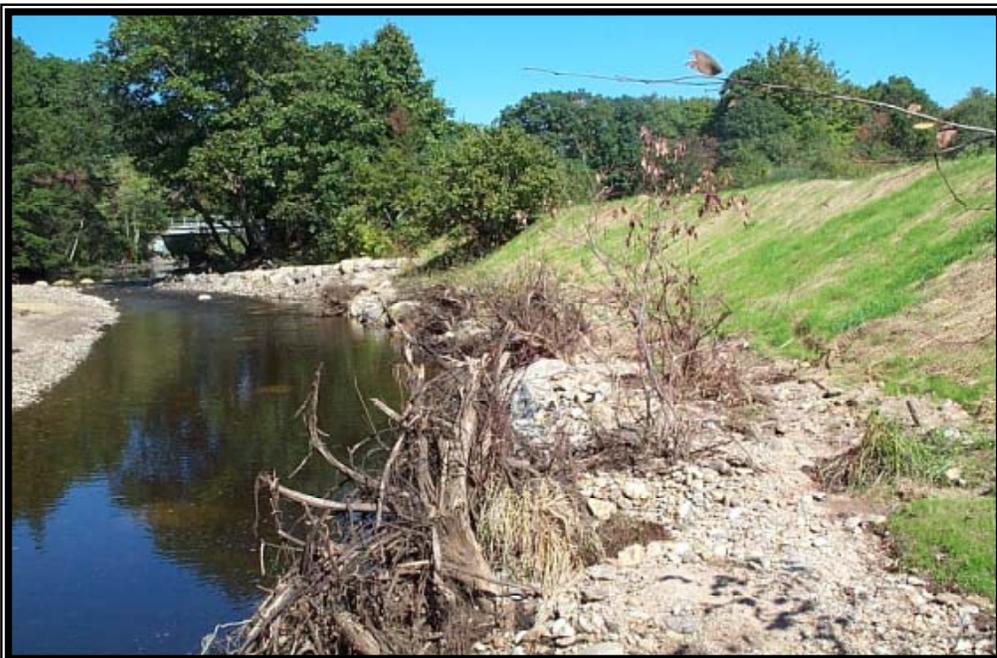
Bank stabilization treatments 1 week post project completion.

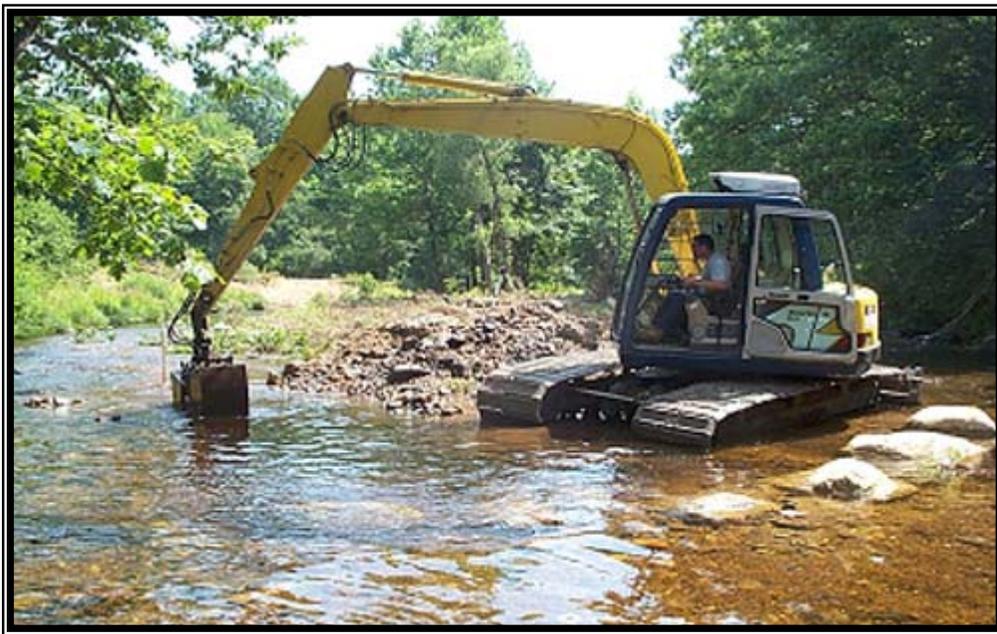
Construction of boulder J-Hook, a structure designed to redirect water away from streambank.

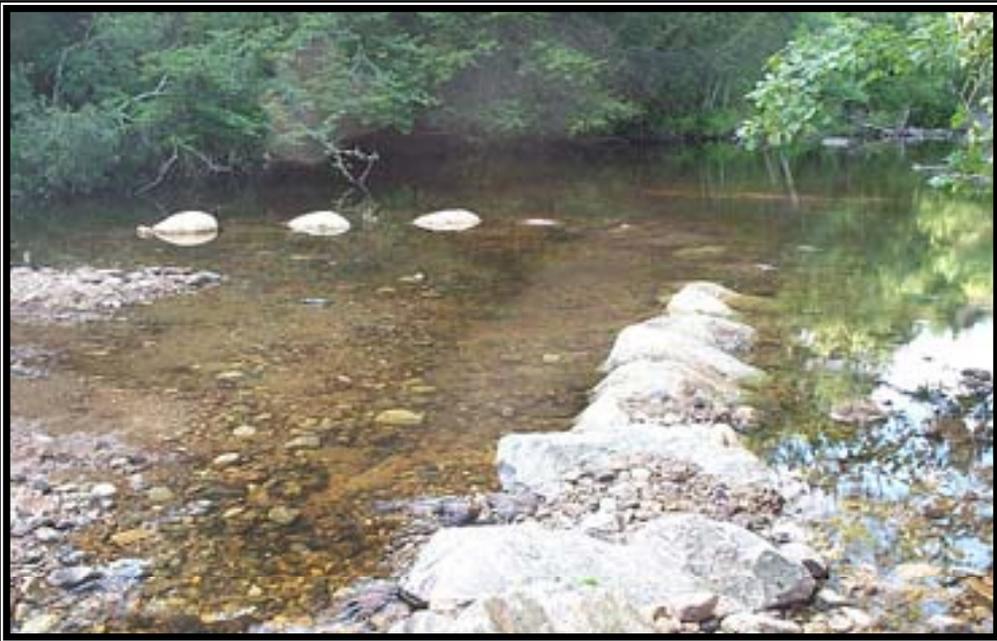
View of J-Hook looking upstream, immediately after construction.

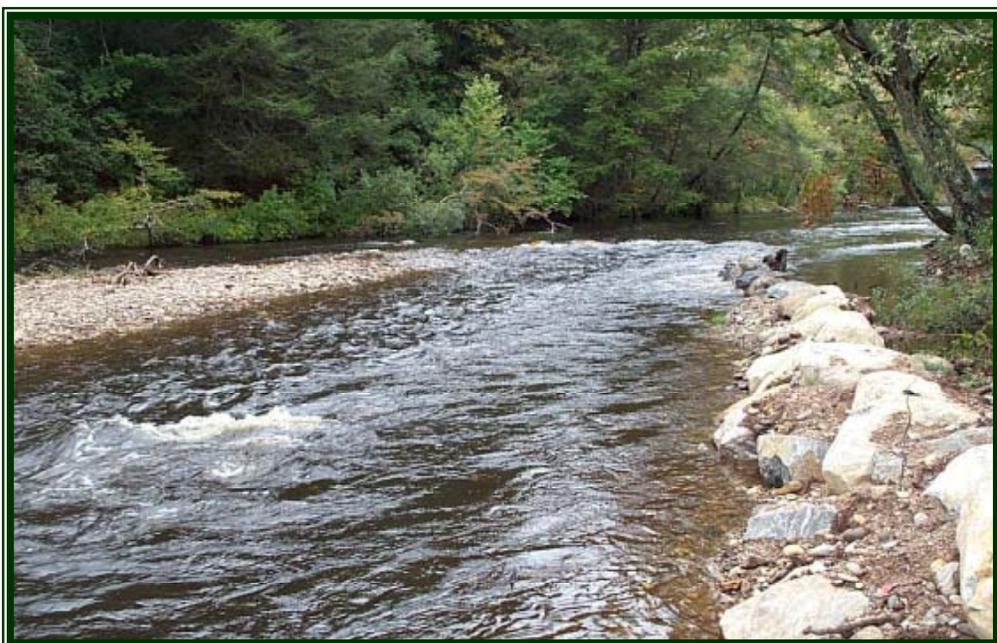
J-Hook functioning during high flows to redirect water away from streambanks.
