## Mount Hope River Habitat Restoration Project

**Location:** Ashford, Private property

**Completed:** September 2006

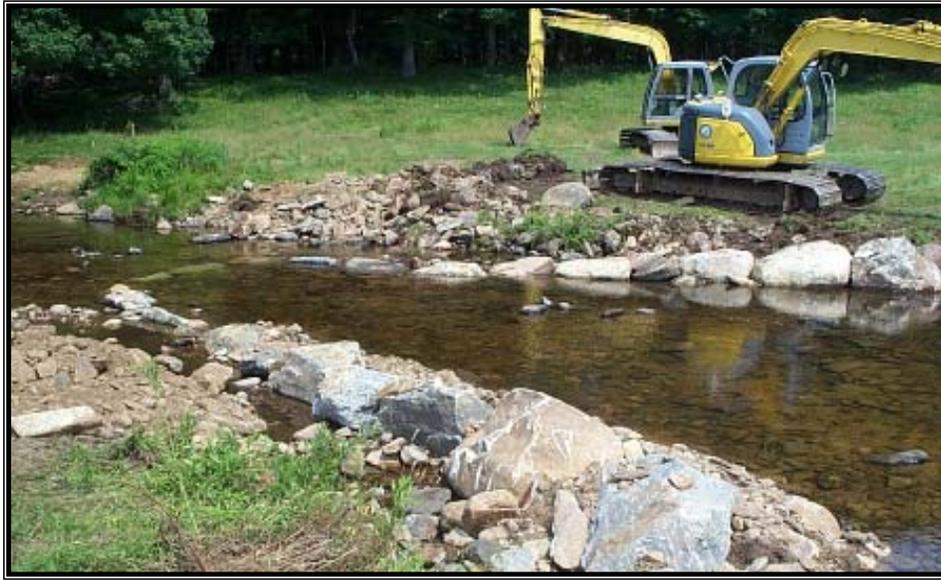
**Completed construction of cross vane immediately below the upstream cattle crossing.**

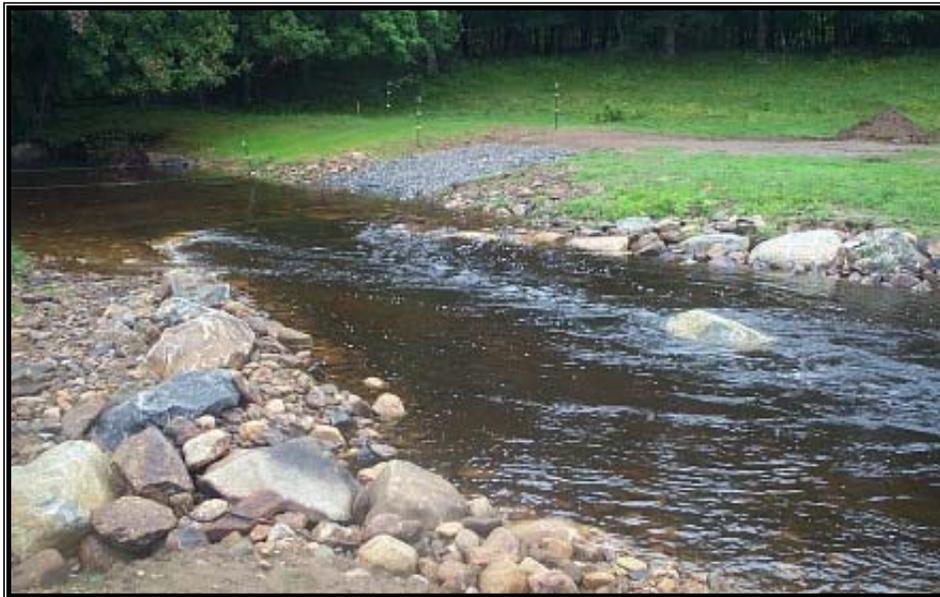
**Photograph of cross vane during a storm event illustrating a primary function of the cross vane to redirect flow into the stream's centerline and away from the streambank.**

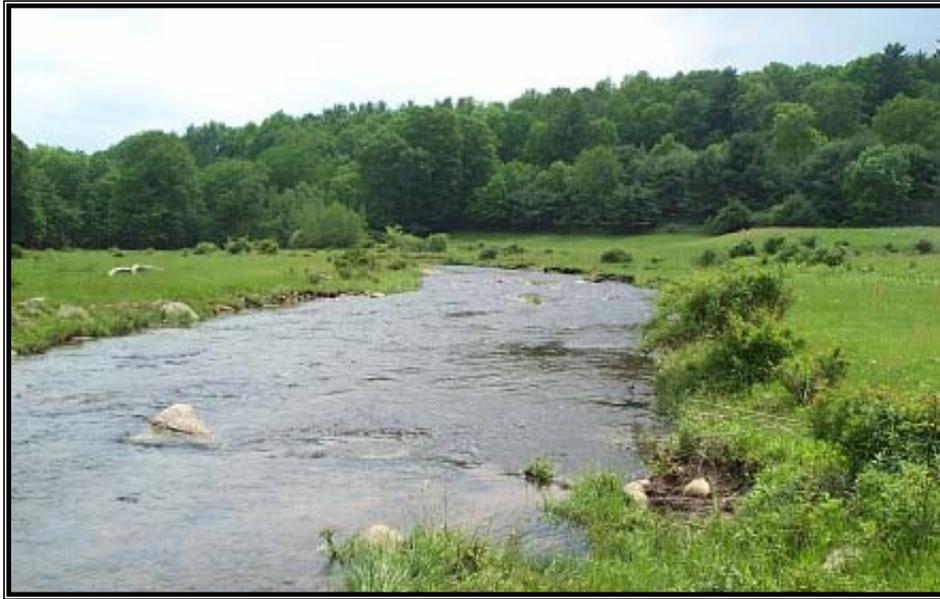
**Pre construction photograph of river demonstrating channel overwidening**

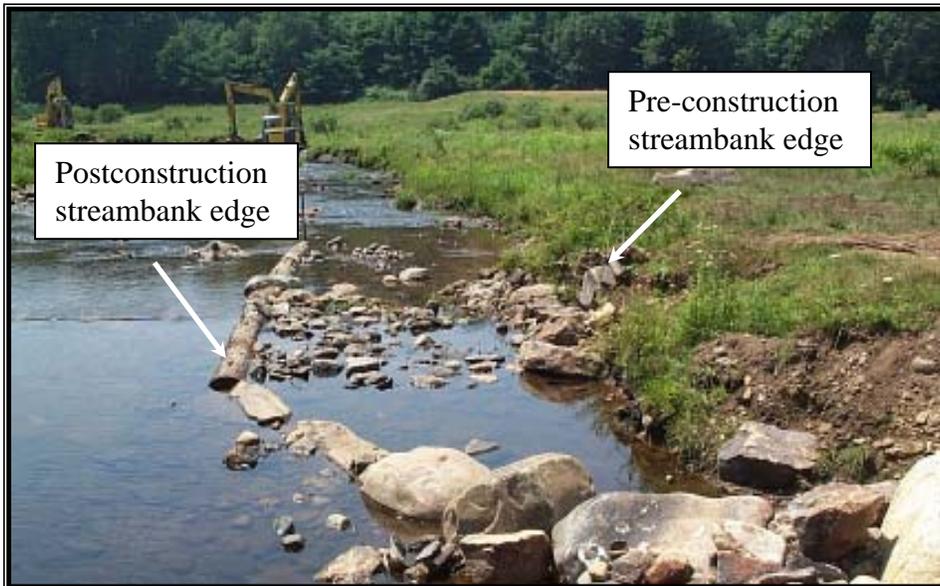
**Photograph comparing preconstruction streambank edge and area of channel that will be filled to create the bankfull bench.**

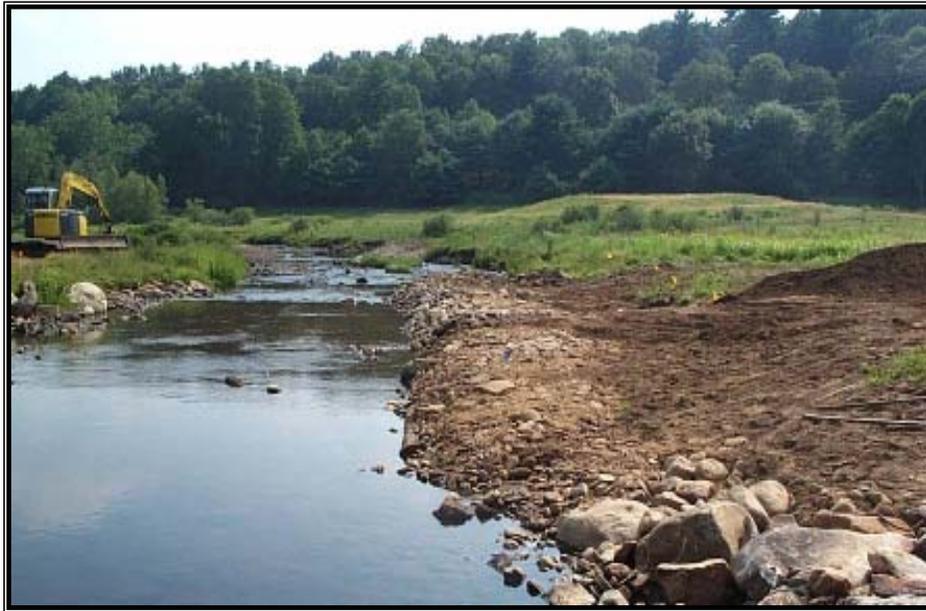
**Photograph showing final grading, reduction in channel width and creation of bankfull bench.**

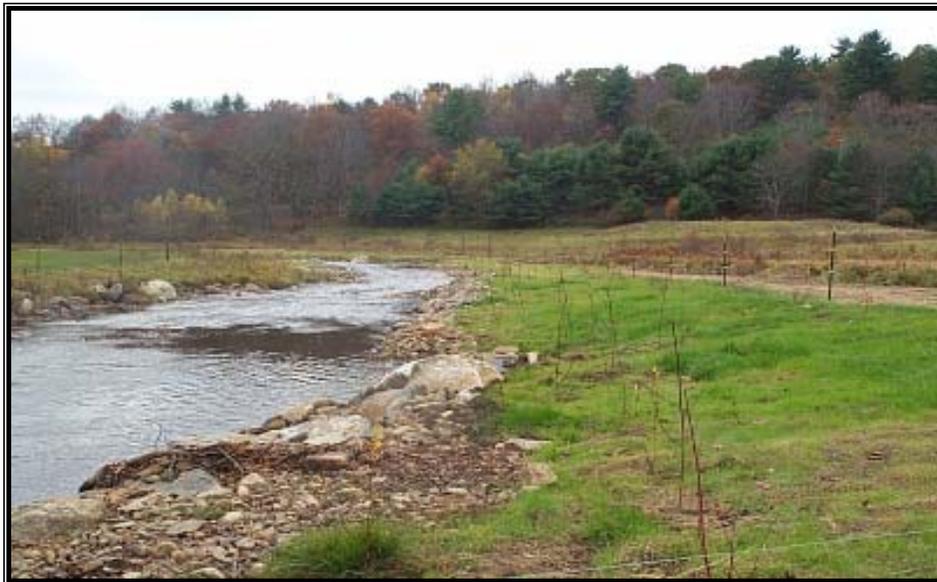
**Photograph showing vegetation reestablishment along bankfull bench.**
