Water Quality Investigation Summary

Contract 12-05f French River Watershed-Based Plan and Implementation Action

**Eastern Connecticut Conservation District
August 25, 2015**

Task 1d – Conduct Water Sampling

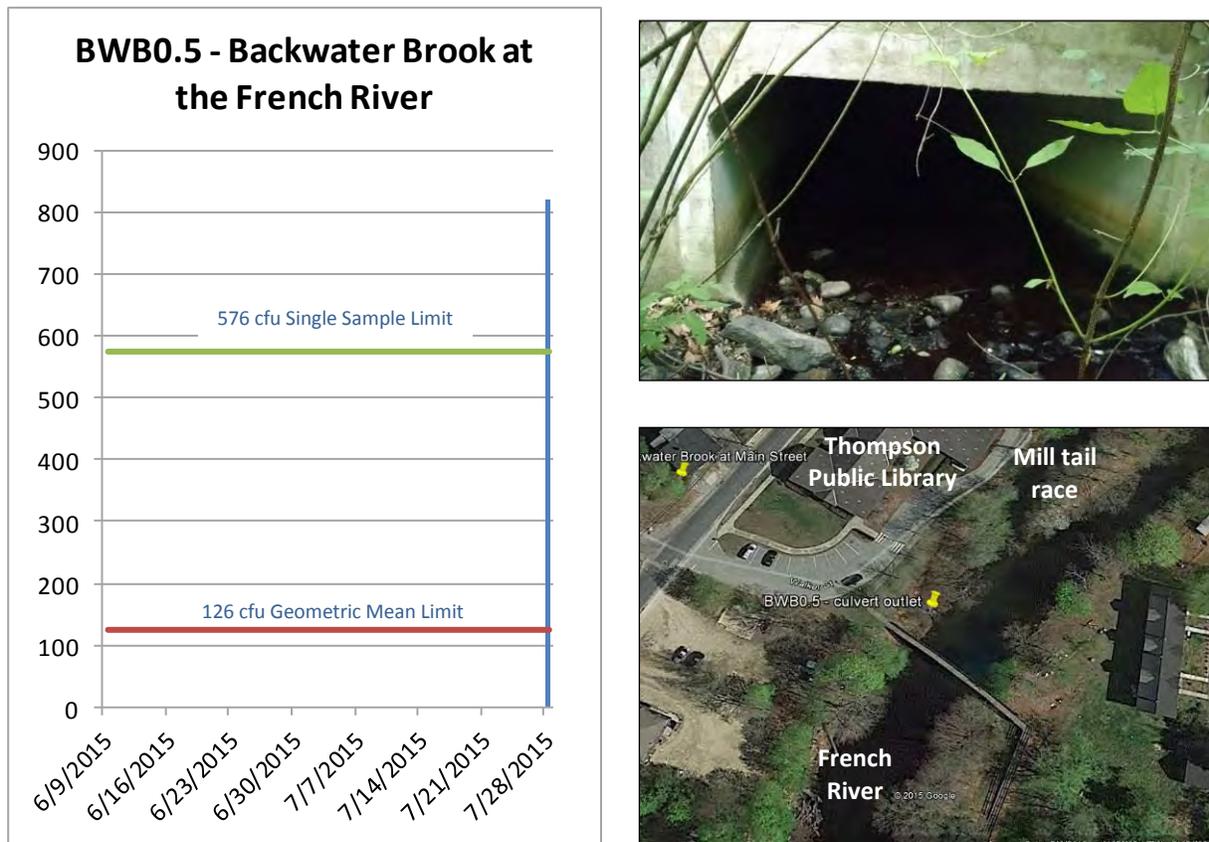
BWB0.5 – Backwater Brook at the confluence with the French River:

Figure 20. Graph of bacteria sampling results at BWB0.5; view of the culvert conveying Backwater Brook under the public library property and Main Street, just upstream of the sampling location; and an aerial image of the sampling site location and vicinity.

A single water sample was collected at a third site on Backwater Brook (BWB0.5) on the final day of sample collection (7/28/15). ECCD staff and water quality volunteers noted a foul odor emanating from a storm drain behind the library (Fig. 31). Backwater Brook is culverted a distance of approximately 250 feet under Main Street and the Thompson Public Library property, before it discharges to the French River (Fig. 31). It is believed that a portion of the storm drain system serving the library parking lot may be tied into the culverted section of stream. A water sample was collected at the outlet of the culvert to determine if discharge from the storm drain system was contributing to bacteria load in Backwater Brook. This single dry weather sample yielded a bacteria level of 820 cfu/100 ml, indicating that further investigation into the layout of the storm drain system at the library should be conducted.

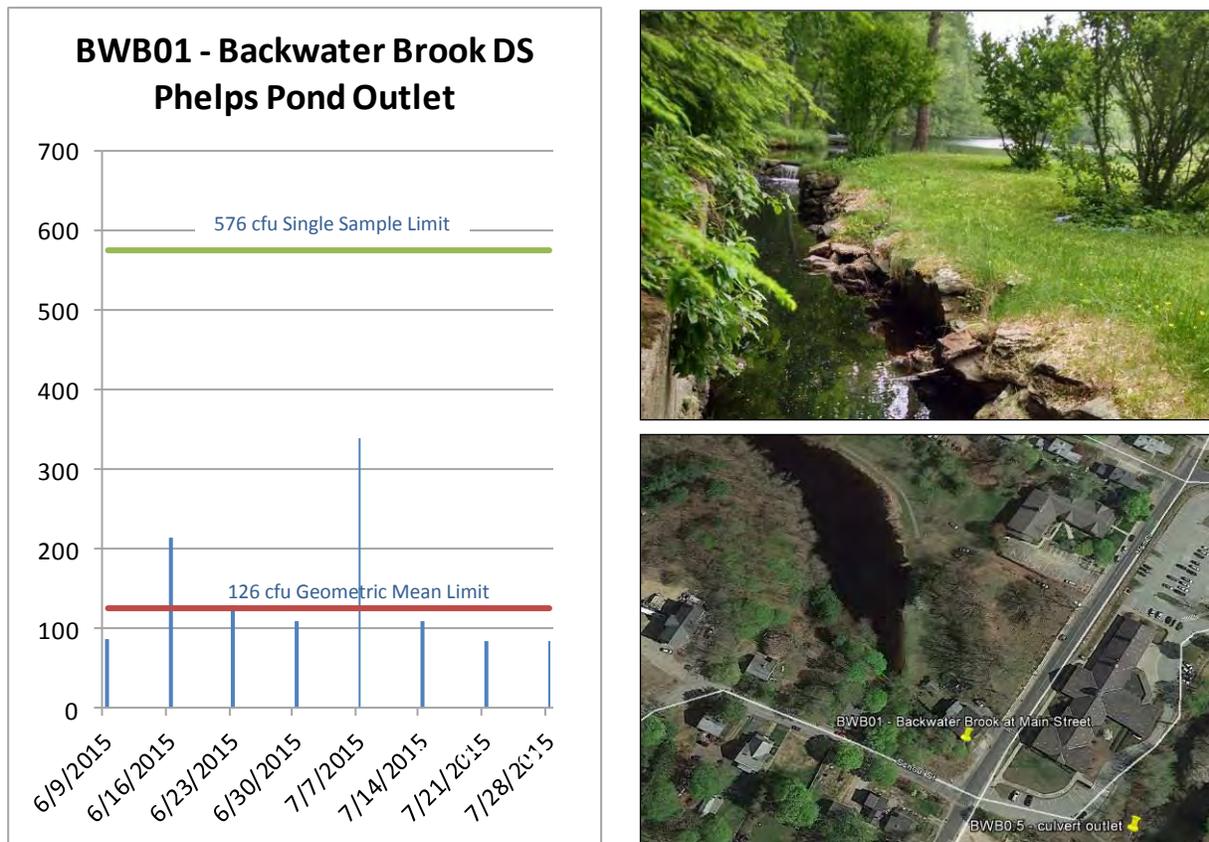
BWB01 – Backwater Brook near Main Street:

Figure 21. Graph of bacteria sampling results at BWB01; view of Backwater Brook upstream of the sampling location; and an aerial image of the sampling site location and vicinity.

Bacteria levels at BWB01 were generally low (84 – 230 cfu/100 ml, with one higher measurement of 340 cfu/100 ml on 7/7/15). None of the samples exceeded the single sample limit of 576 cfu/100 ml. A comparison of bacteria levels at BWB01 to precipitation data collected by the Army Corps of Engineers at nearby West Thompson Lake (Fig. 30) indicates that bacteria levels spike immediately after precipitation. For example, a bacteria level of 215 (the average of 200 and 230 cfu/100 ml, the second value being a sample duplicate) was documented on 6/16/15, one day after a rainfall of 1.4 inches. In the absence of rainfall within 24 or so hours of sampling, bacteria levels in the stream water were generally low, indicating that stormwater runoff may be the primary vector for bacteria transport to Backwater Brook. The exception to this observation is a somewhat aberrant bacteria level of 340 cfu/100 ml collected on 7/7/15, during a period of dry weather. This value may be reflective of a bacteria plug from Phelps Pond due to waterfowl activity or other disturbance, or may be the result of sampling error. It should be noted that several domestic ducks were observed being kept at a property immediately upstream of the sampling site.

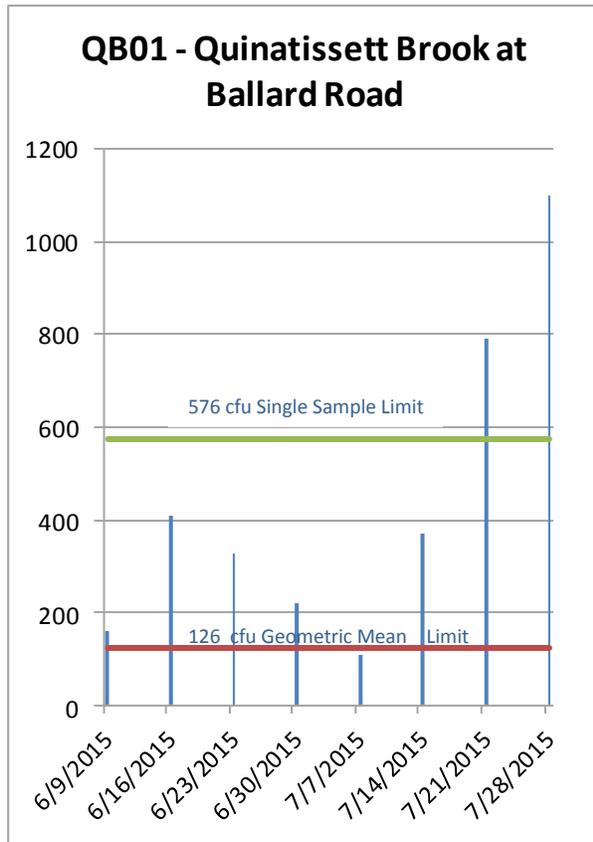
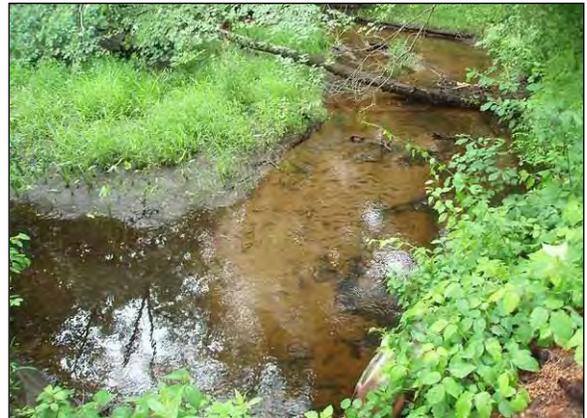
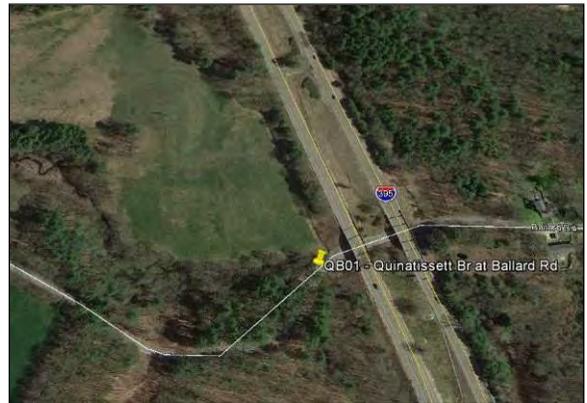
QB01 – Quinatissett Brook at Ballard Road:

Figure 25. Graph of bacteria sampling results at QB01; view of Quinatissett Brook downstream of the sampling location; and an aerial image of the sampling site location and vicinity.

Bacteria levels in Quinatissett Brook at Ballard Road (QB01) were generally higher than those observed at other sites in the French River watershed (Table 1), and dry weather samples collected on July 21st and 28th exceeded the single sample limit (Fig. 32). Typically, dry weather bacteria spikes indicate point sources, illicit discharges or base flow-related conditions such as

septic system failures. However, there is little nearby development, so potential sources of, or contributing to, the observed bacteria levels are not immediately apparent.

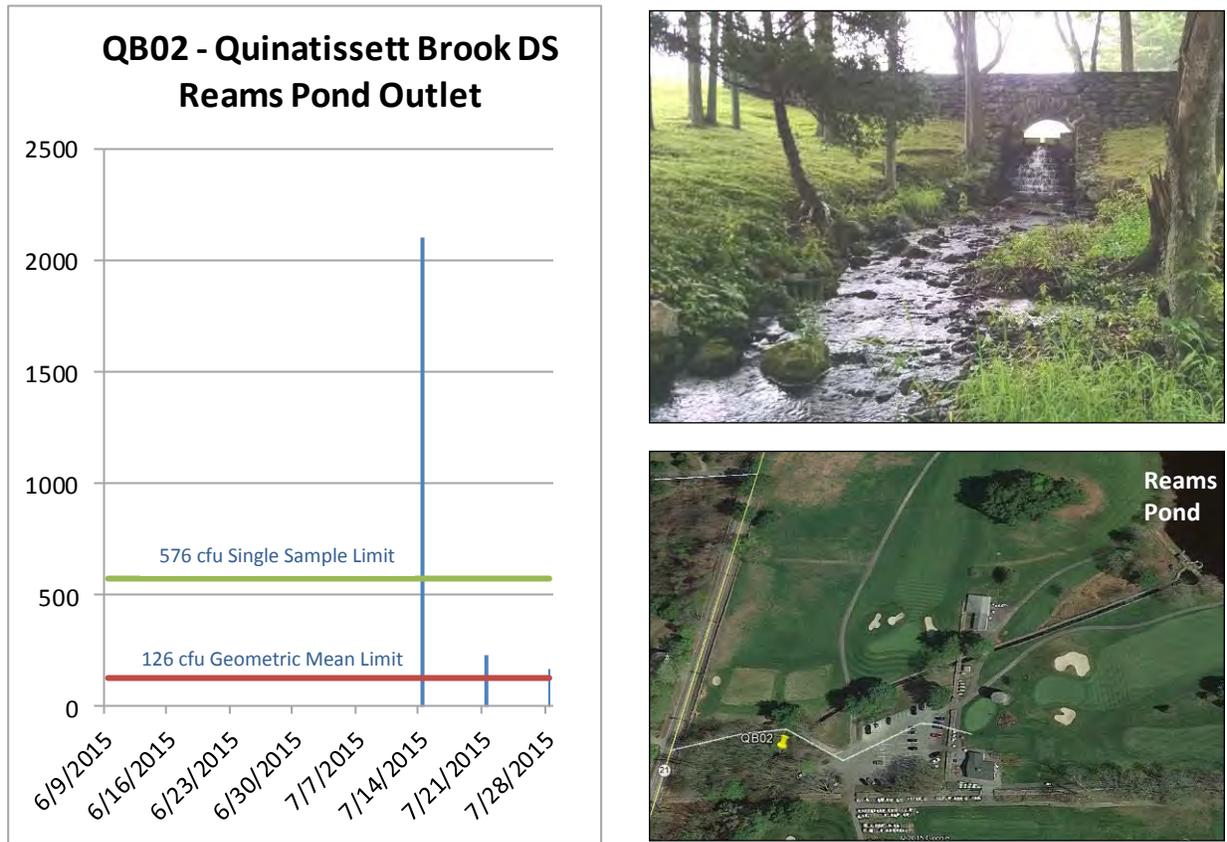
QB02 – Quinatissett Brook at Quinatissett Golf Course, County Home Road (State Route 21):

Figure 26. Graph of bacteria sampling results at QB02; view of Quinatissett Brook upstream of the sampling location; and an aerial image of the sampling site location and vicinity.

Four water samples were collected at this site. Three samples (75%) met Connecticut water quality standard of 576 cfu/100 ml for single samples. The geometric mean for this site is 361, which exceeds the allowable geometric mean of 126 cfu/100 ml. A 65% bacteria reduction is required at this site. It should be noted that only four samples were collected from this site during the sampling period, which does not constitute a reliable sample set.

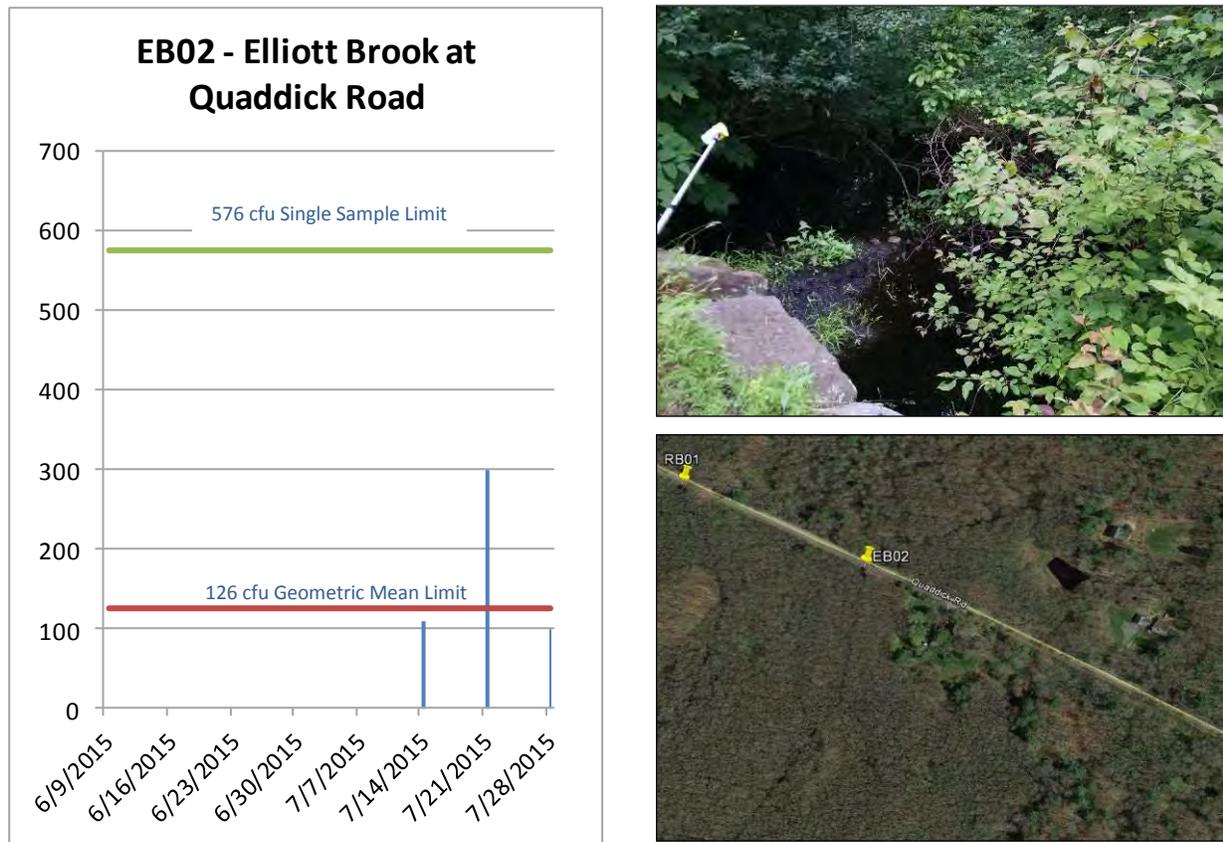
EB02 – Elliott Brook at Quaddick Road:

Figure 29. Graph of bacteria sampling results at EB02; view of Elliott Brook at the sampling location; and an aerial image of the sampling site location and vicinity.

Three samples were collected at this site. All the samples (100%) met Connecticut water quality standard of 576 cfu/100 ml for single samples. The geometric mean for this site is 148, which exceeds the allowable geometric mean of 126 cfu/100 ml. A 15% bacteria reduction is required at this site. It should be noted that only three samples were collected from this site during the sampling period, and do not constitute a reliable sample set.

cfu/100 ml. The geomean at EB02 was 148 cfu/100 ml, which exceeded the allowable geometric mean. There were no obvious nearby conditions such as residential development or agricultural land that might have contributed to the documented bacteria levels in the stream. However, water levels in the stream were extremely low, and it is possible that low flow and ponding conditions may have concentrated background bacteria levels.

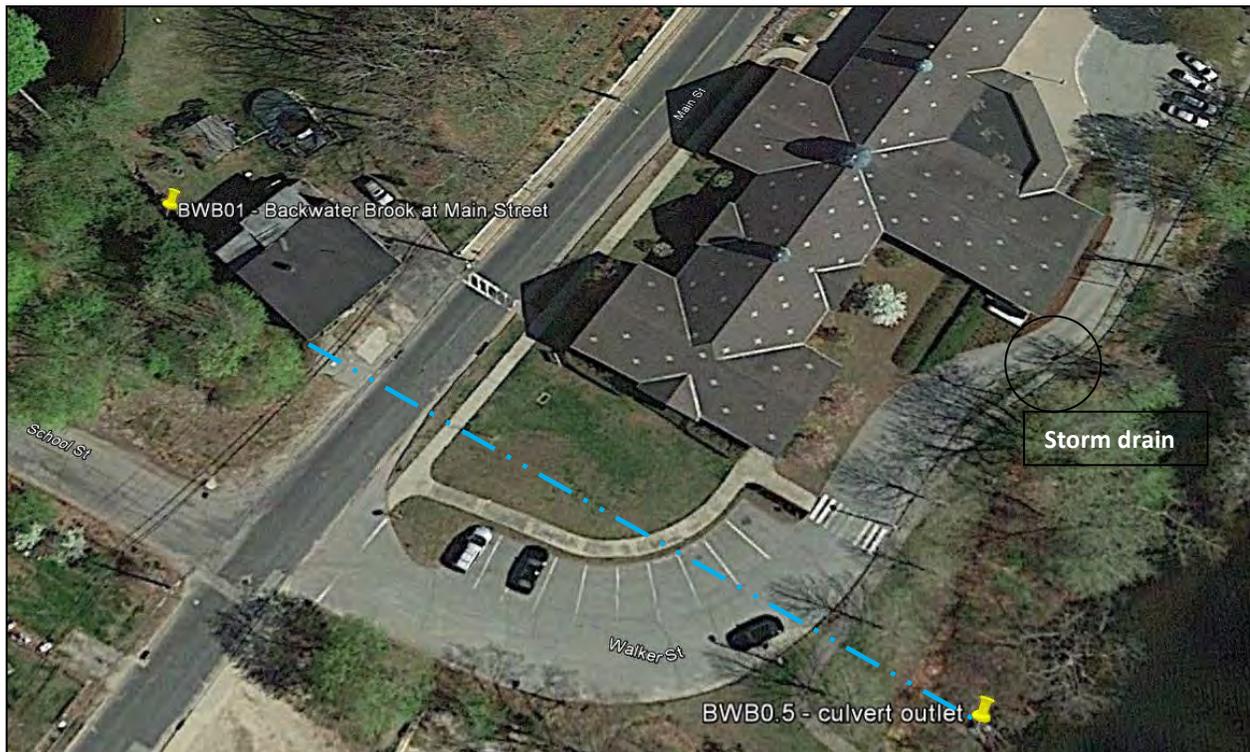
Figure 31. Culverted segment of Backwater Brook (dashed line). Approximately 250 feet of the stream is culverted under Main Street and the Thompson Public Library property.

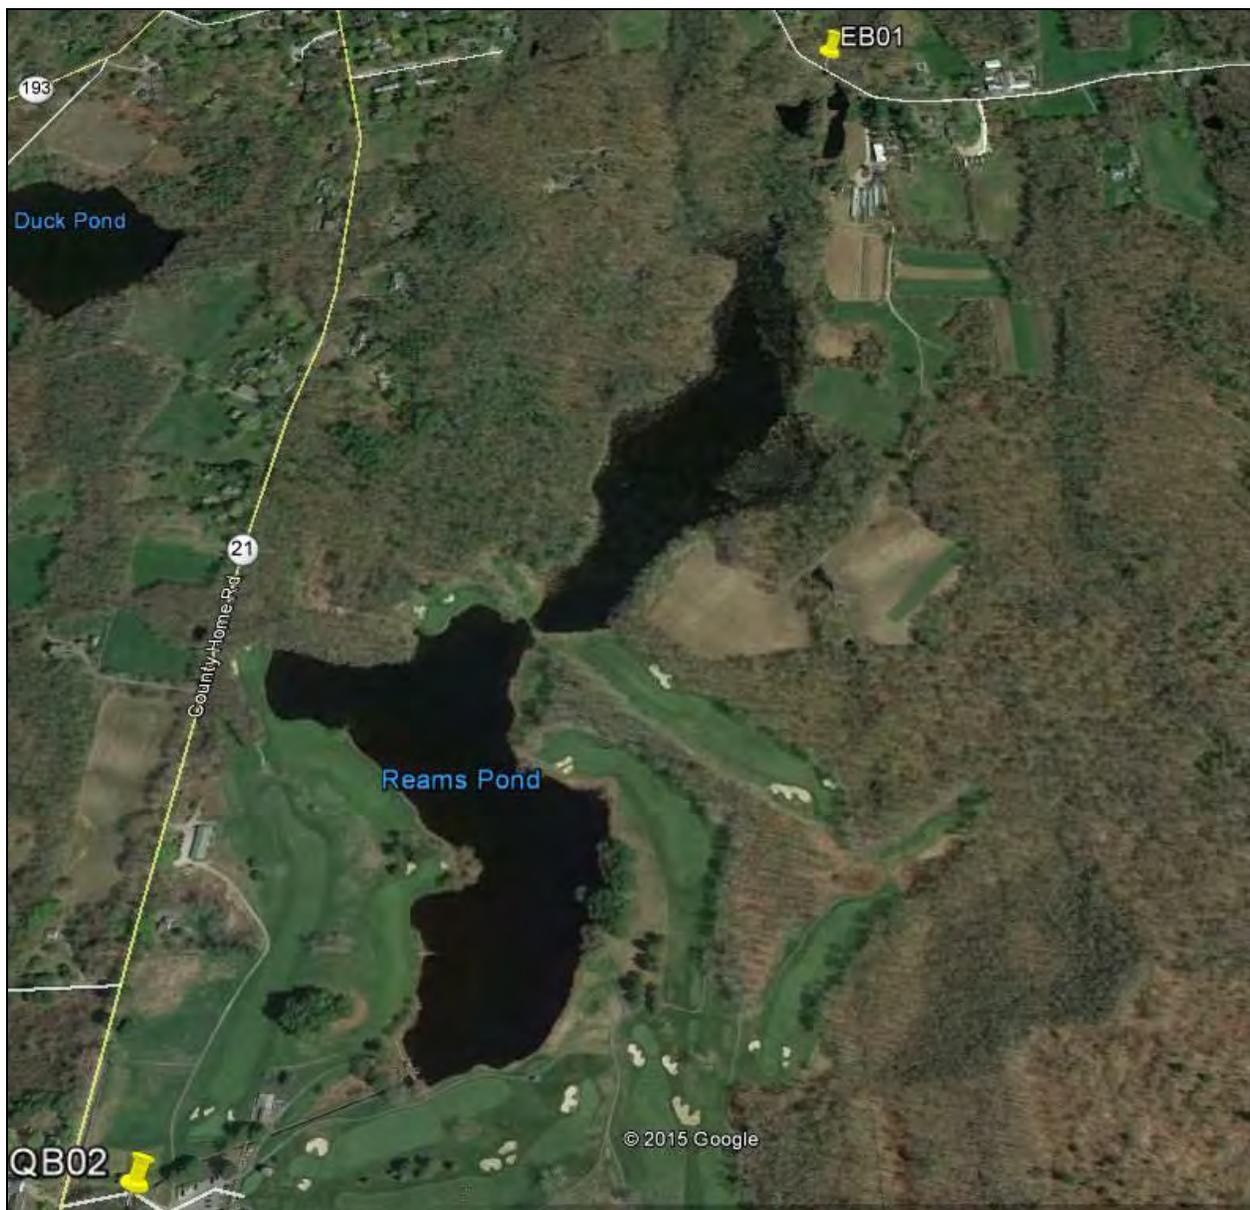
Potential bacteria sources to Reams Pond and Quinatissett Brook upstream of QB02 include agricultural land along the northeast shoreline, and Quinatissett Golf Course along the southeast, south and southwest shorelines. The shoreline of Reams Pond in the vicinity of the golf course is cleared with the greens extending to the water’s edge, potentially creating attractive foraging conditions for waterfowl (Fig. 33). ECCD will follow up with golf course managers to determine if nuisance waterfowl is an issue at the facility.

Figure 33. View of land use along Reams Pond, between QB02 and EB01.

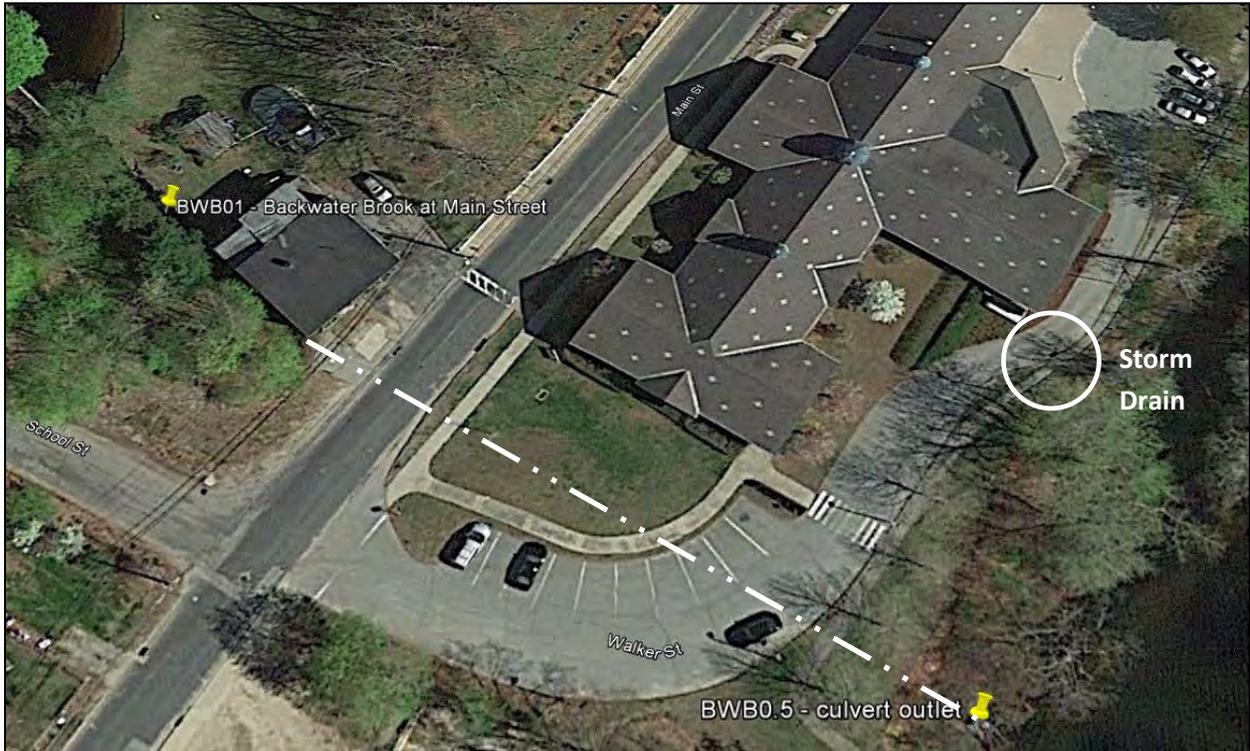
Figure 6. Culverted segment of Backwater Brook (dashed line). Approximately 250 feet of the stream is culverted under Main Street and the Thompson Public Library property.

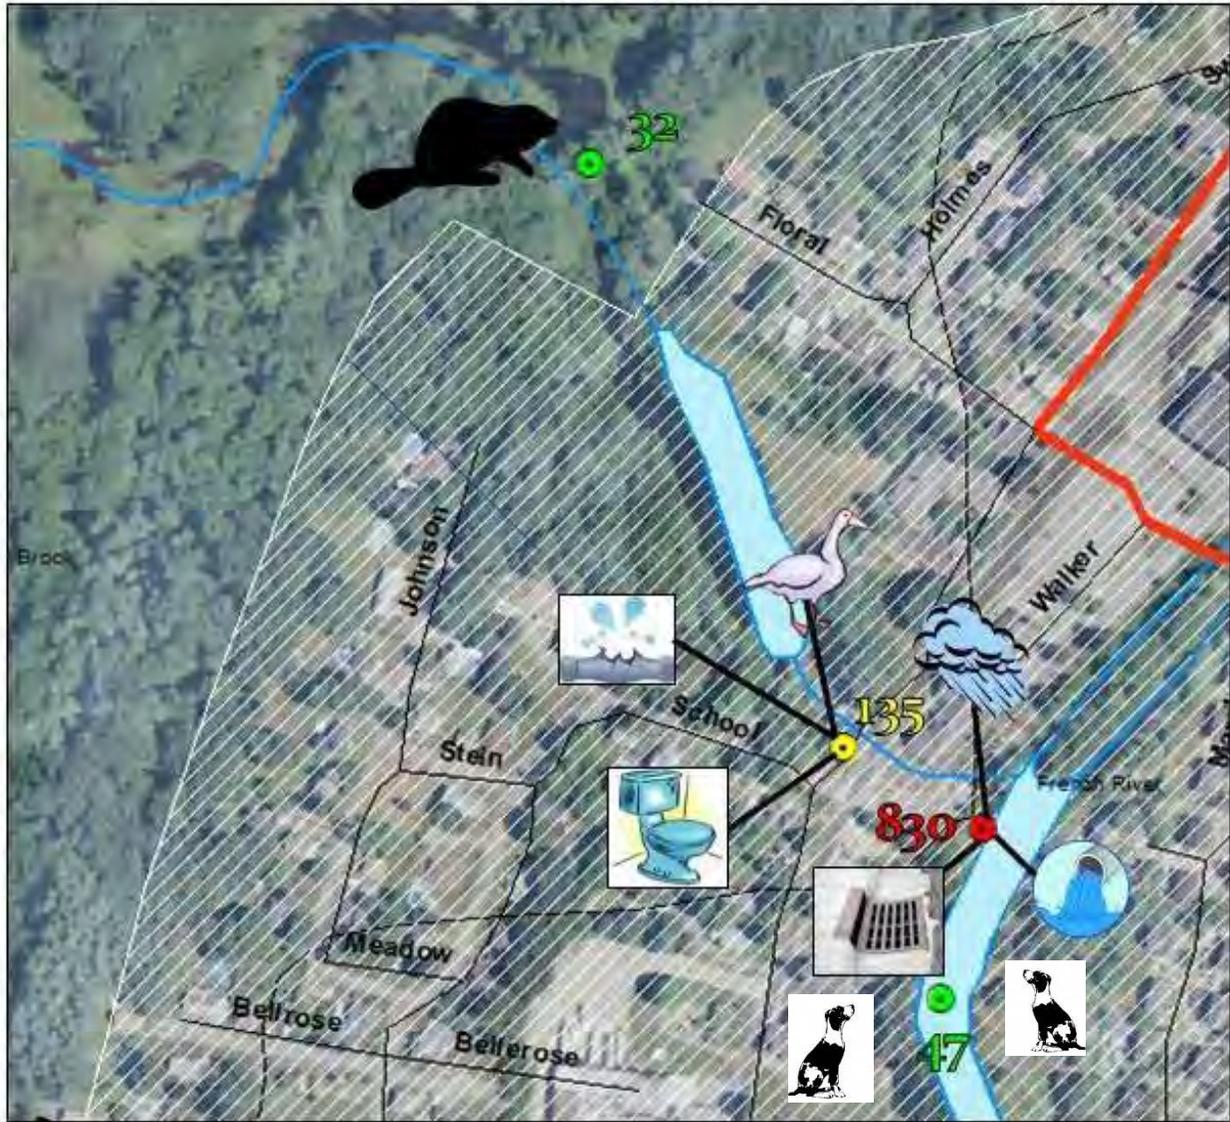
- waterfowl observed at Duhamel Pond;
- unauthorized/un-sewered properties;

- sewer line leaks, including the abandoned sewer main and laterals on the library parcel;
- grey water (which is waste water from domestic sources such as kitchen, bathroom, or laundry, but **not** the toilet) discharges to old septic systems or dry wells;
- fecal bacteria contained in stormwater runoff, including canine fecal bacteria; and
- illicit discharges to the existing storm drain system. An illicit discharge is a discharge to the storm drain system that is not composed of stormwater. This could include the discharge of household waste (grey and black water), automotive chemicals such as gasoline, oil or antifreeze, and carwash waste water.

Figure 8. Possible fecal bacteria sources in the vicinity of Backwater Brook in North Grosvenordale. The hatched area depicts the extent of the municipal sewer service area.

- manage animal waste and waterfowl at Duhamel Pond;
- verify that all properties abutting Duhamel Pond are properly connected to the sanitary sewer system;
- conduct sewer main inspections/regular maintenance; verify the abandoned sewer main at the former Walker Road is not conveying waste;
- identify/verify presence of greywater discharges;
- reduce, infiltrate and/or treat stormwater runoff from surrounding developed area (roads, sidewalks, driveways, buildings, parking lots) prior to discharge to Backwater Brook and the French River;
- encourage dog owners/walkers to clean up after their pets; and
- identify and eliminate illicit discharges to the existing storm drain network.

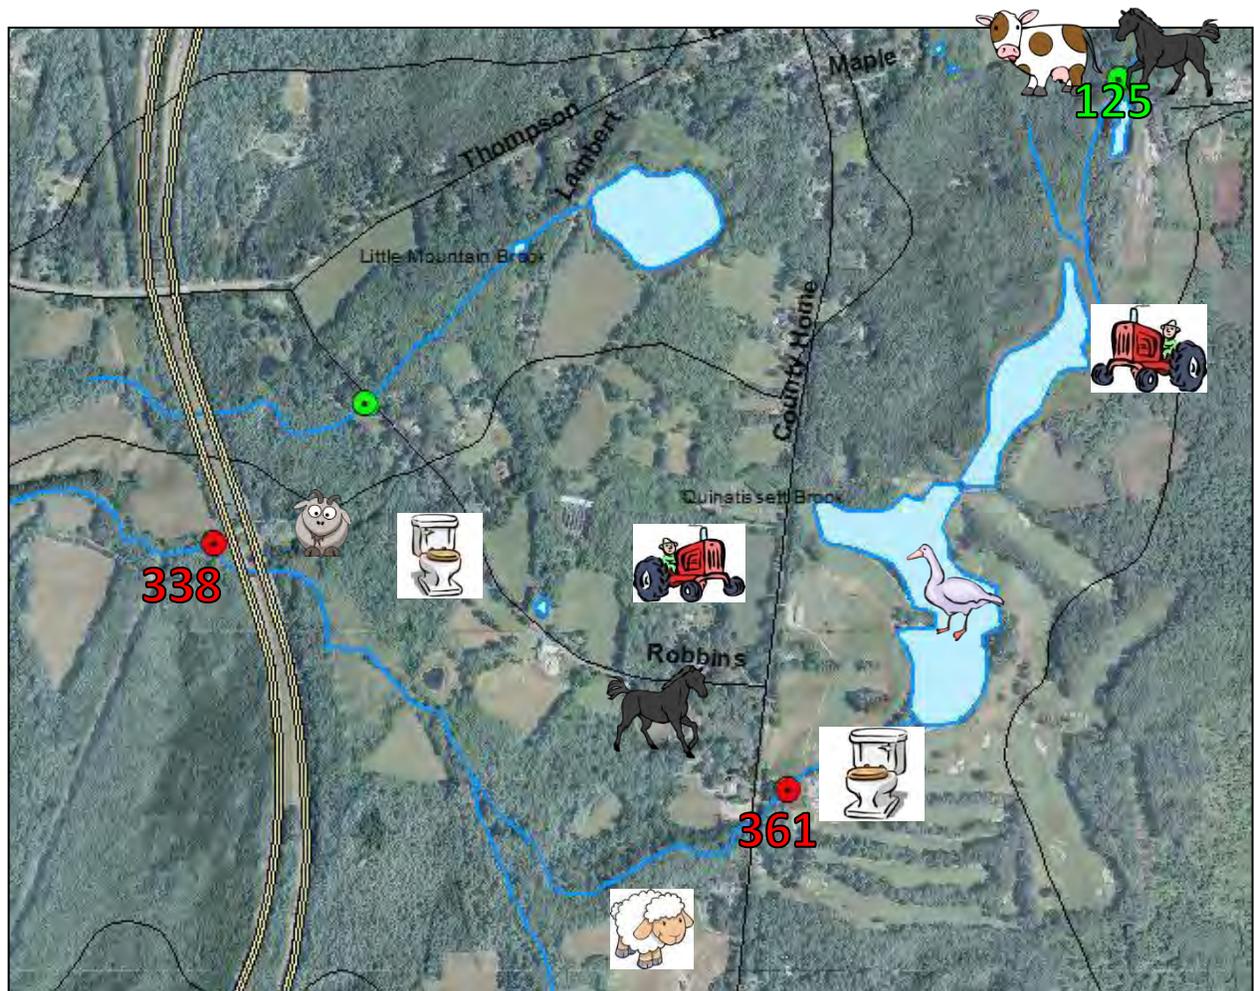
- underperforming/failing septic system at Quinatissett Golf Course;
- underperforming/failing septic systems on Robbins Road and Ballard Road;
- waterfowl at Reams Pond;
- livestock upstream of Reams Pond; and
- livestock on RT 21, Robbins Road and Ballard Road.

Figure 9. Possible fecal bacteria sources in the vicinity of Quinatisset Brook.
