Norwalk River Habitat Restoration Project

Location: Merwin Meadows Park, Wilton
Public property

Implemented: August 1999

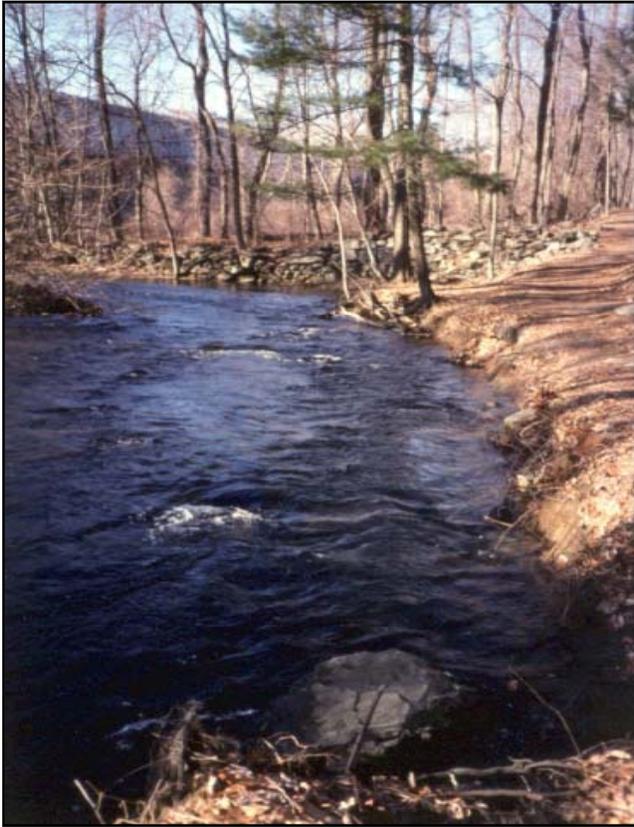
Preconstruction view of project area.

A park maintenance road/pedestrian walking trail is founded atop a major sanitary sewer line paralleling the western bank of the Norwalk River within Merwin Meadows Park. Heavy use of the trail by pedestrians combined with increased watershed development helped accelerate streambank instability and erosion and sedimentation within a 500-ft. stretch of the Norwalk River. Streambank instability was compromising the integrity of the sewer line. The project was designed to stabilize the streambanks, stem the introduction of sediment into the river and restore and enhance instream fish habitats.

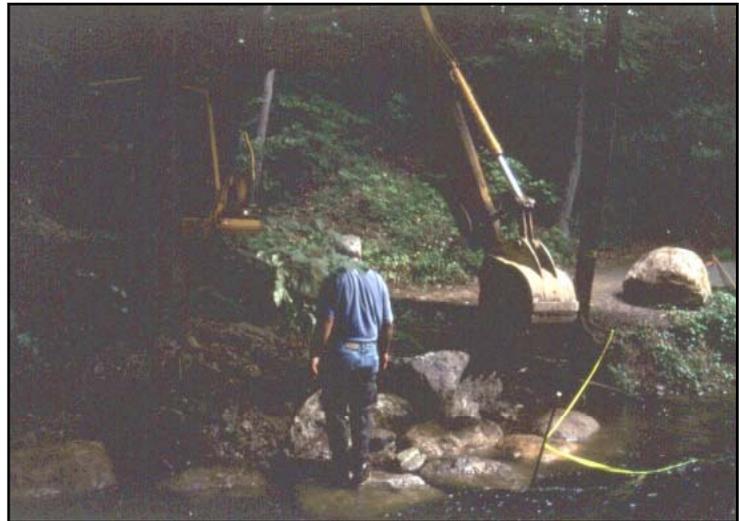
Boulder toe construction.

This streambank stabilization and fish habitat restoration project utilized a variety of hard armoring and soil bioengineering techniques. The 500 linear feet of streambank was stabilized with a large boulder toe, backfilled with organic soil, and then seeded with a quick growing grass mix. Biodegradable erosion control fabric protected the fill slope until the seed germinated. Live stake plantings were later installed. A rock deflector was constructed to concentrate the river's thalweg towards the center of the channel, away from the eroding streambank. A cantilevered timber structure was installed to replicate an undercut bank; this habitat feature provides valuable overhead cover for fish. Random boulders were placed to enhance instream fish habitats.

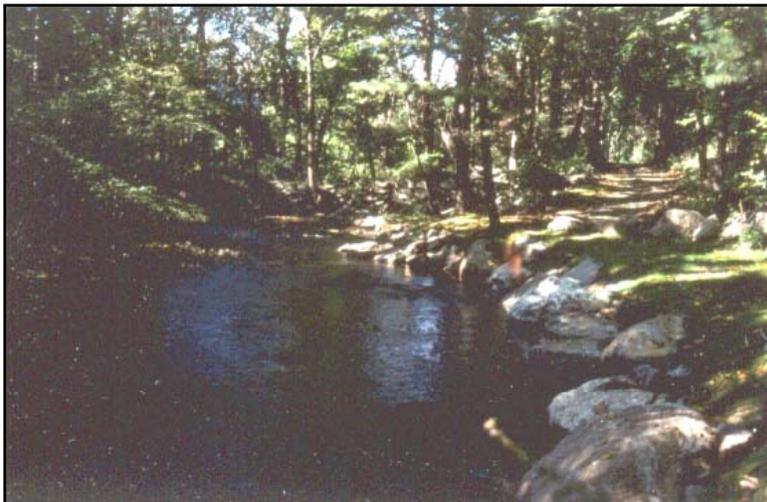
Post construction view of bank stabilization using boulders.
