West Branch Farmington River Habitat Restoration Project

Location: West River Road,
Barkhamsted, Public property

Implemented: September 2002

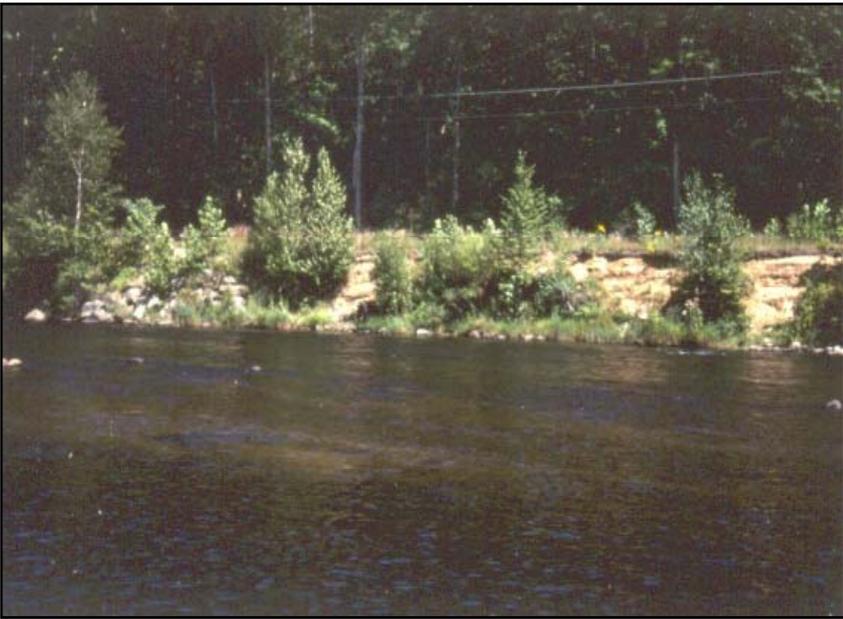
Bank instability prior to restoration efforts.

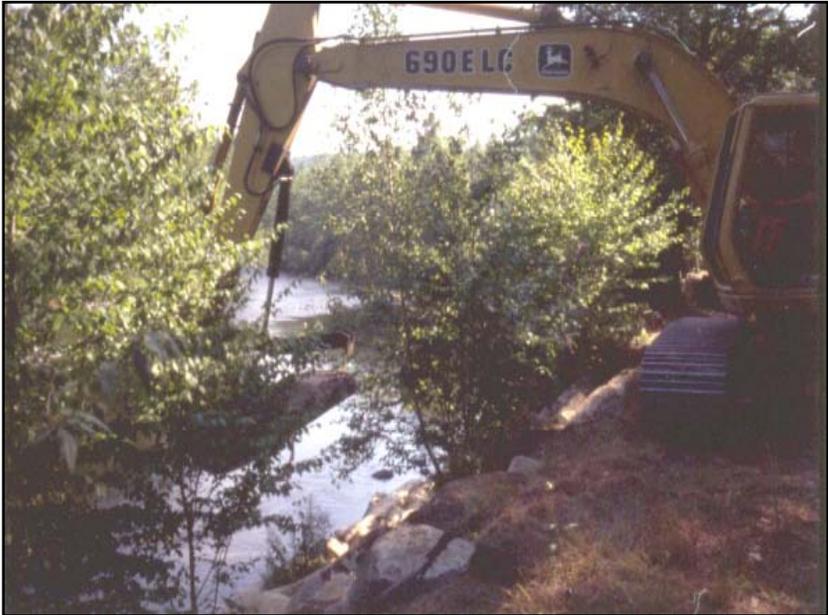
Stabilization of streambank toe using boulders.

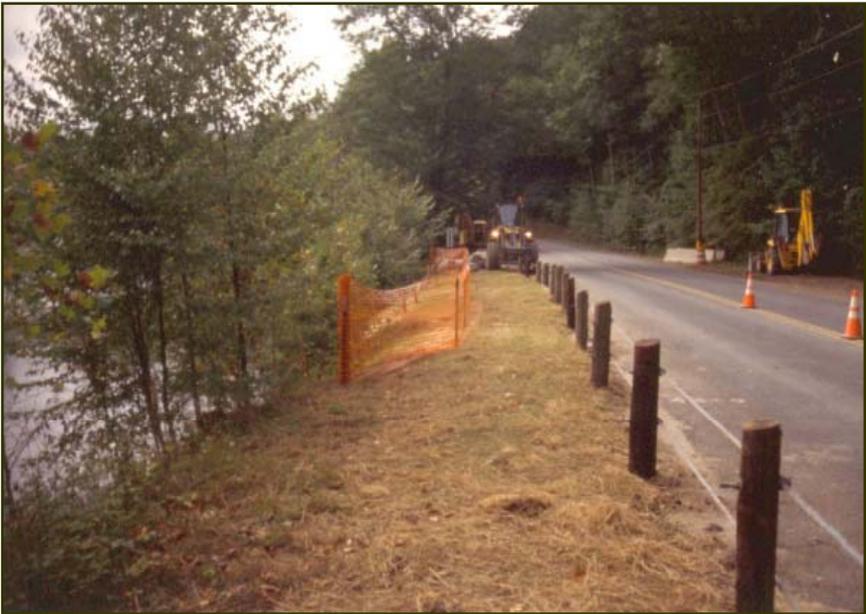
Stabilization of top of bank adjacent to West River Road.

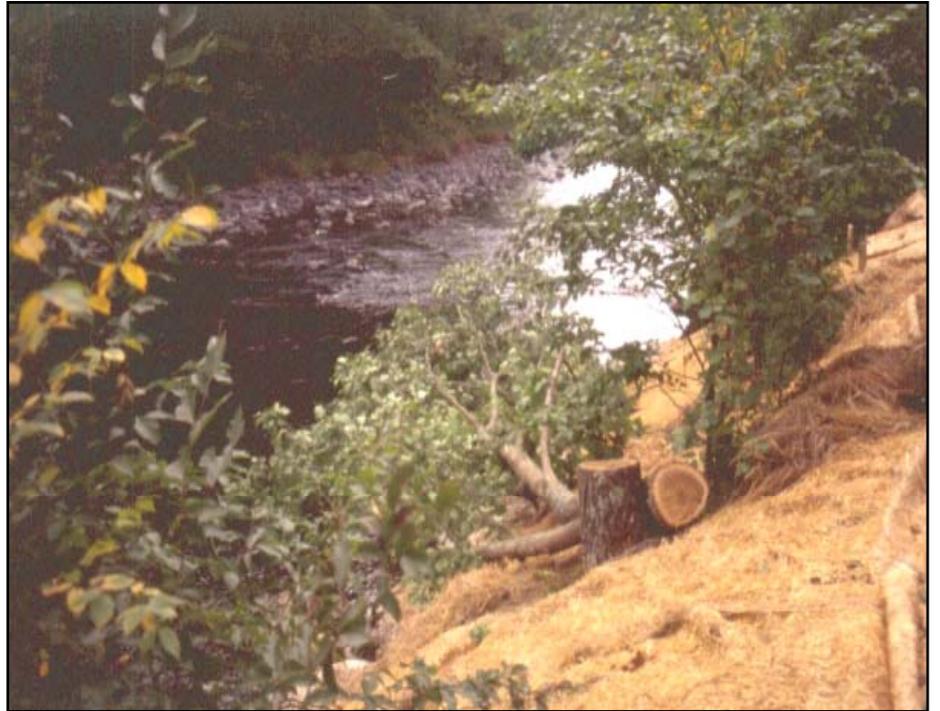
**Hinge-felled tree
placed in Farmington
River to provide
overhead fish cover.**

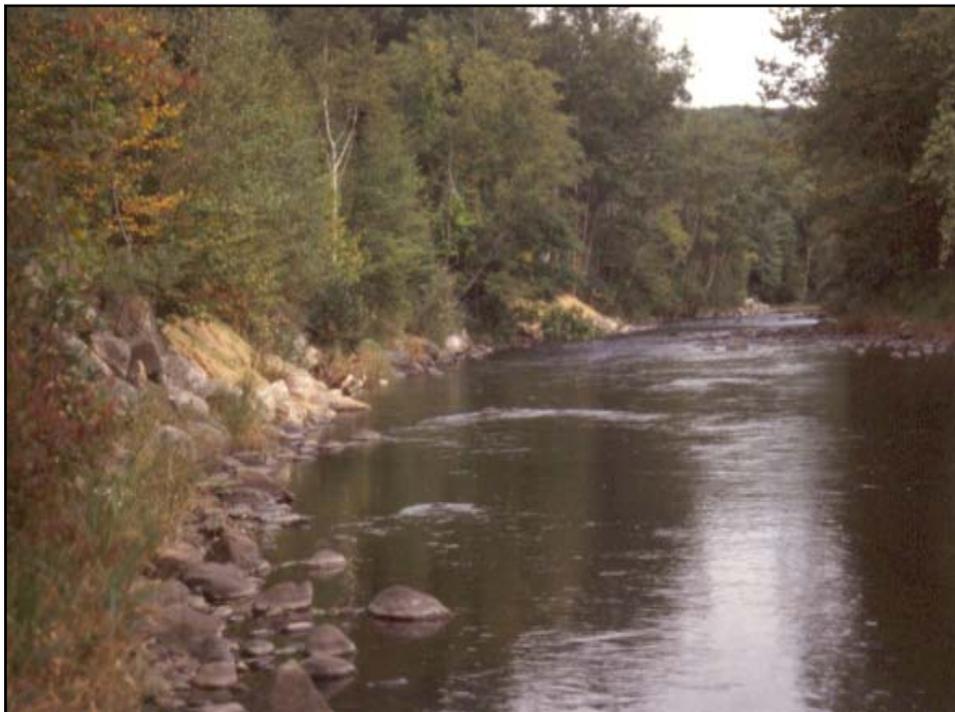
**View of
streambank
stabilization
post restoration.**
