Public Meeting

Norwalk River Site 2 Dam

Dam Rehabilitation Project

April 19, 2018

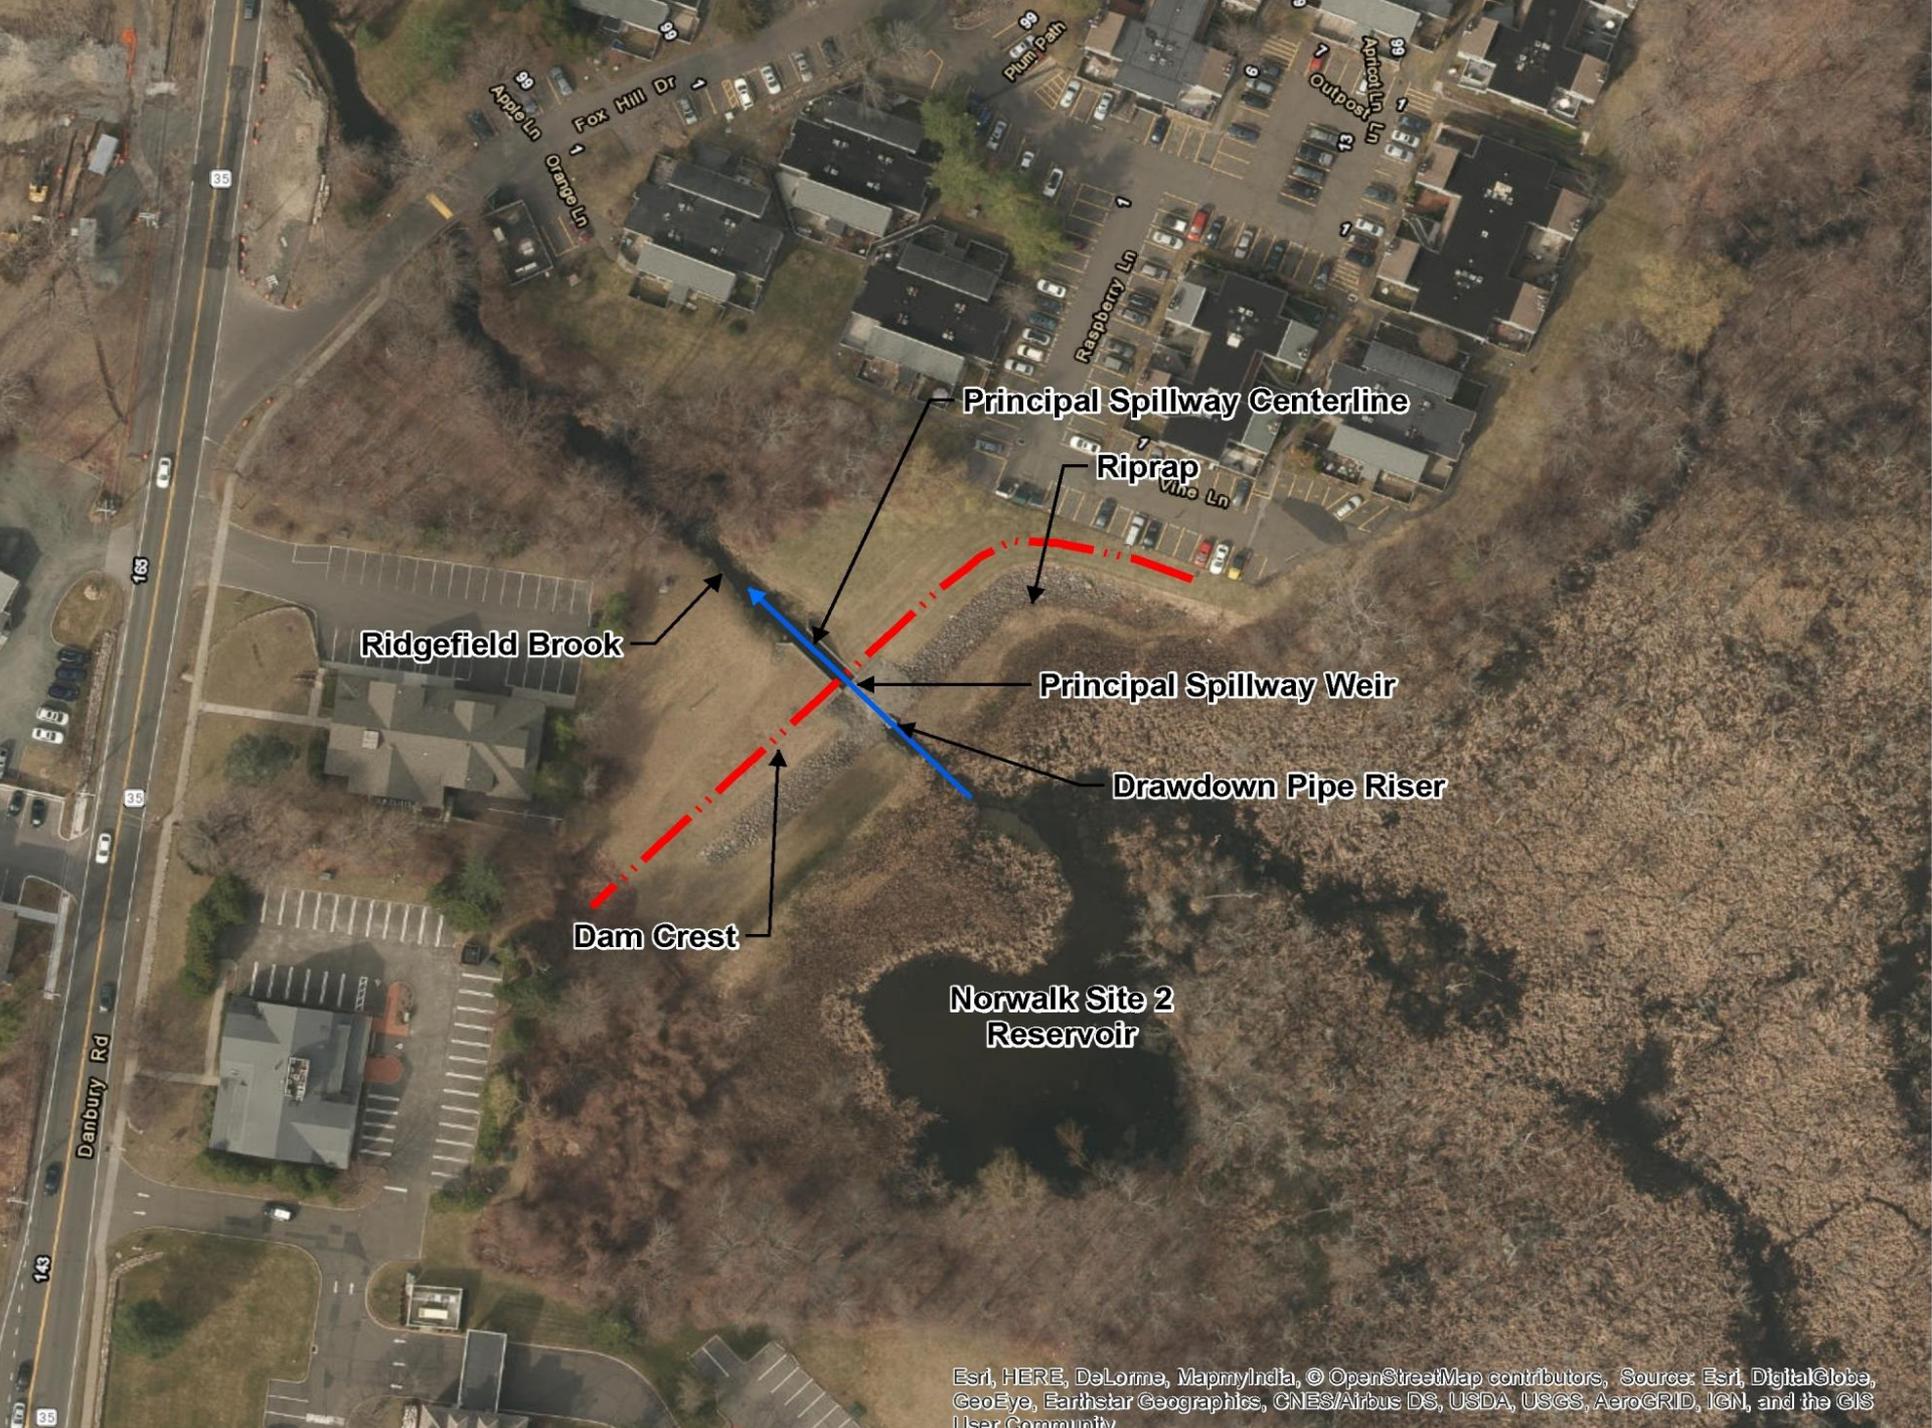
Ridgefield Brook

Dam Crest

Principal Spillway Centerline

Riprap

Principal Spillway Weir

Drawdown Pipe Riser

Norwalk Site 2
Reservoir

- Built in 1979
- Drainage area = 1,628 acres
- Normal pool surface area = 0.8 acres @ EL 571.0
- Design high water = 267 acres
- Top of dam = 336 acres
- Wetland wildlife habitat area = 87 acres
- Length = 440 feet
- Height = 10 feet
- Constructed as a “Significant” hazard dam

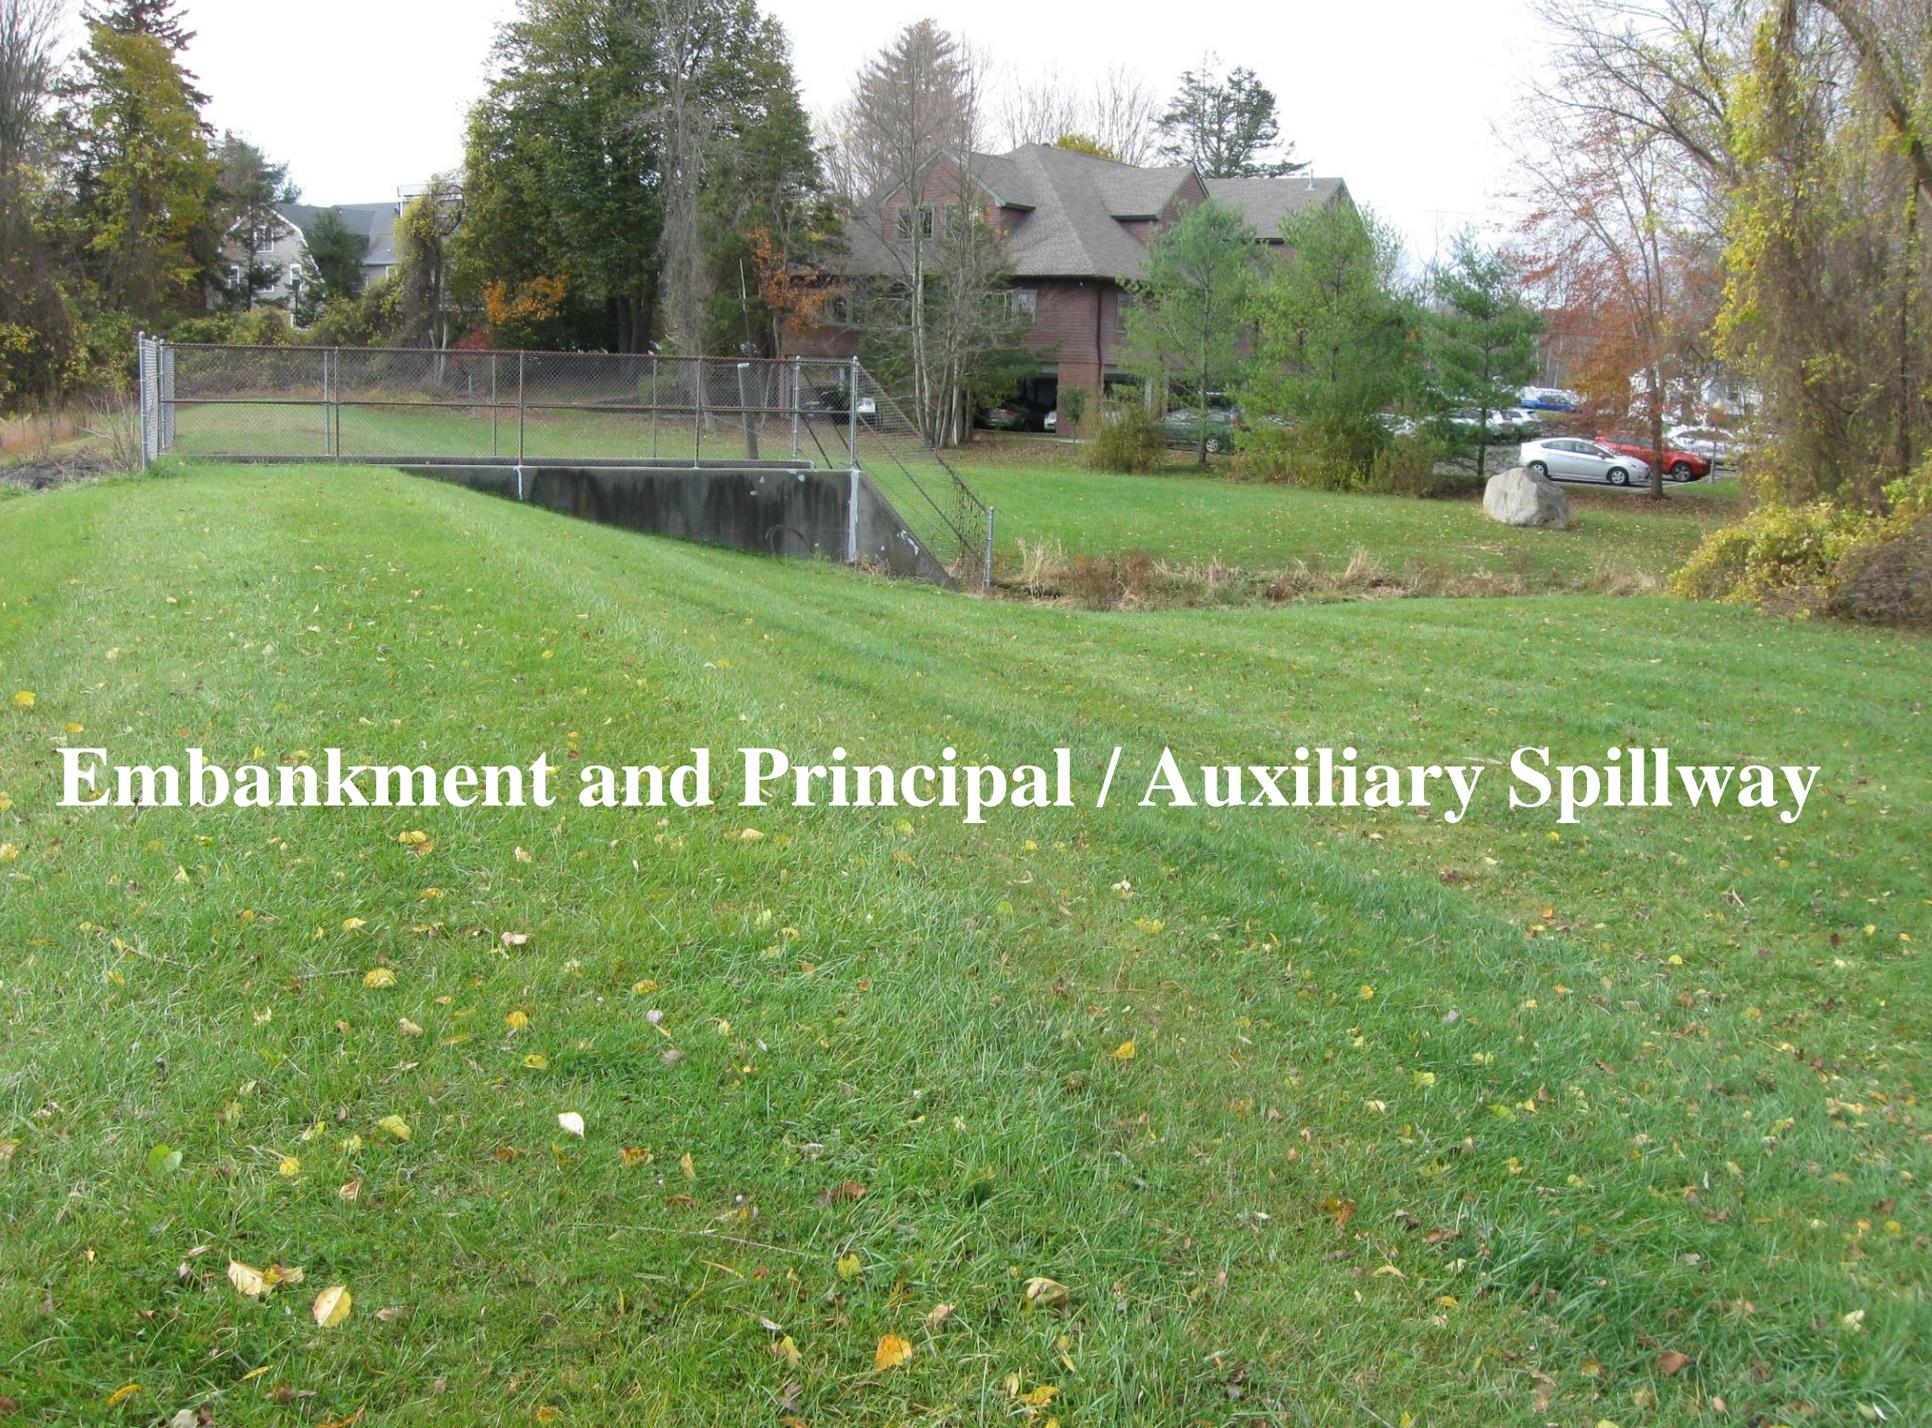
Embankment and Principal / Auxiliary Spillway

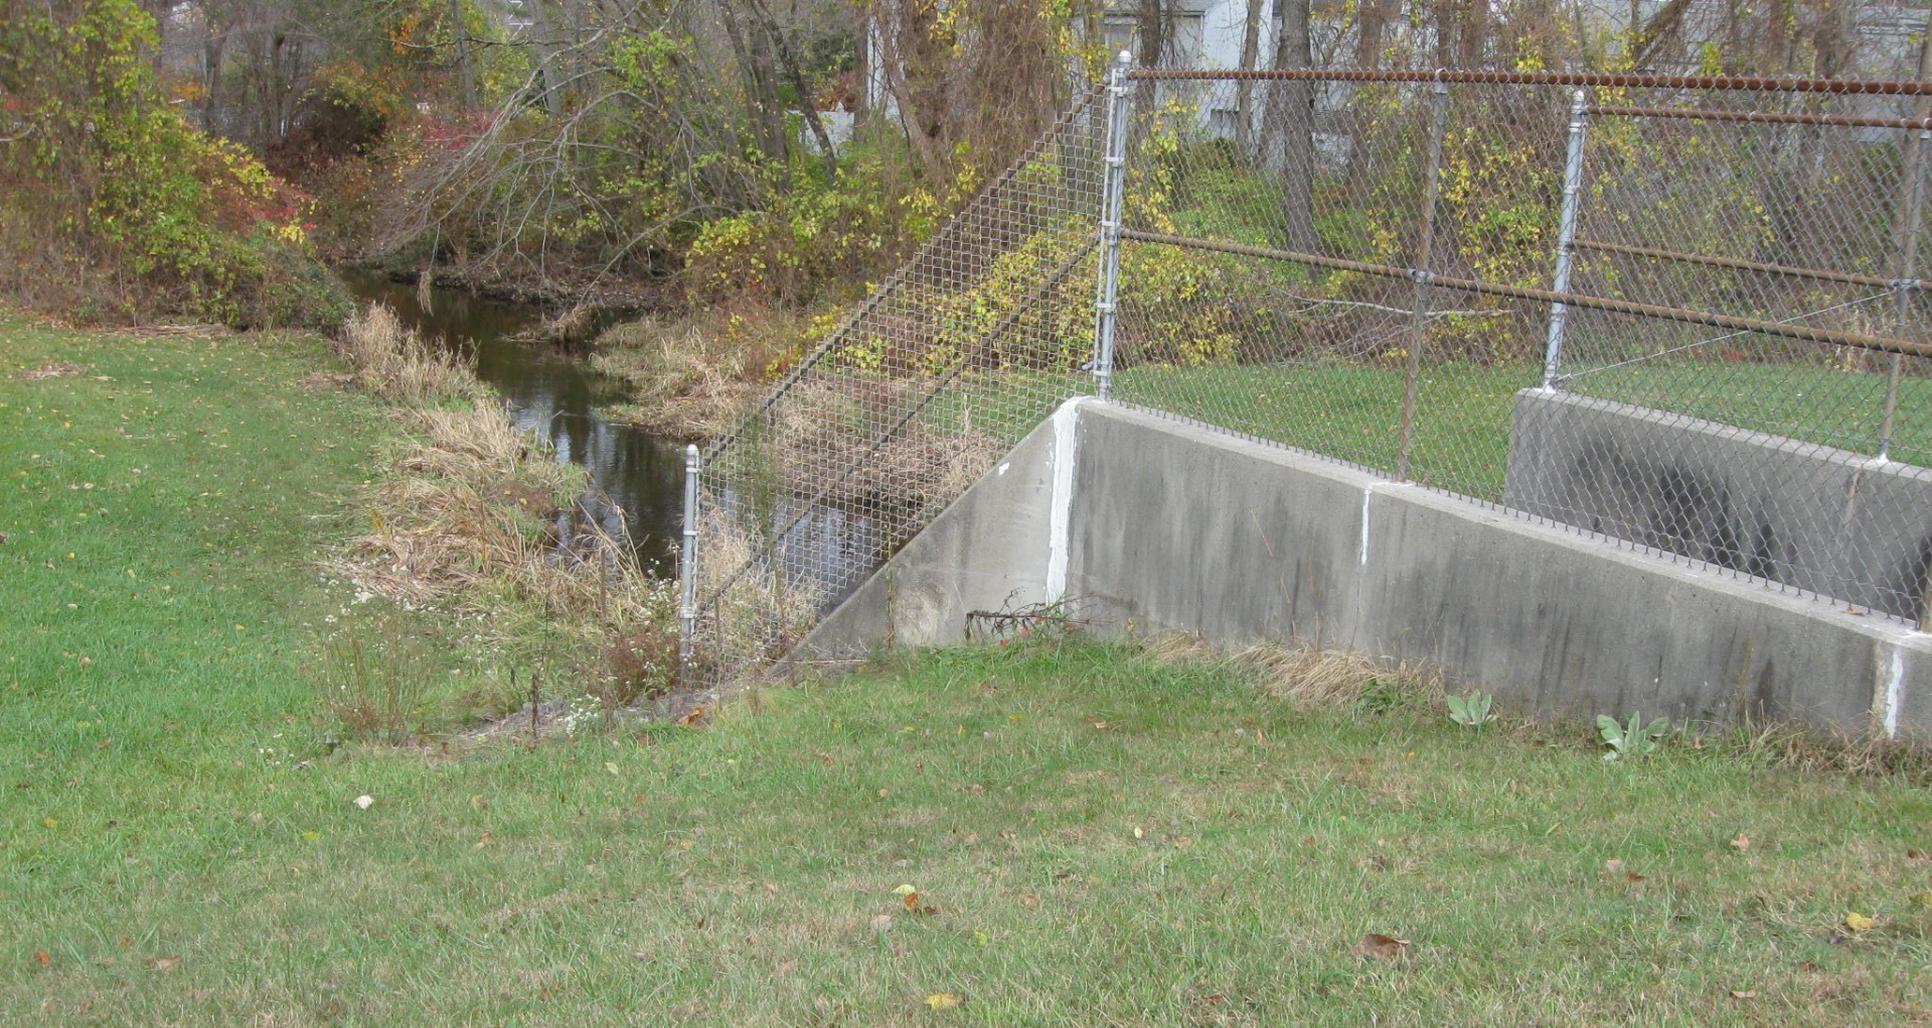
Principal/Auxiliary Spillway – Left Side

Looking from Right Abutment

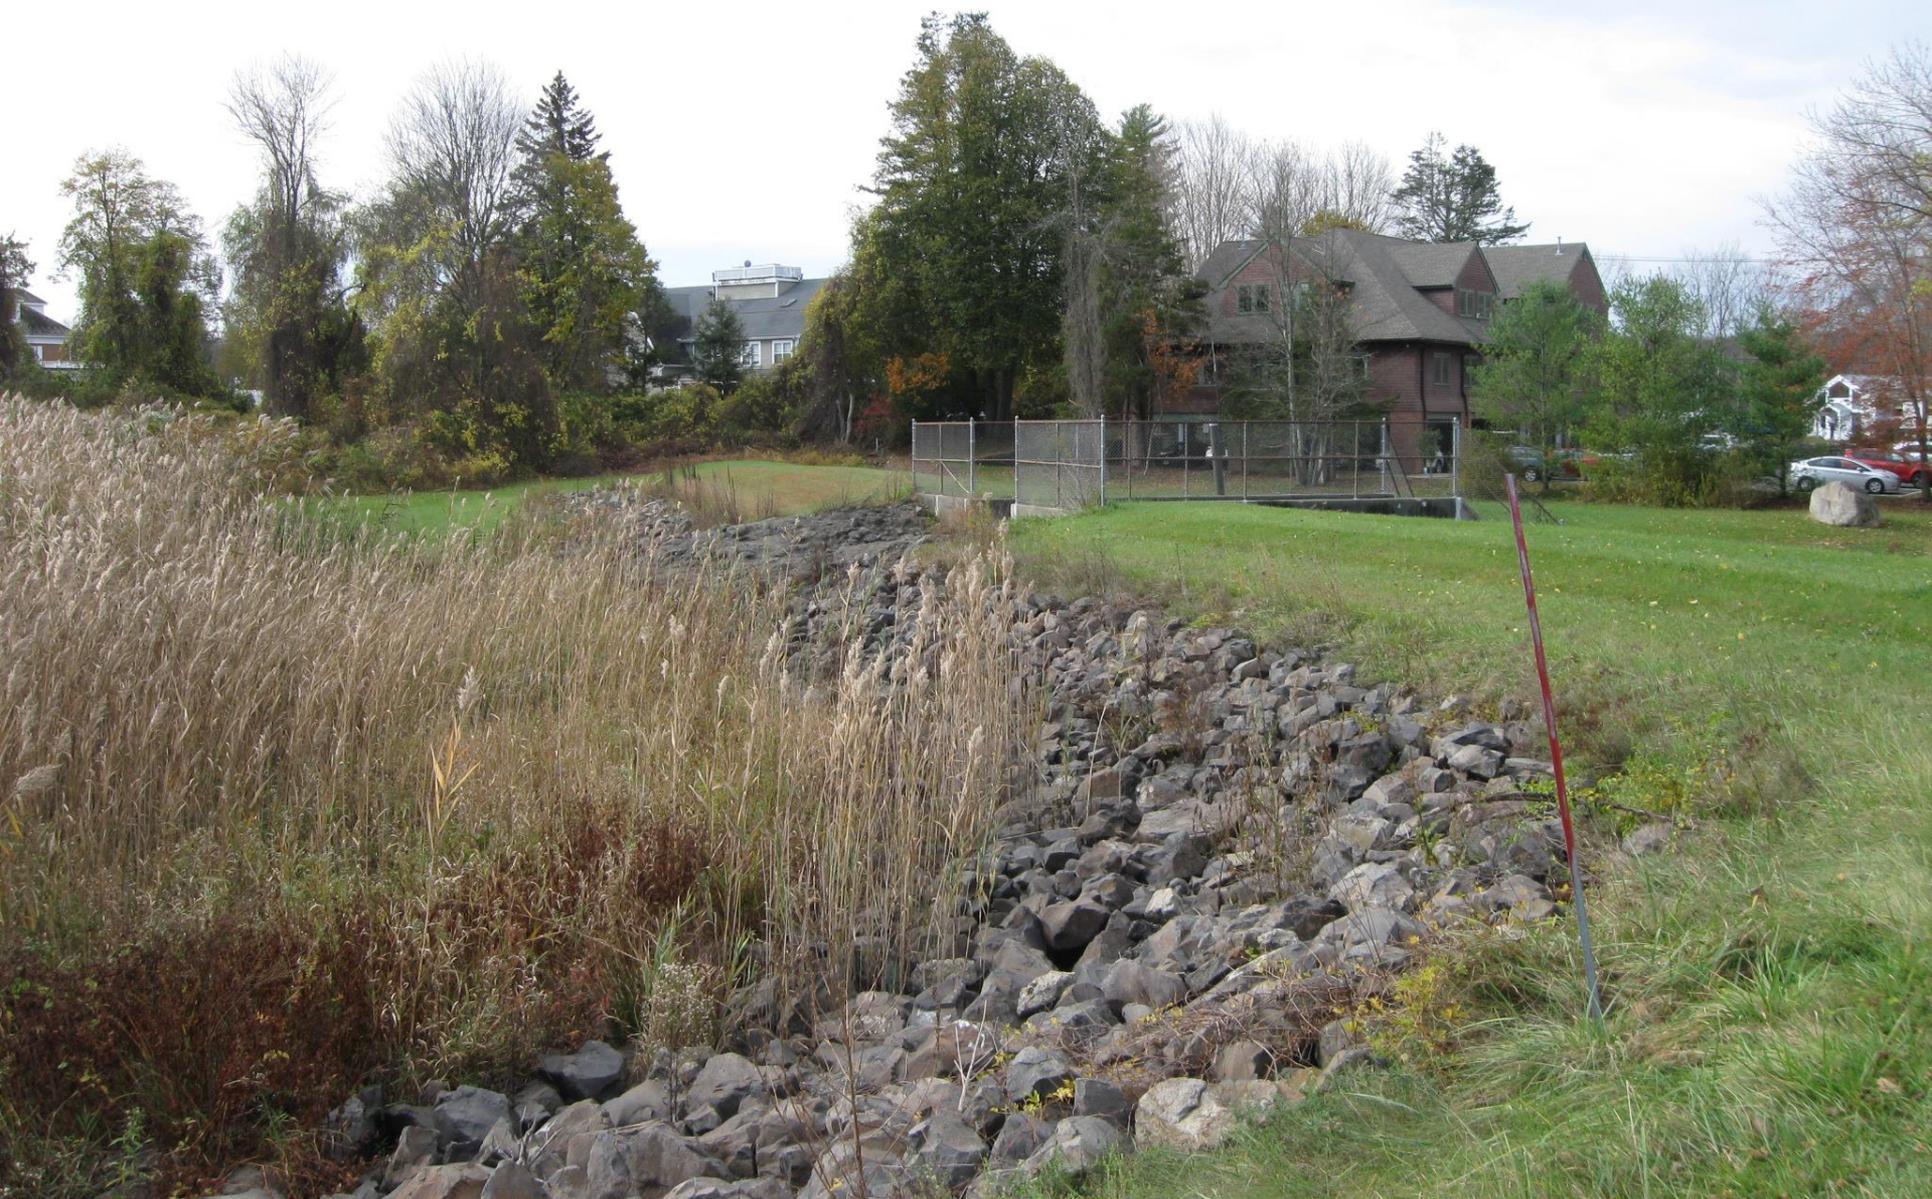
Upstream Embankment-From Principal/Auxiliary Spillway

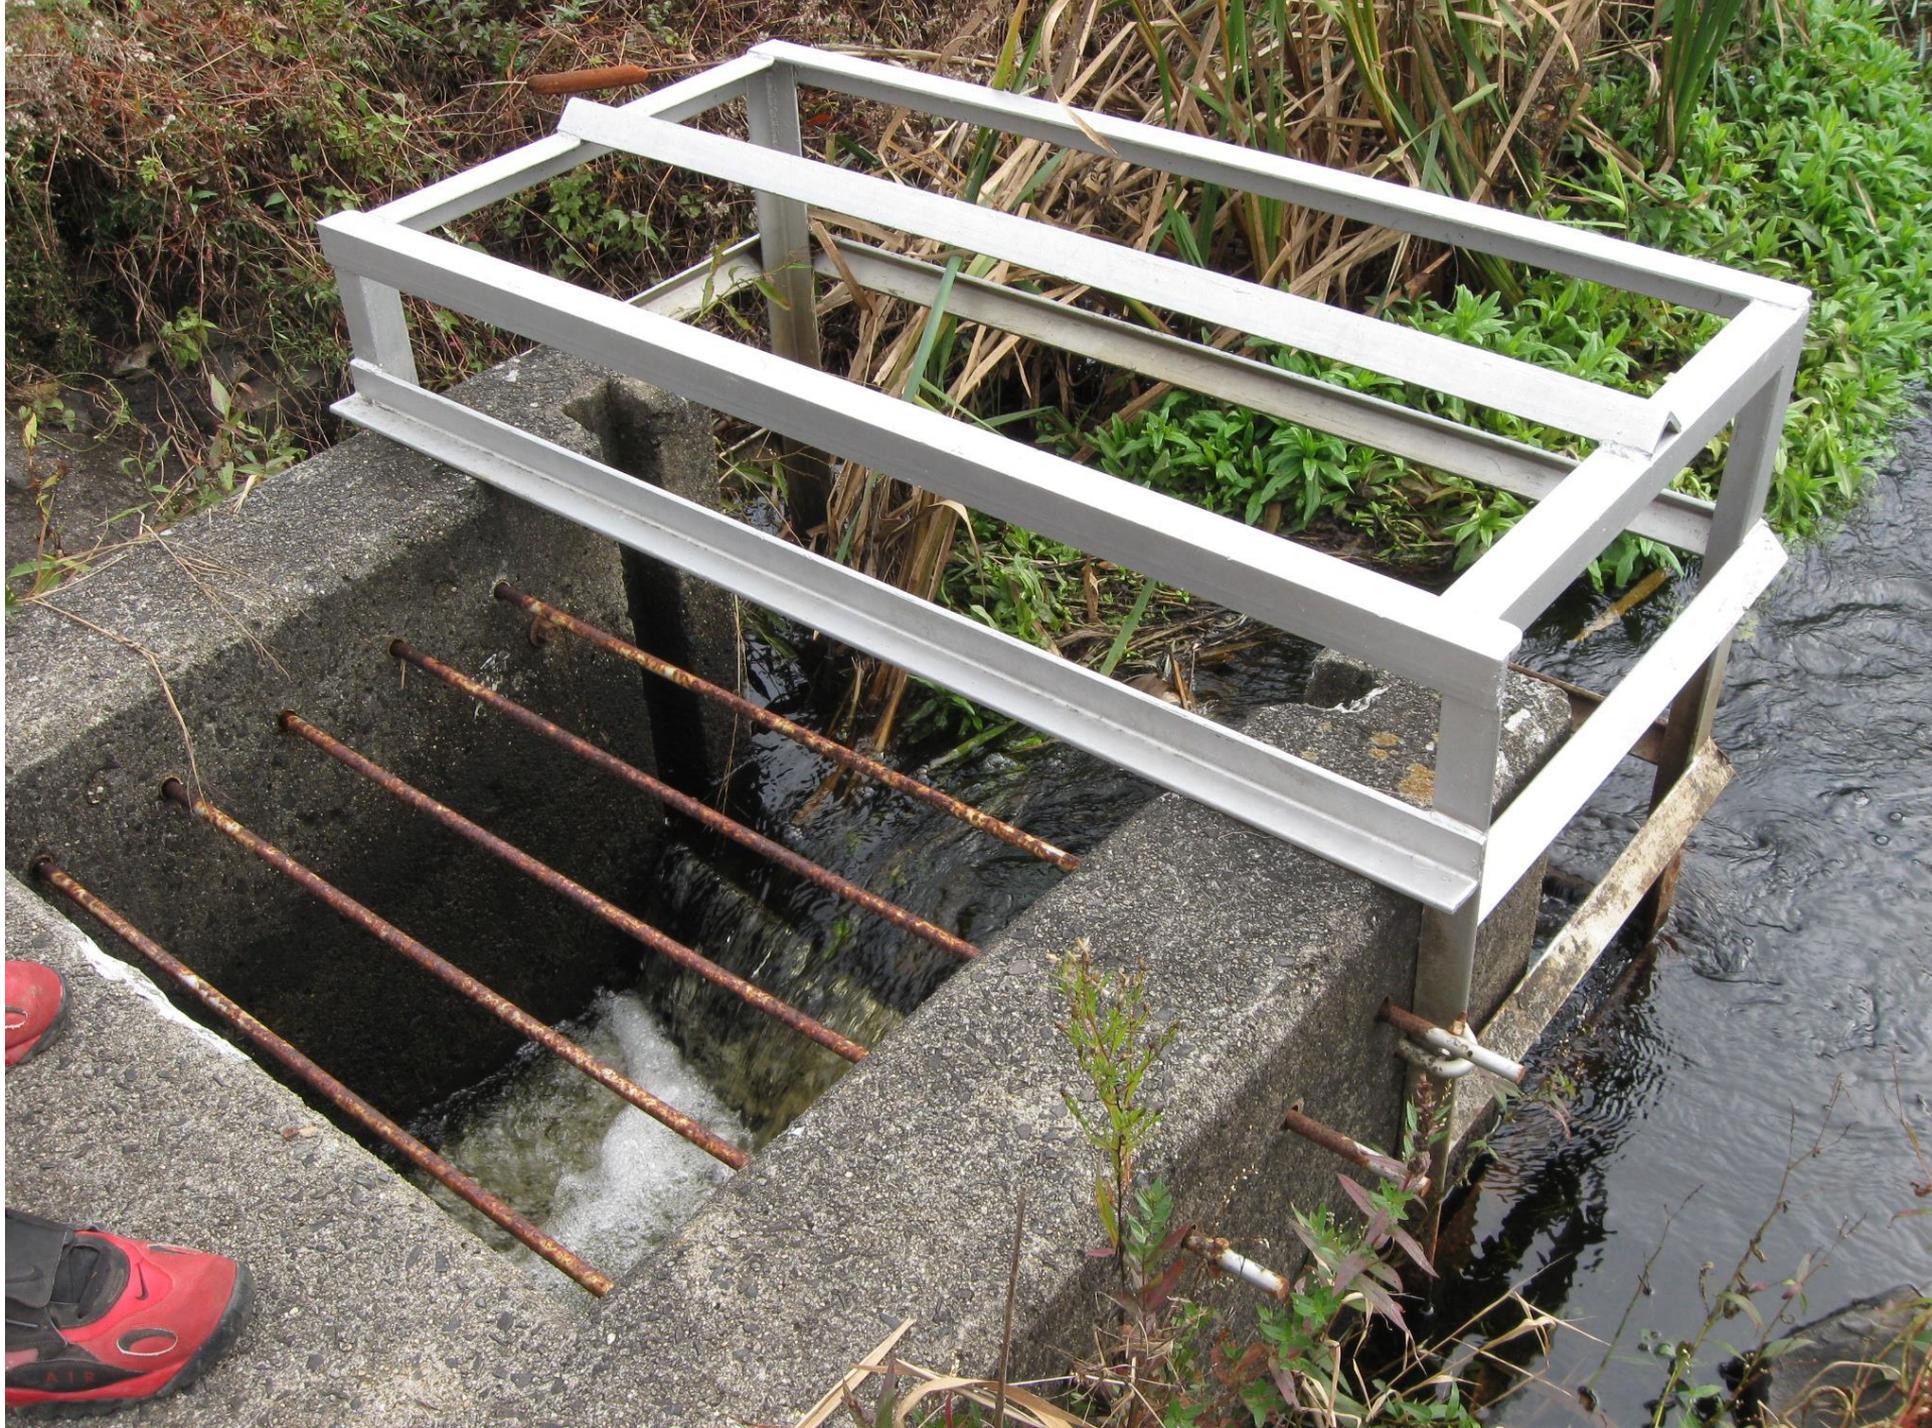
Low Flow Outlet - Looking Upstream

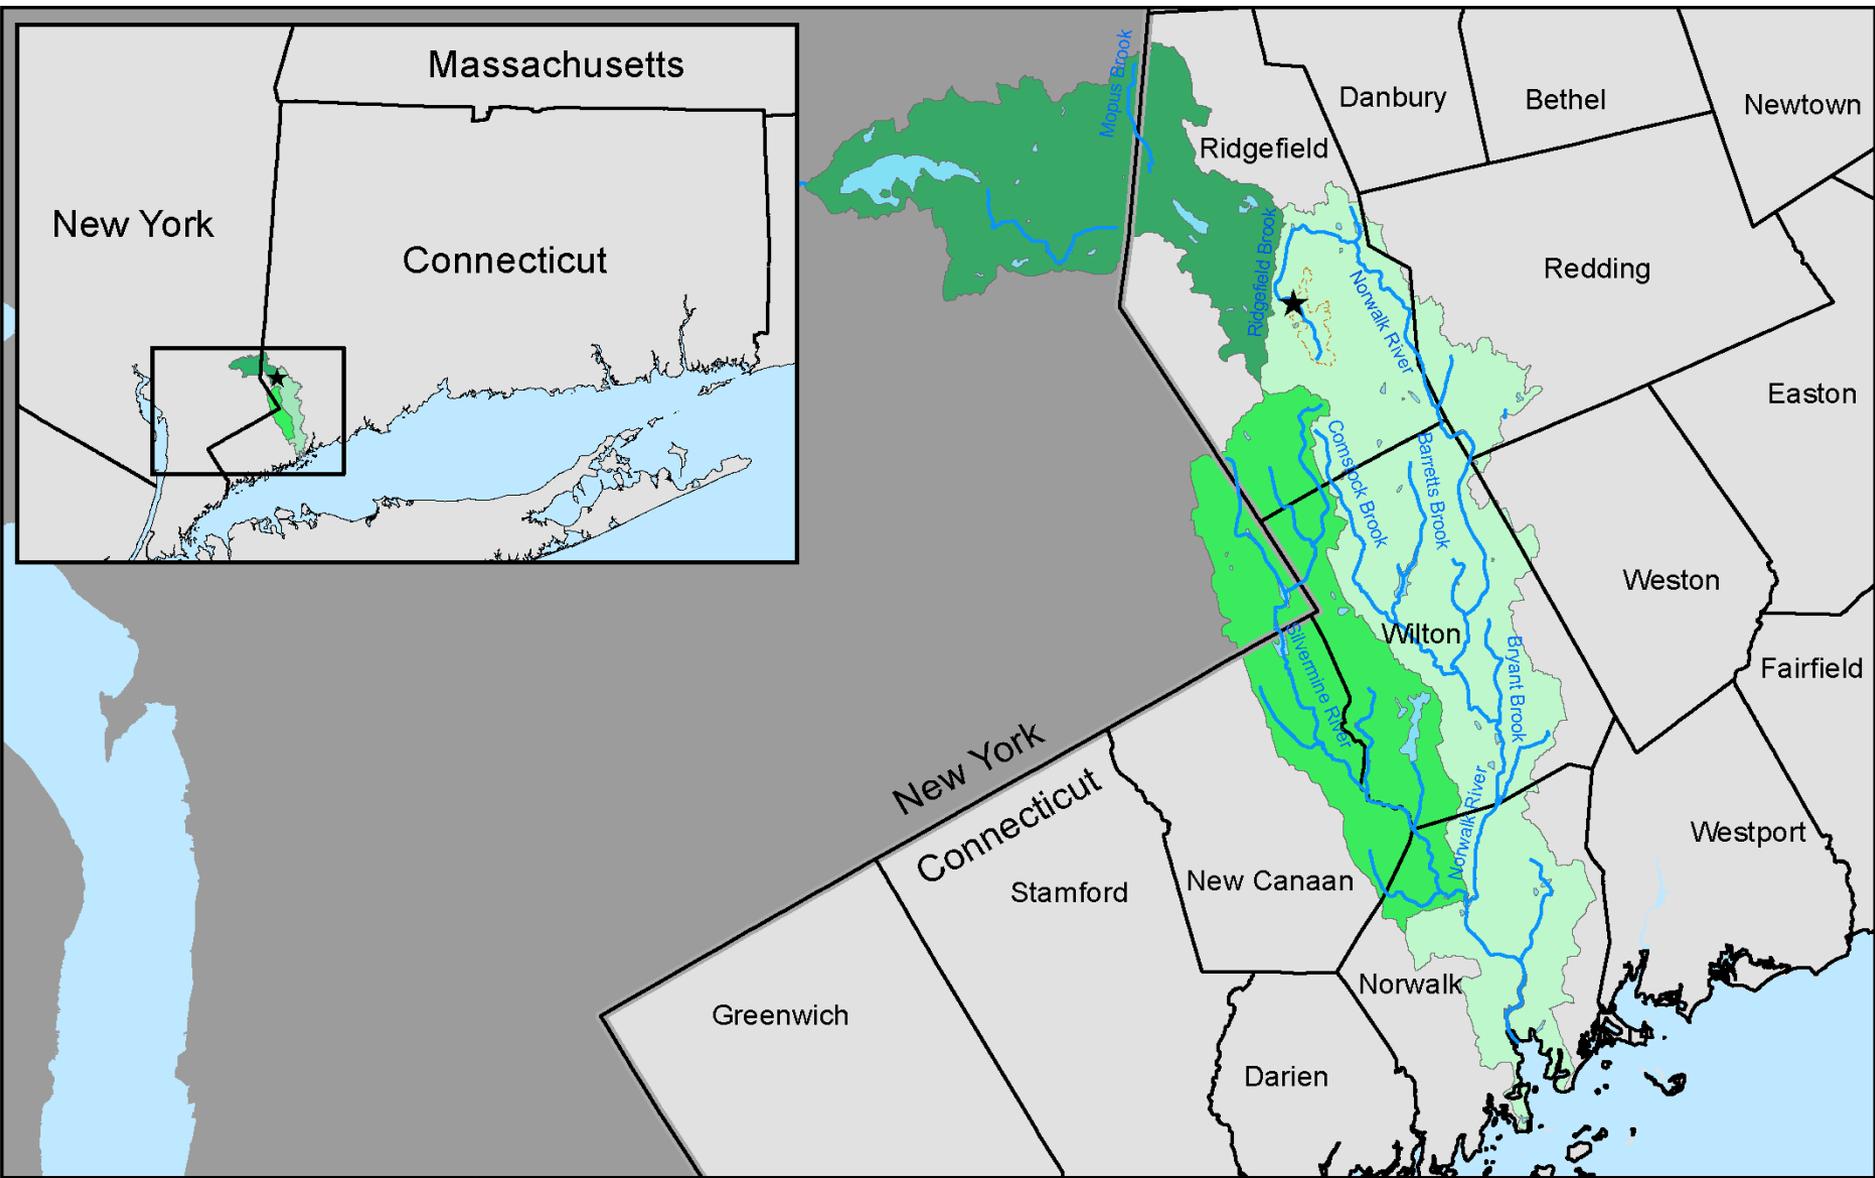
Figure 1-1
Norwalk River Subwatersheds and Adjacent Titicus River Subwatershed

- ★ Norwalk River Site 2 Dam
- Potential Max. Flood Pool (581 ft NAVD88)
- Streams

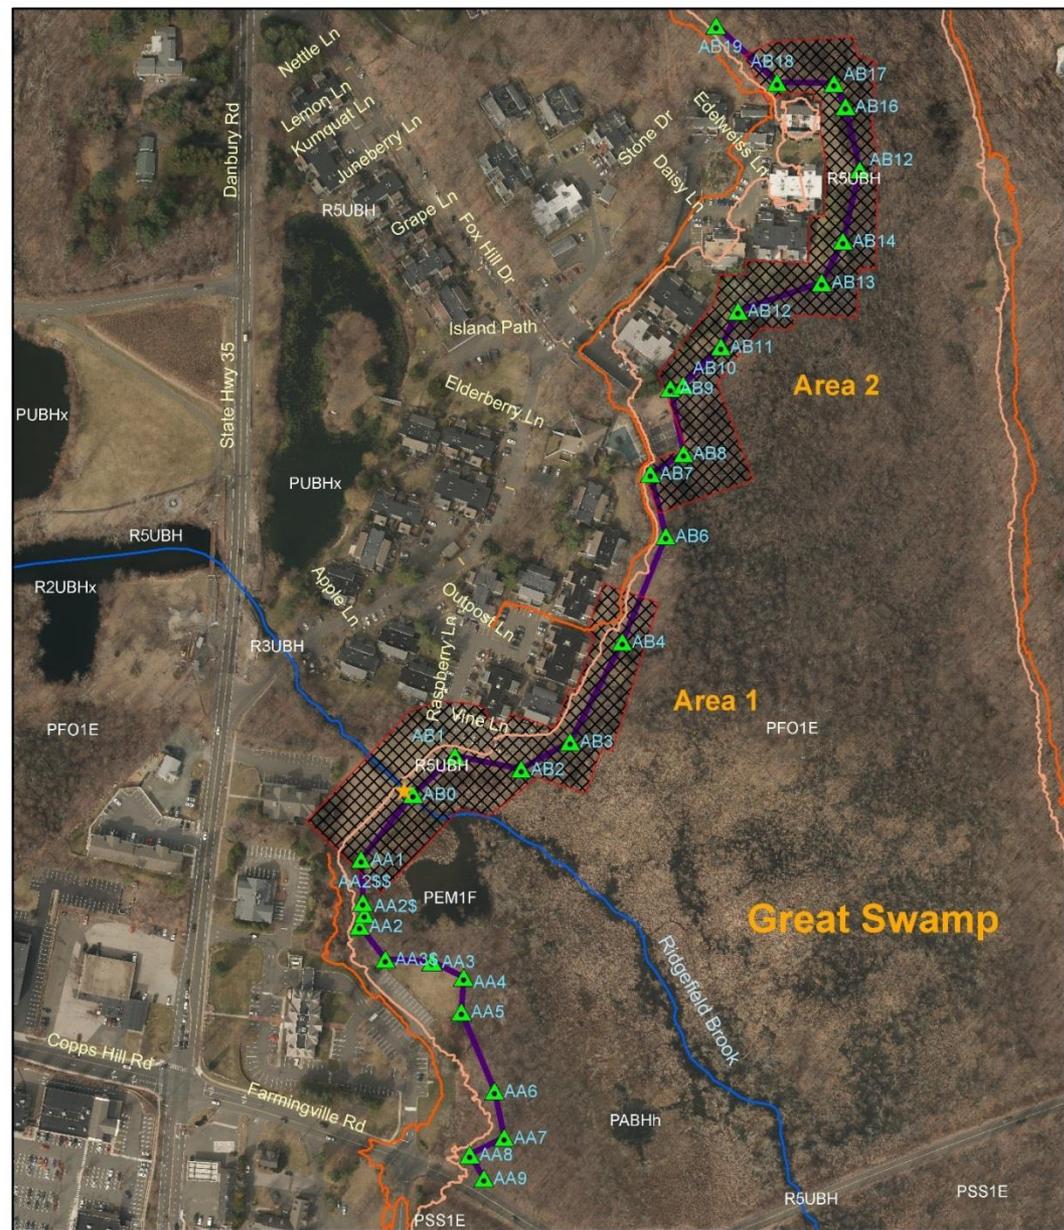
Figure 3-1
Wetlands Delineation
Site 2 Dam Area
December 22, 2017

Wetlands Delineation in Areas 1 and 2 (near Fox Ridge Condos)

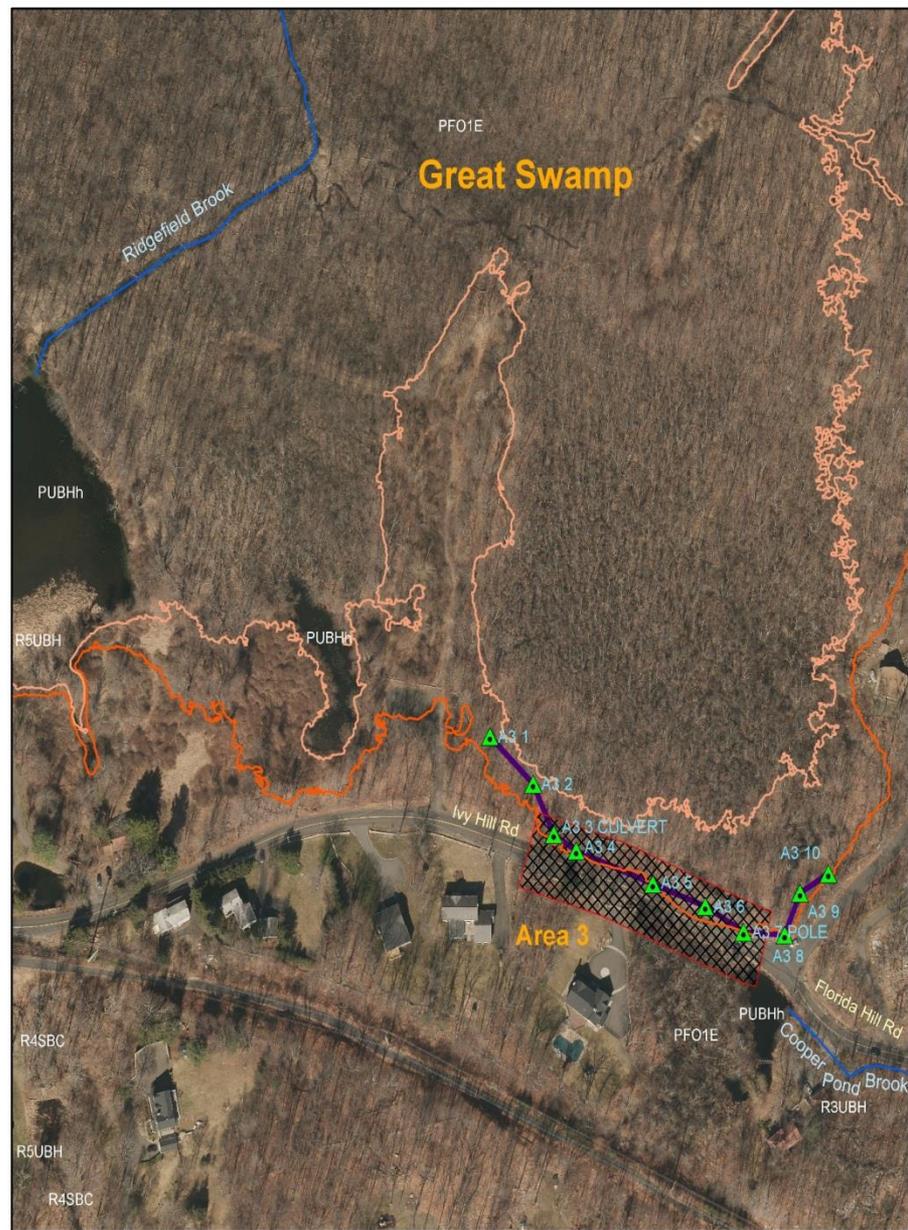
Figure 3-2
Wetlands Delineation
Ivy Hill Road Area
December 22, 2017

Wetlands Delineation in Area 3 (near Ivy Hill Road)

★ Norwalk River Site 2 Dam
 ▲ Wetlands sampling location
 — Stream
 — Wetlands Boundary

— Current Max. Flood Pool (578.2 ft NAVD88)
 — Potential Max. Flood Pool (581 ft NAVD88)
 ▨ Potentially Affected Areas

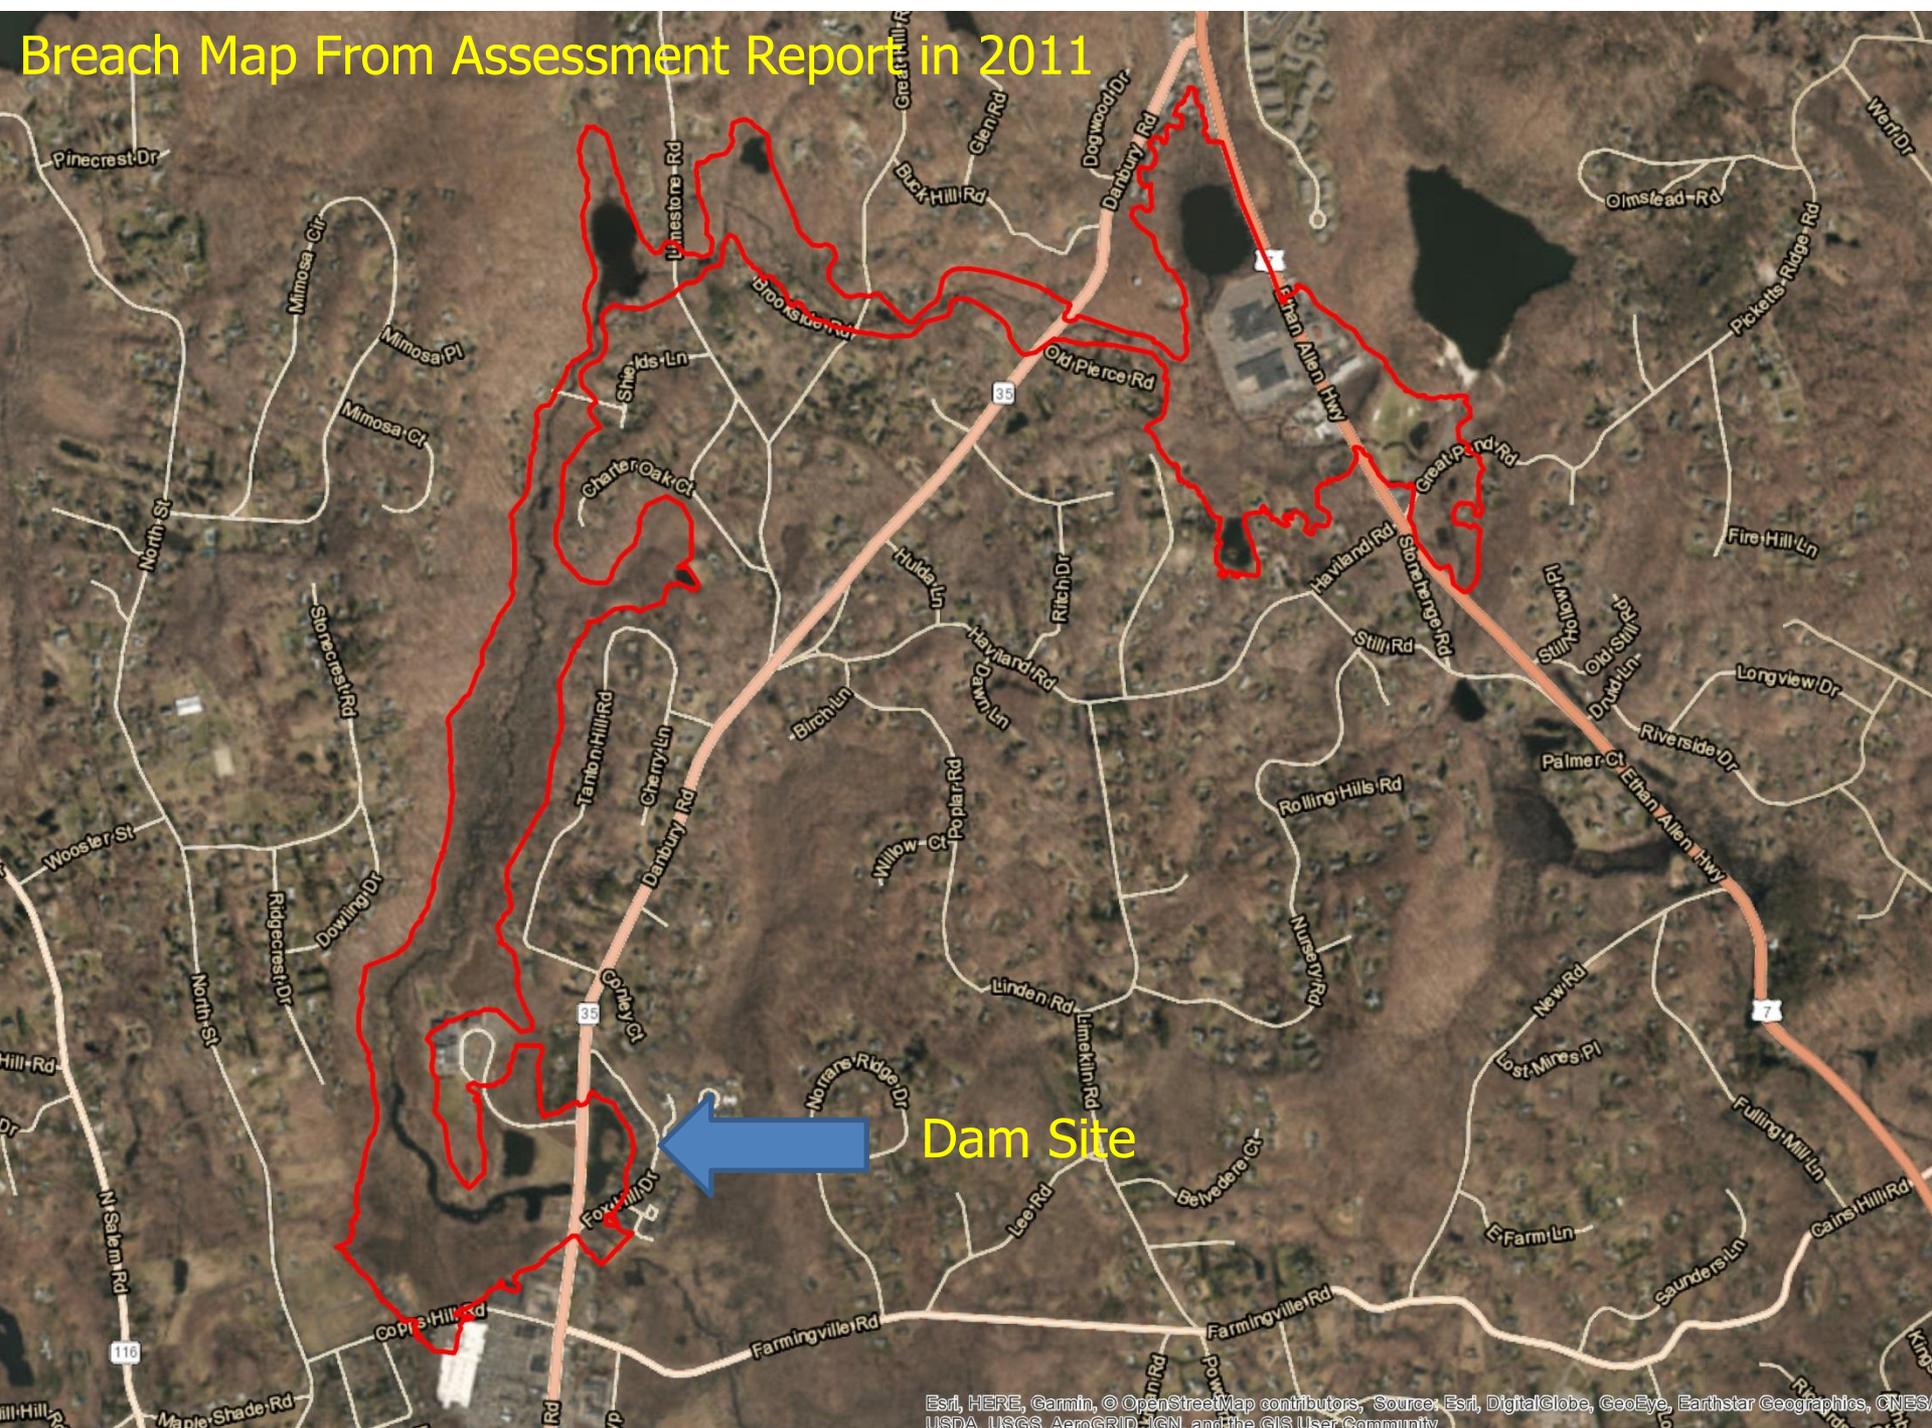
Breach Map From Assessment Report in 2011

Dam Site

- Inspected annually
- Regularly mowed and maintained
- Overall good condition
- High hazard classification now
(Significant when constructed)
- A dam assessment performed by NRCS in 2011 indicates inadequate spillway capacity
