Public Meeting

Farm Brook Sites 1, 2A and 2B

Watershed Planning and Environmental Assessment

Dam Rehabilitation Project
July 18, 2019

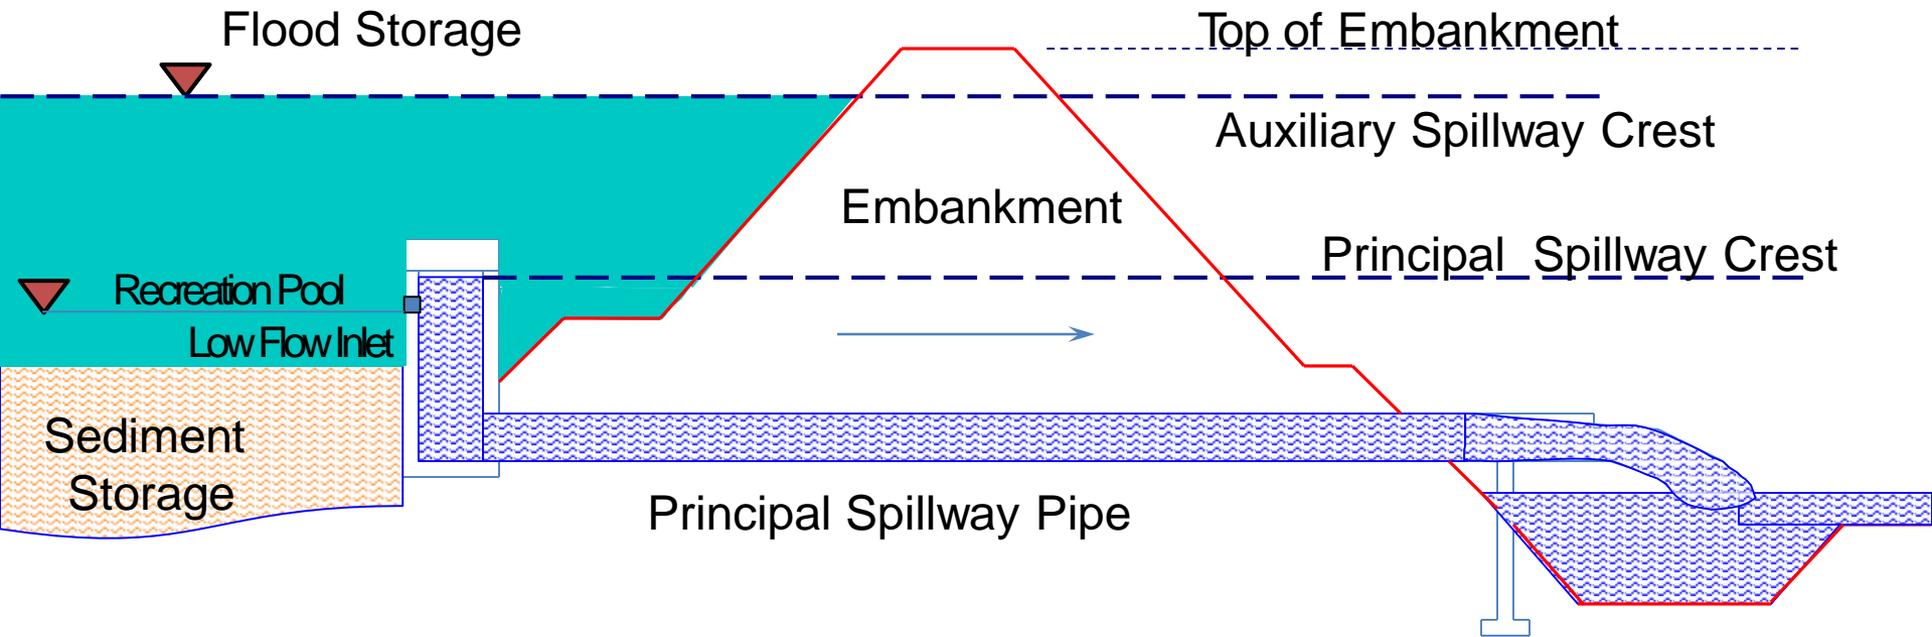
Typical Cross-Section of Site 1 Floodwater Retarding Structure

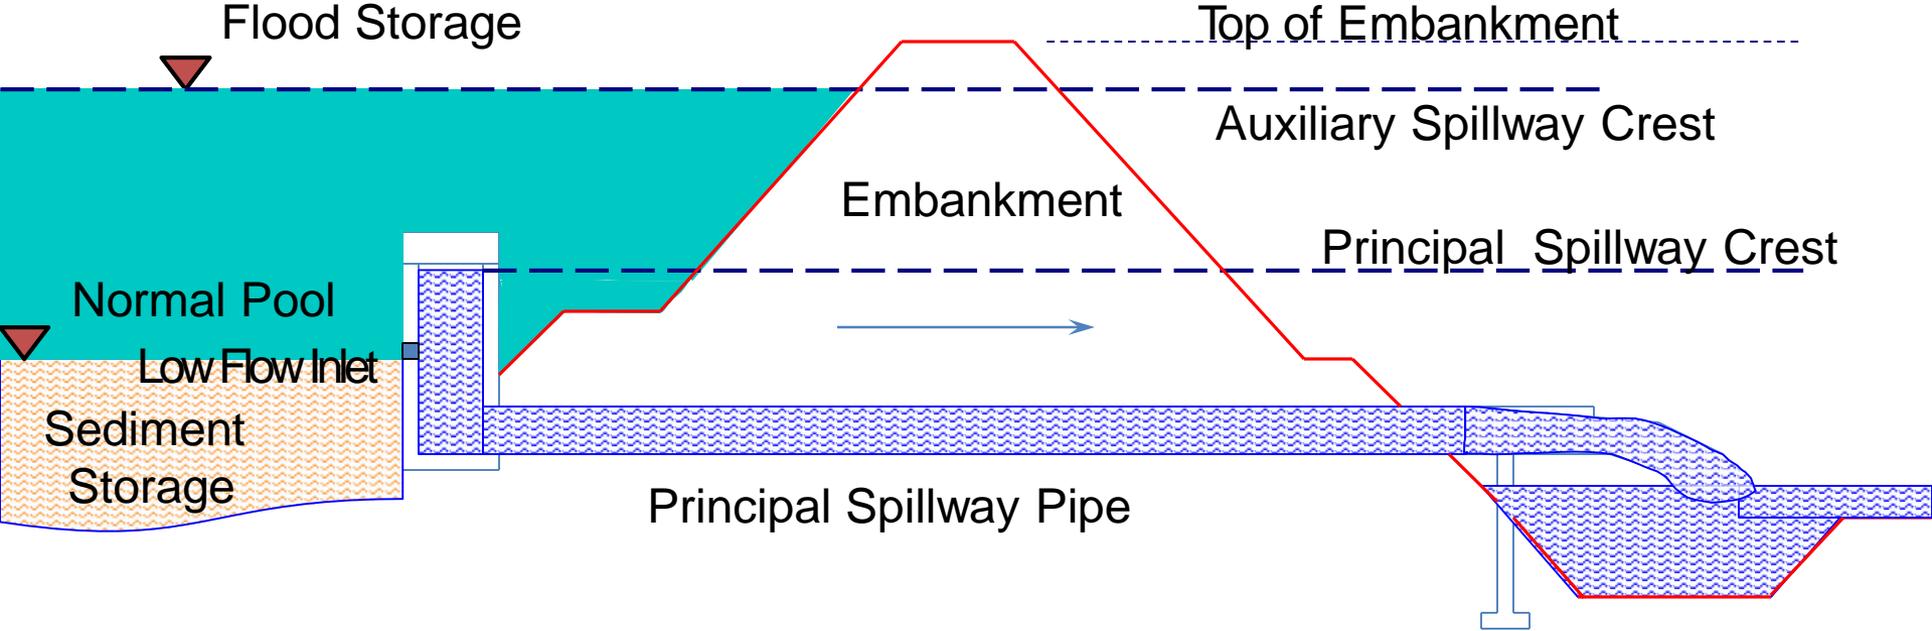
Typical Cross-Section of Sites 2A & 2B Floodwater Retarding Structure

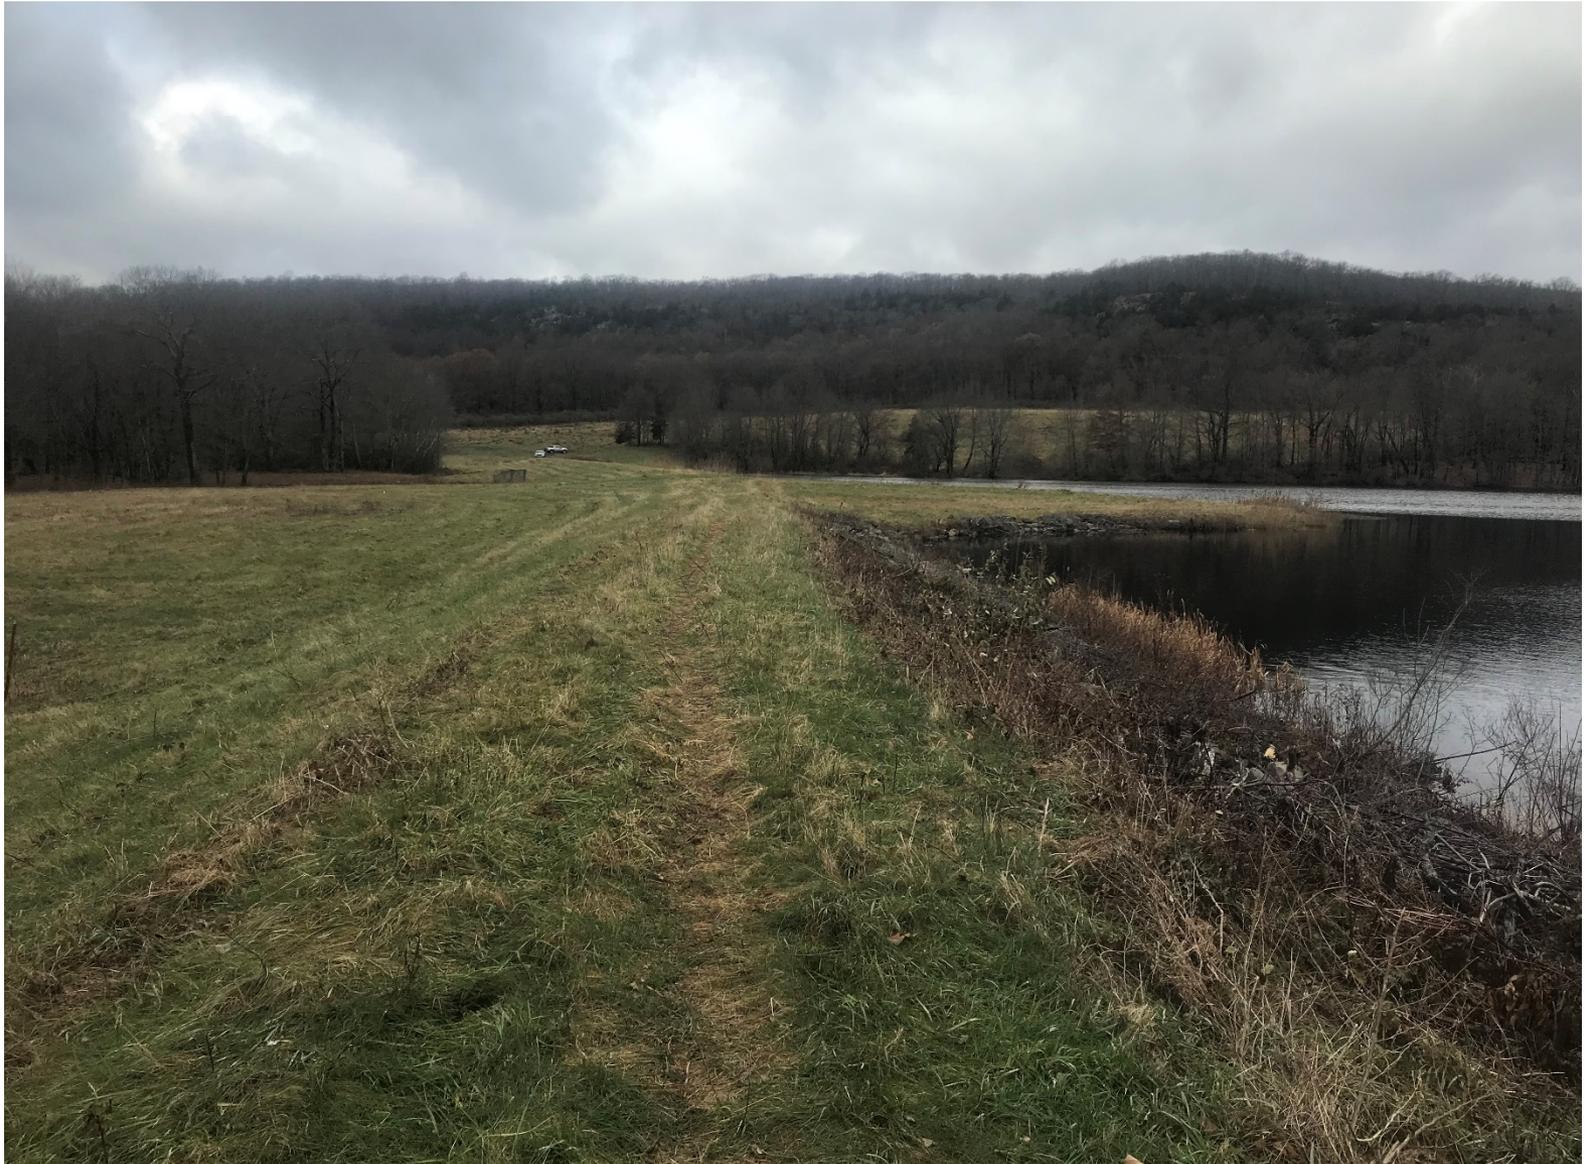
Site 1 – Crest

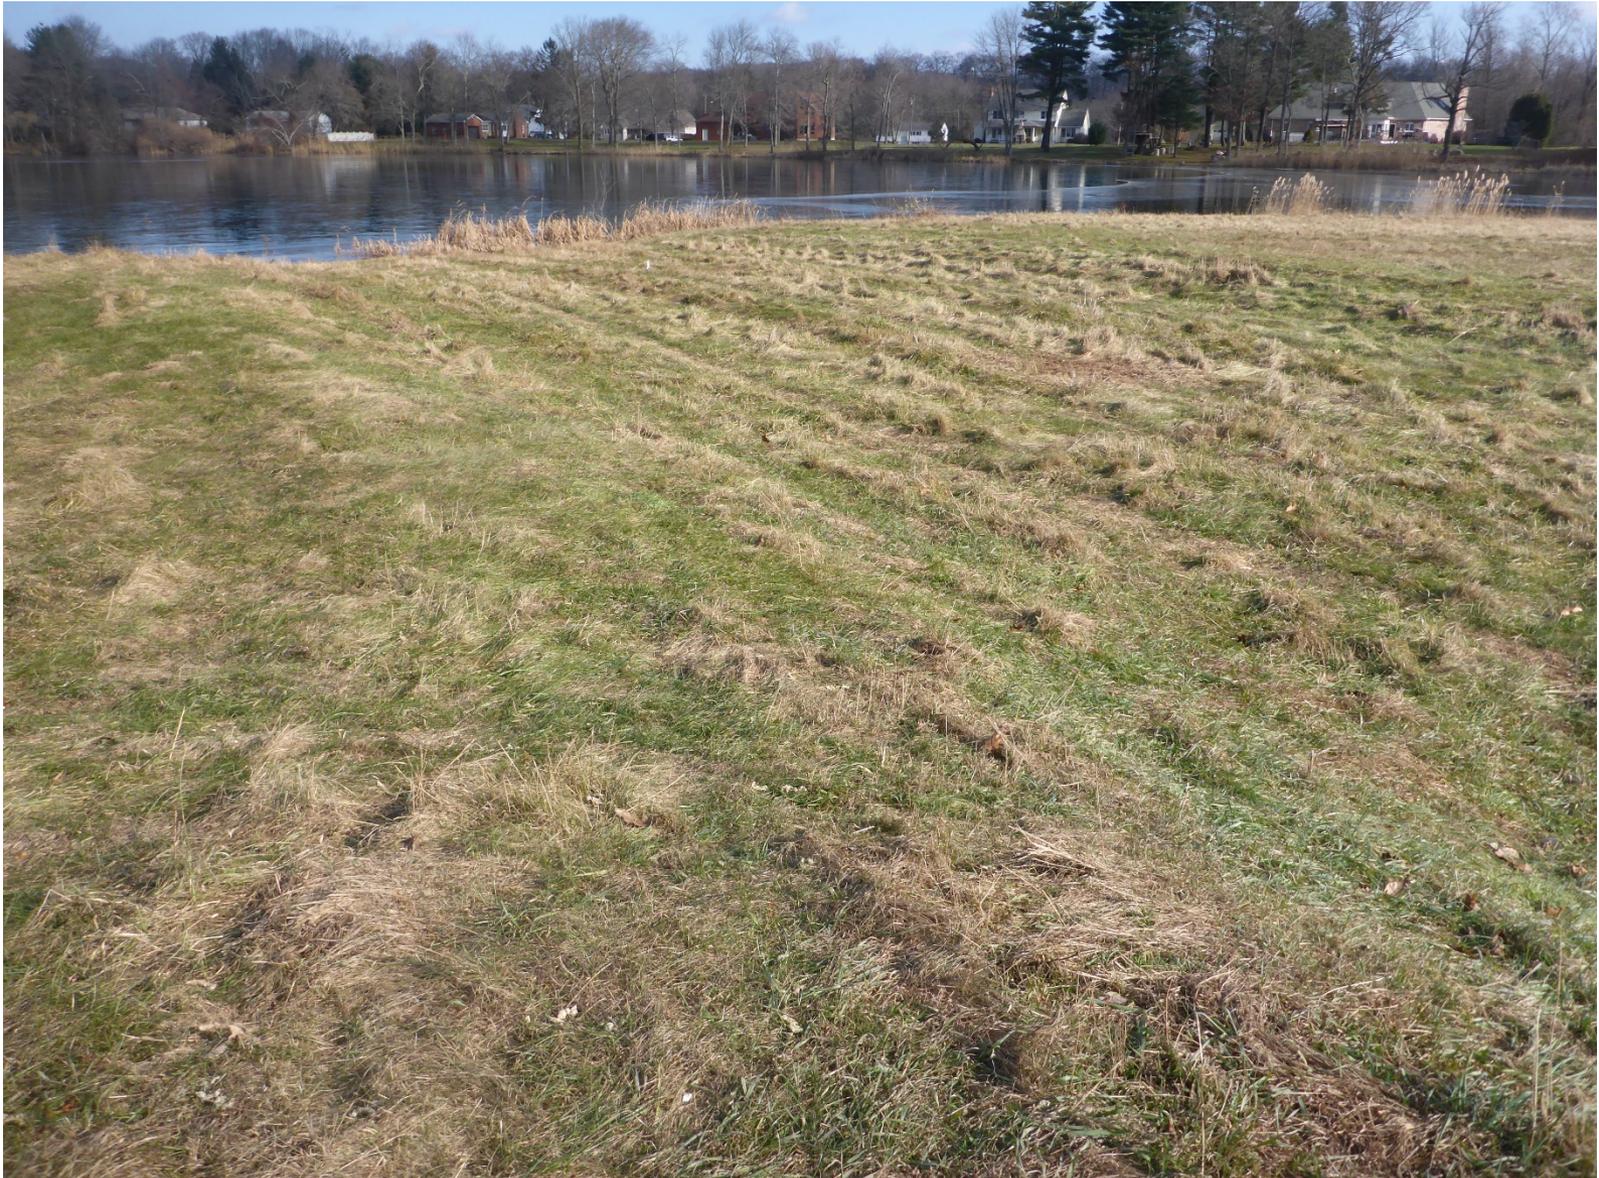
Site 1 – Upstream Portion of Auxiliary Spillway

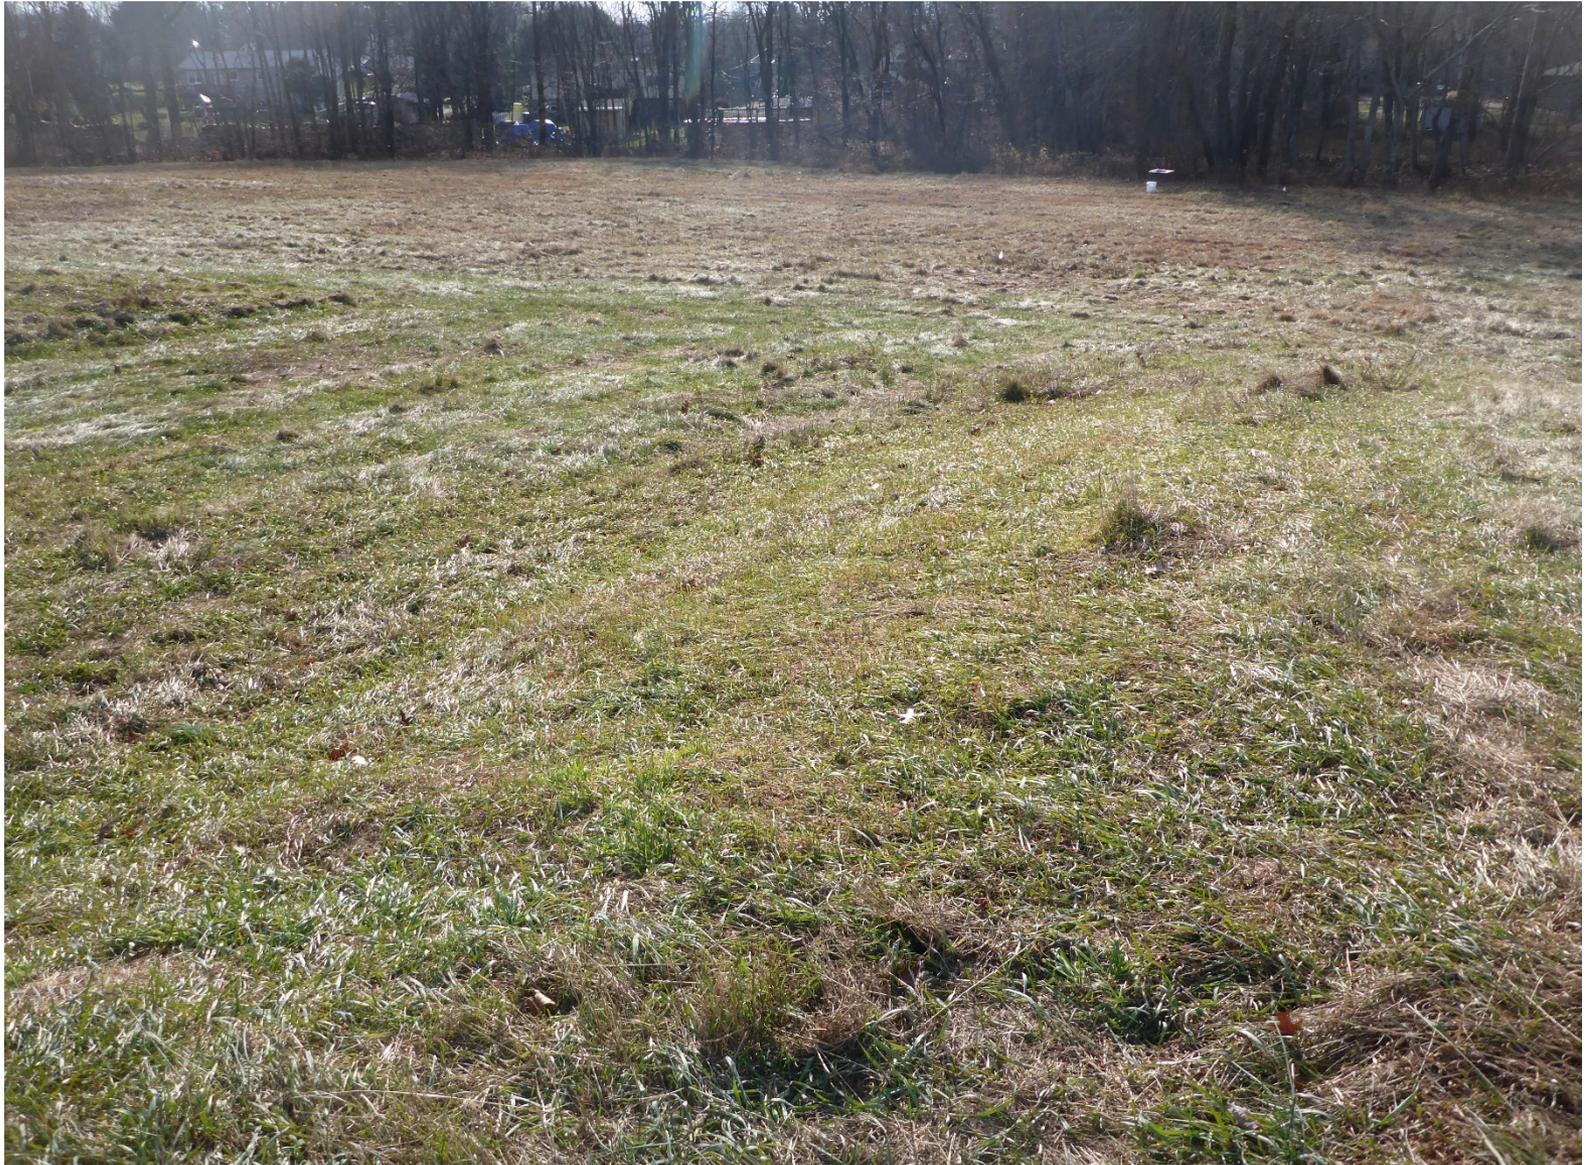
Site 1 – Downstream Portion of Auxiliary Spillway

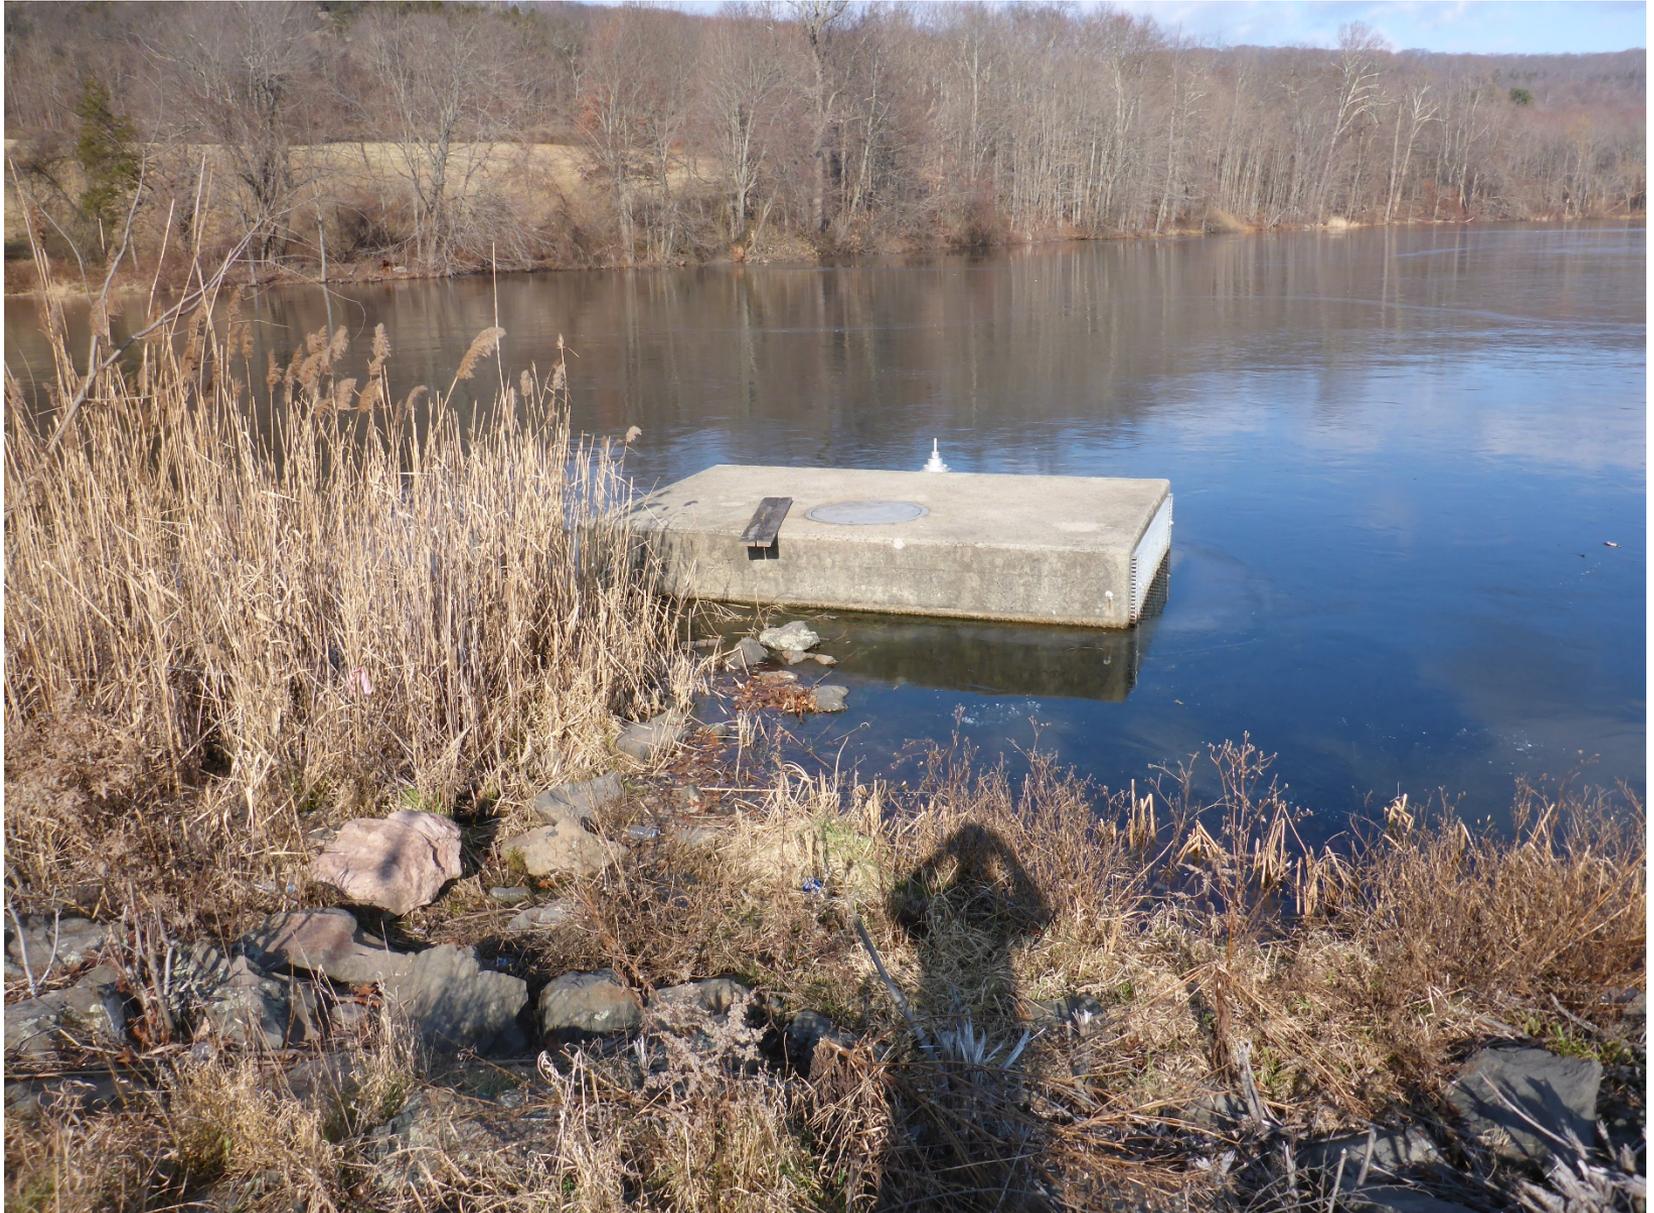
Site 1 – Principal Spillway Inlet

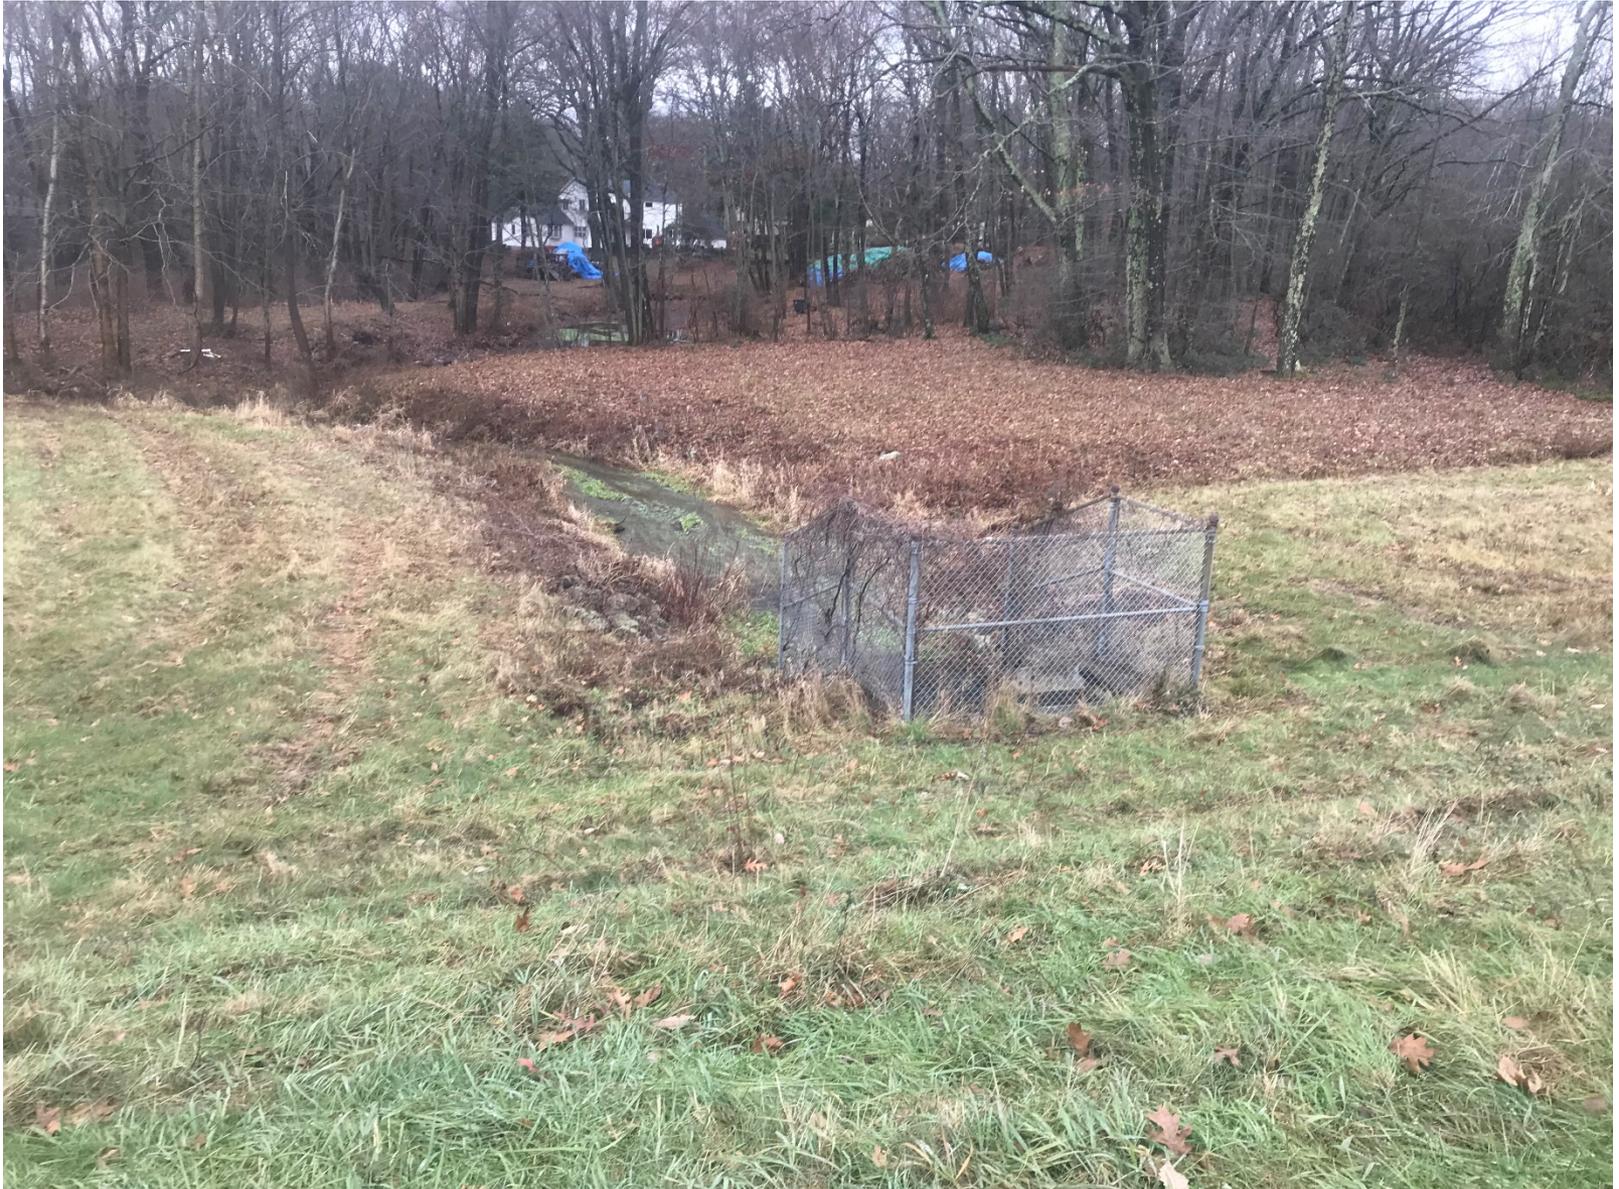
Site 1 – Downstream Slope & Outlet Works

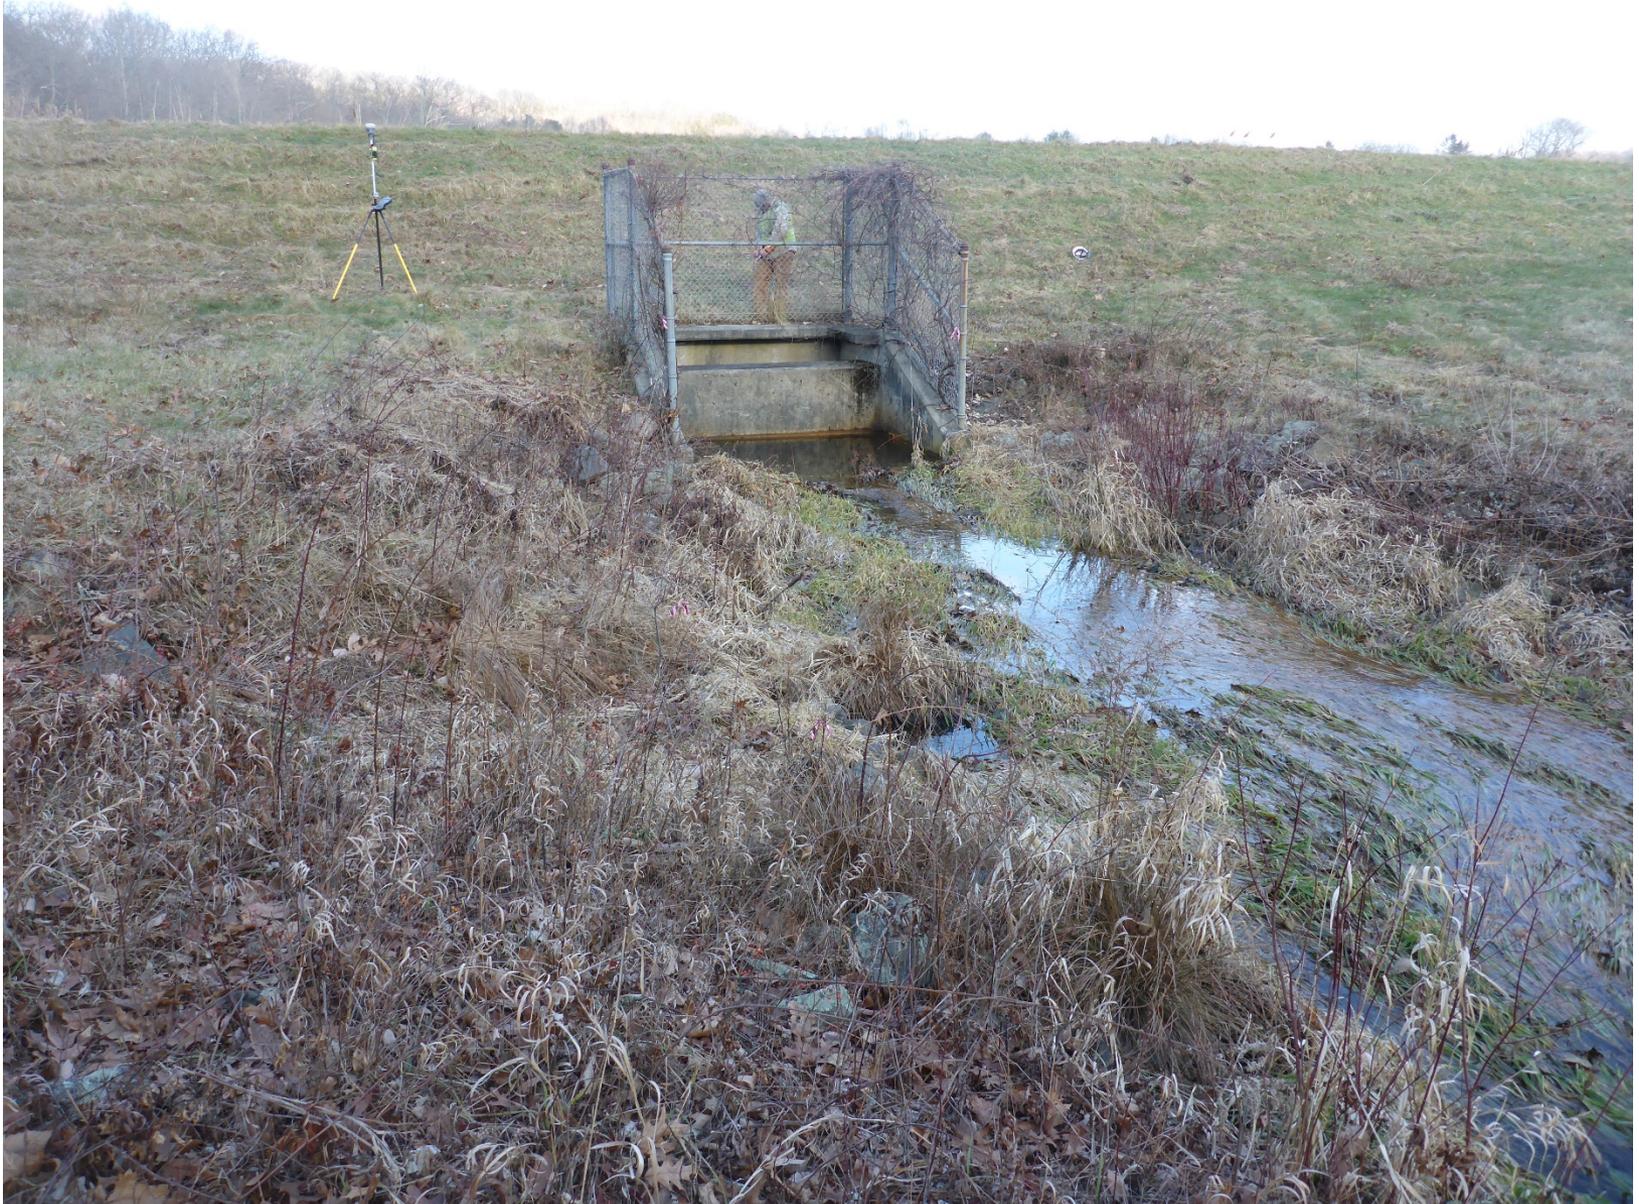
Site 1 – Principal Spillway Outlet Structure

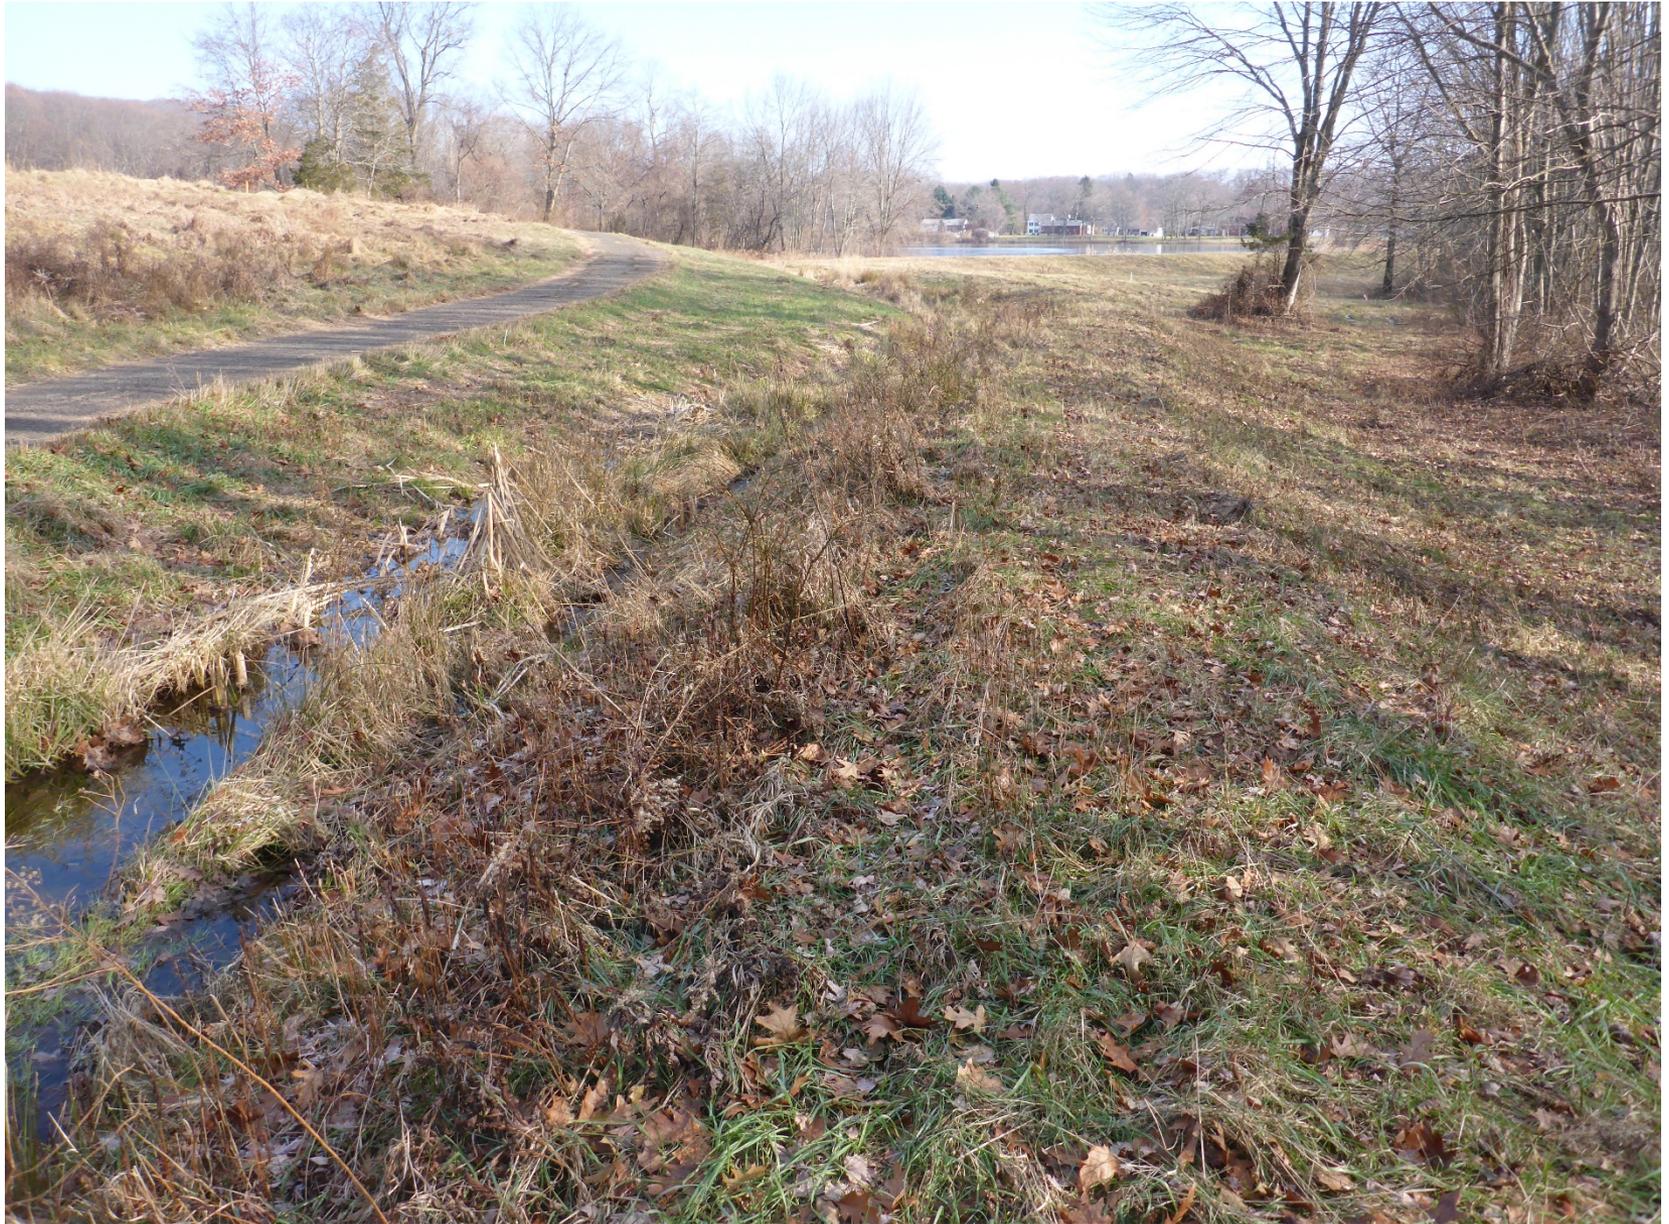
Site 1 – Diversion Ditch

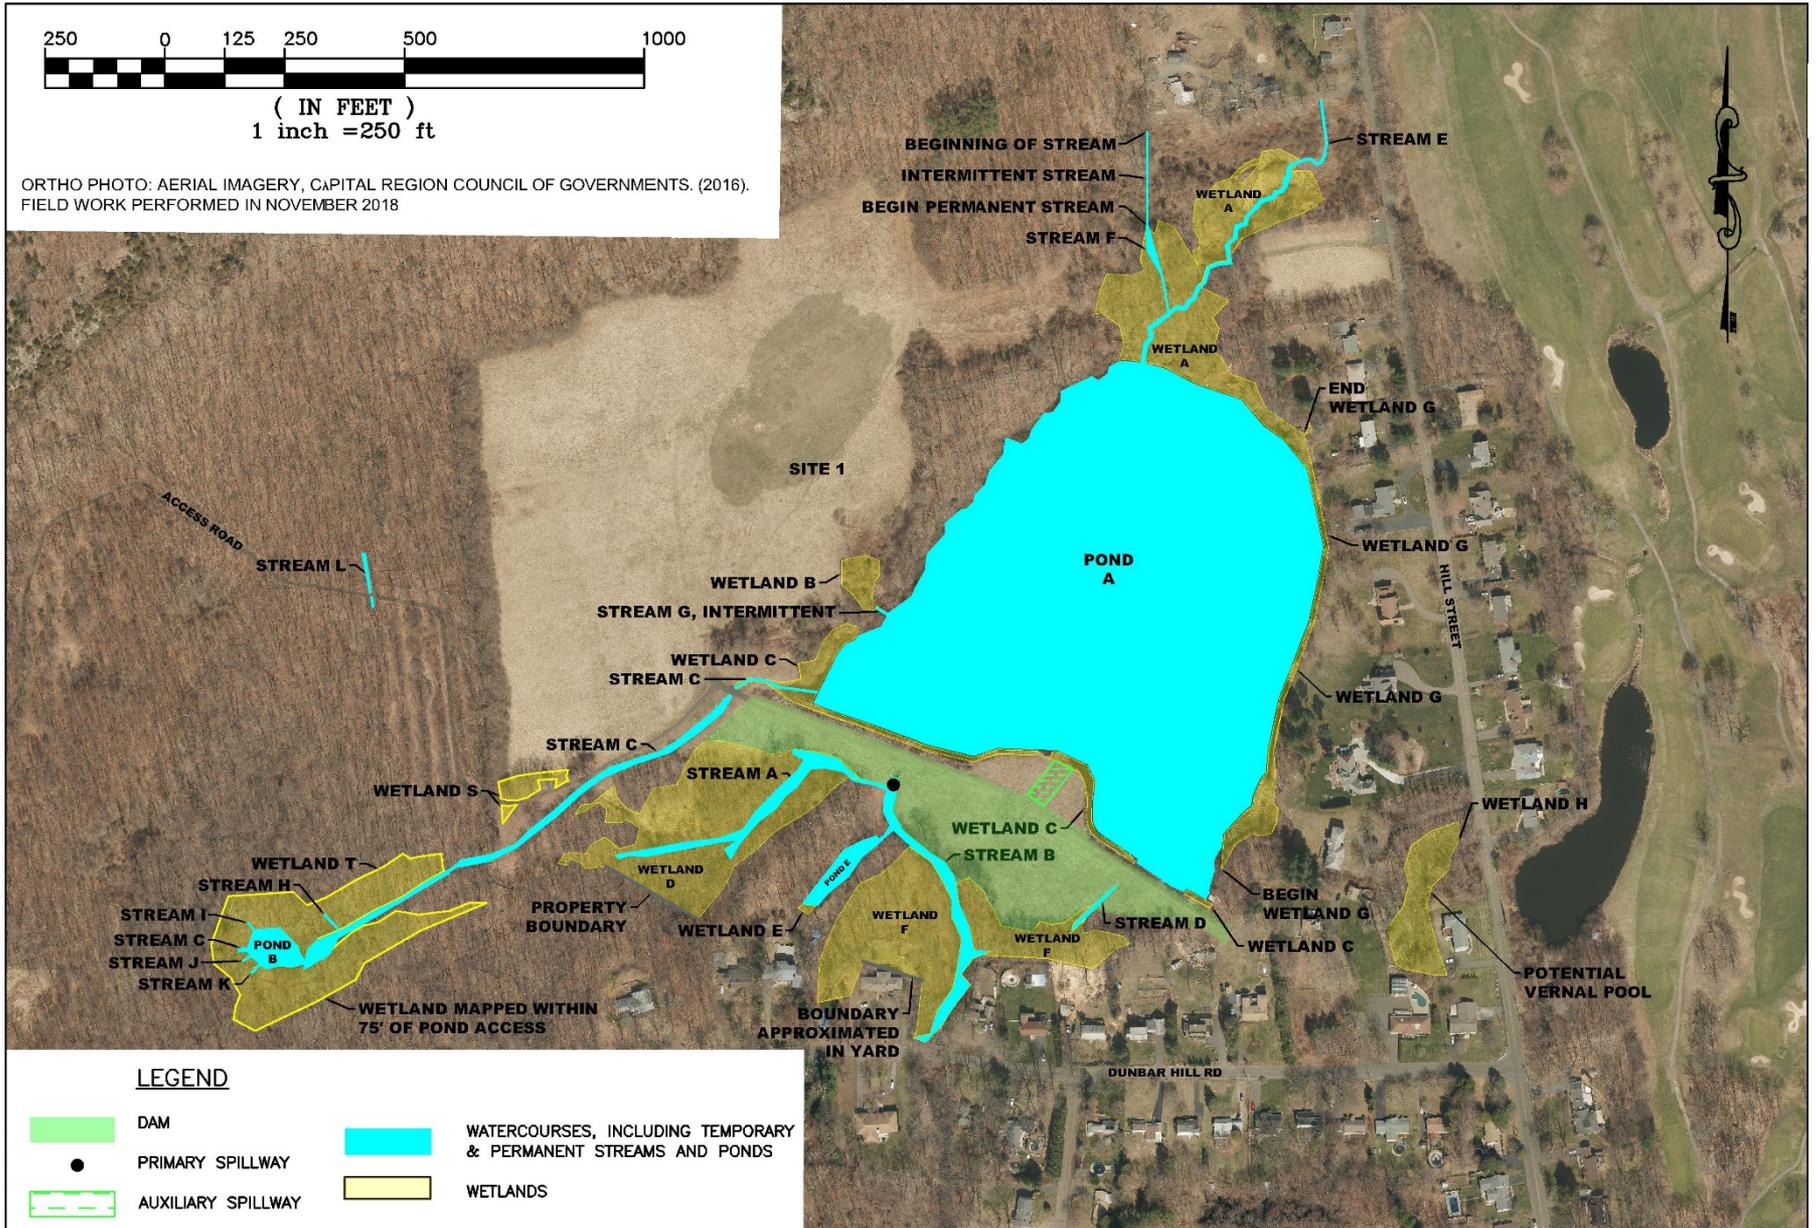
Site 1 Aquatic Resources

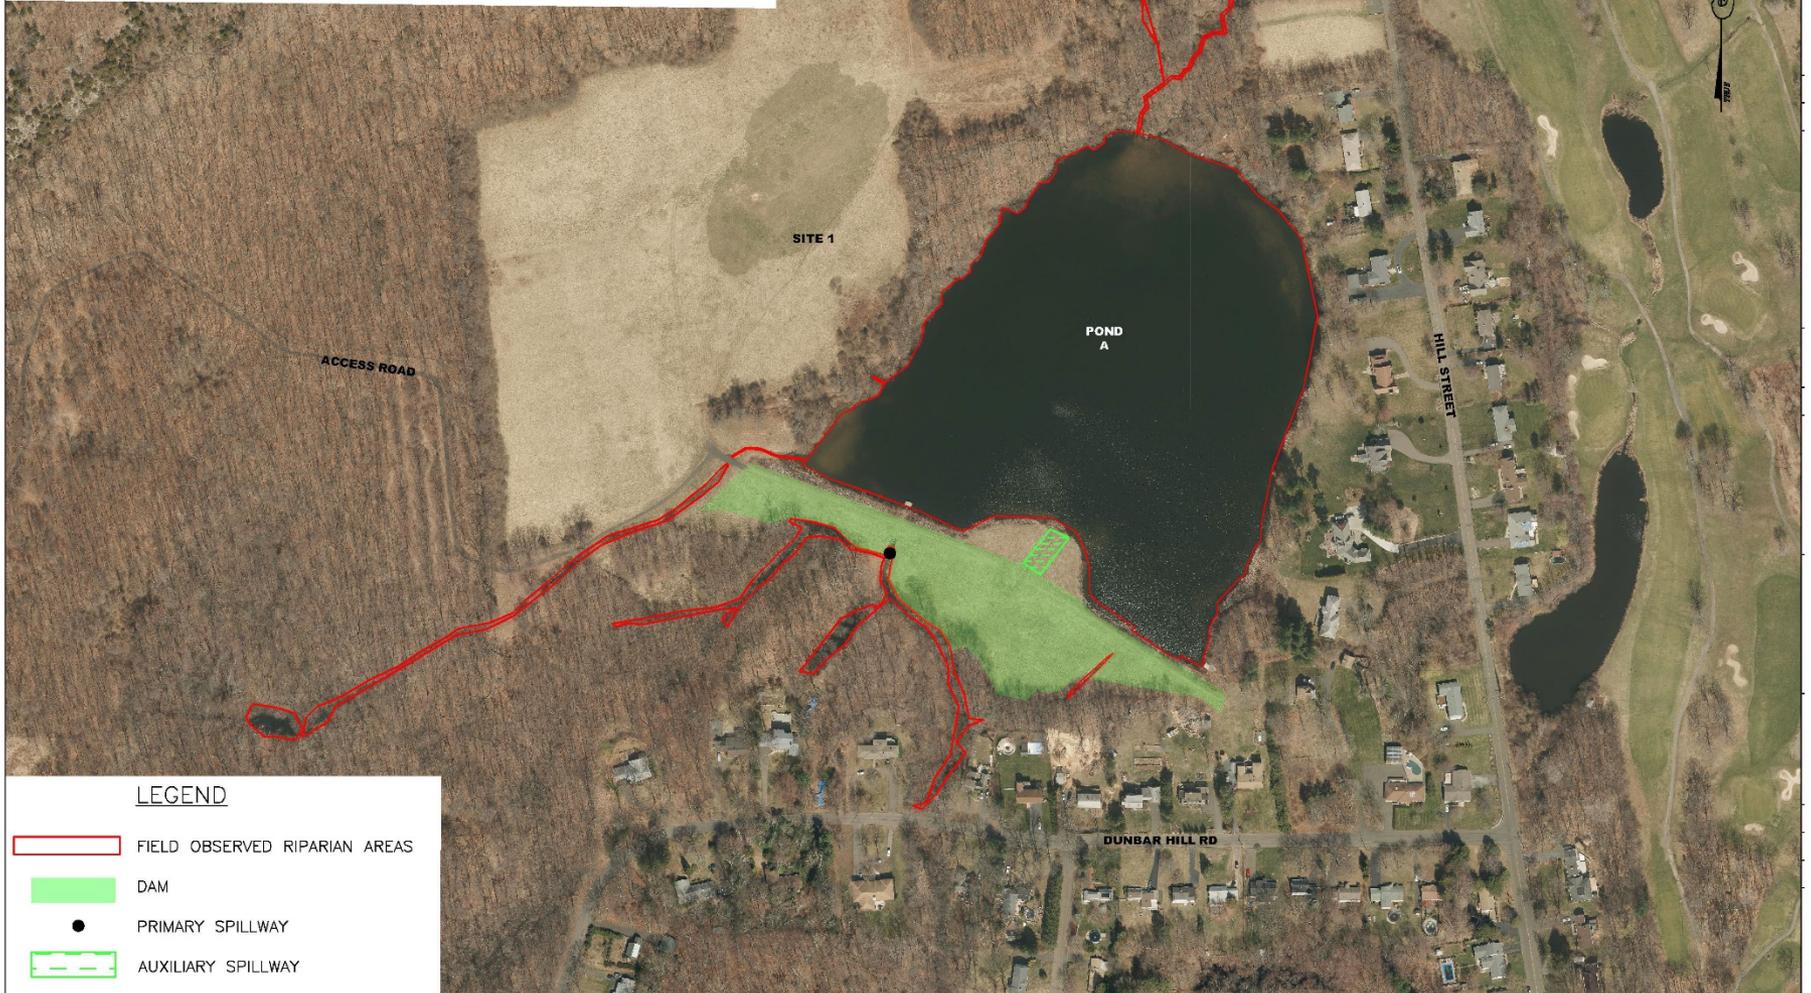
Site 1 Riparian Areas

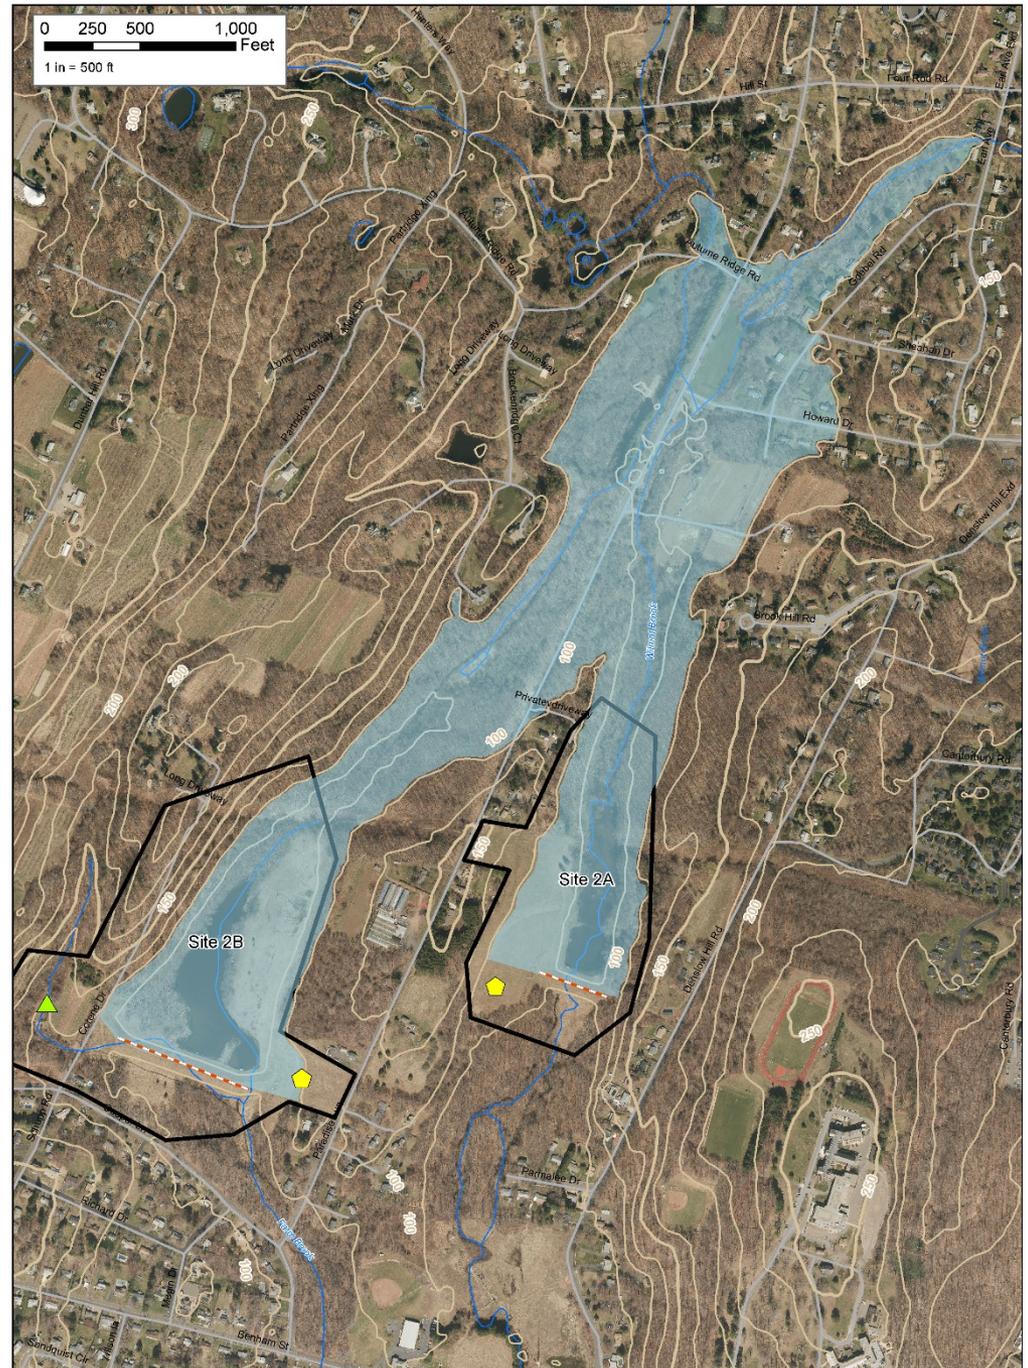
Site 2A & 2B Combined Pool at Approximate Crest El. 108
