Public Meeting

Farm Brook Sites 1, 2A and 2B

Watershed Planning and Environmental Assessment

Dam Rehabilitation Project
July 18, 2019

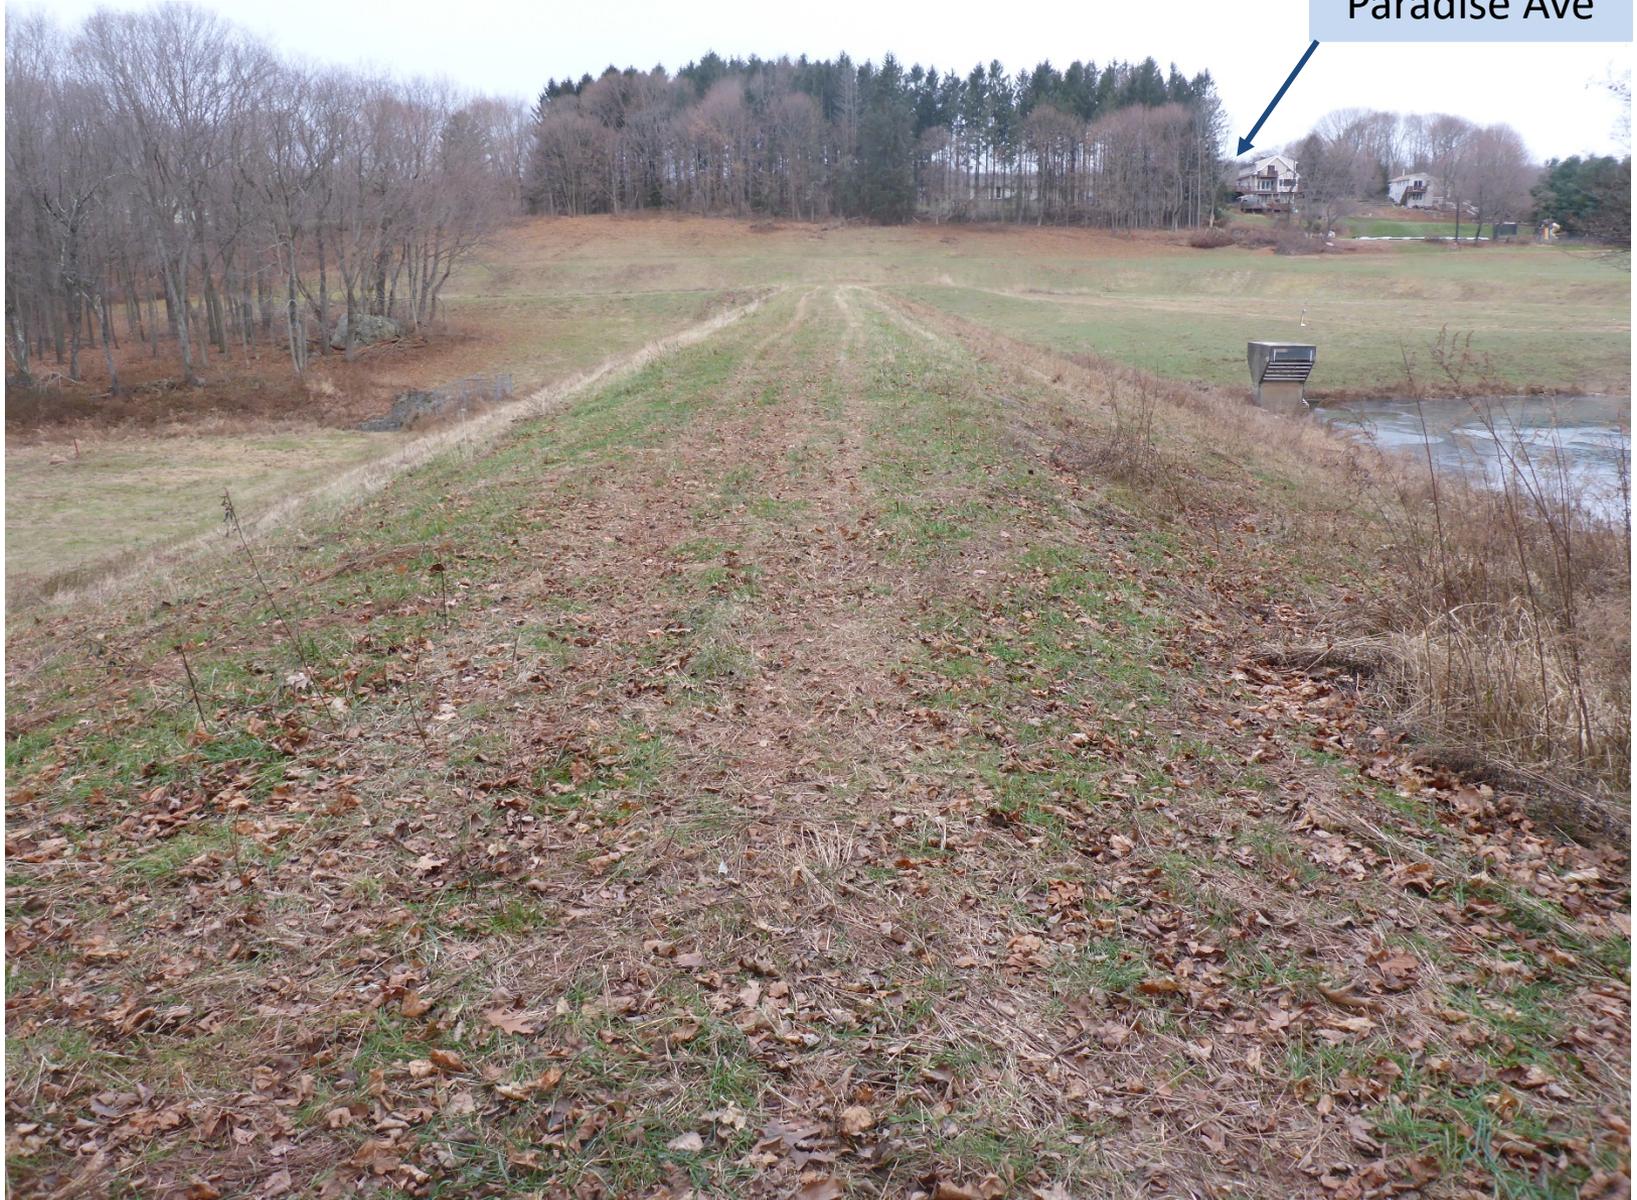
Site 2A – Crest

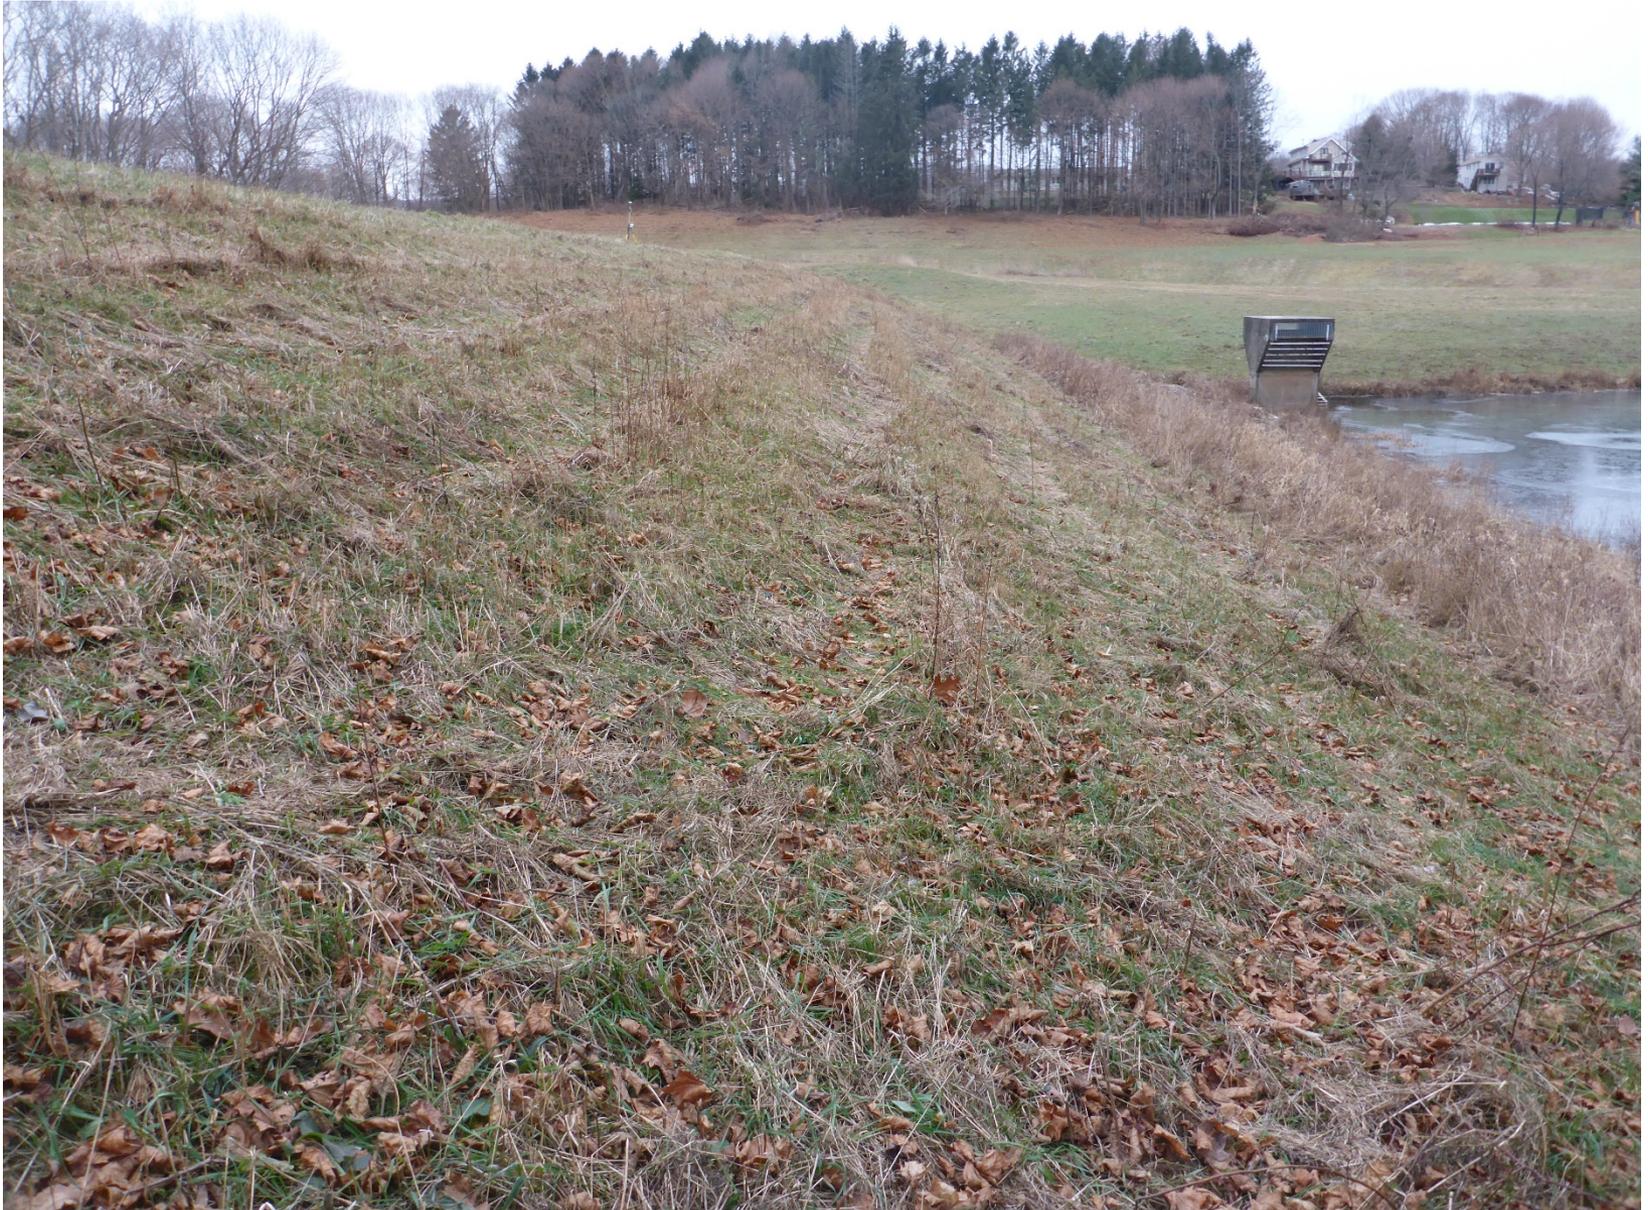
Site 2A – Upstream Slope

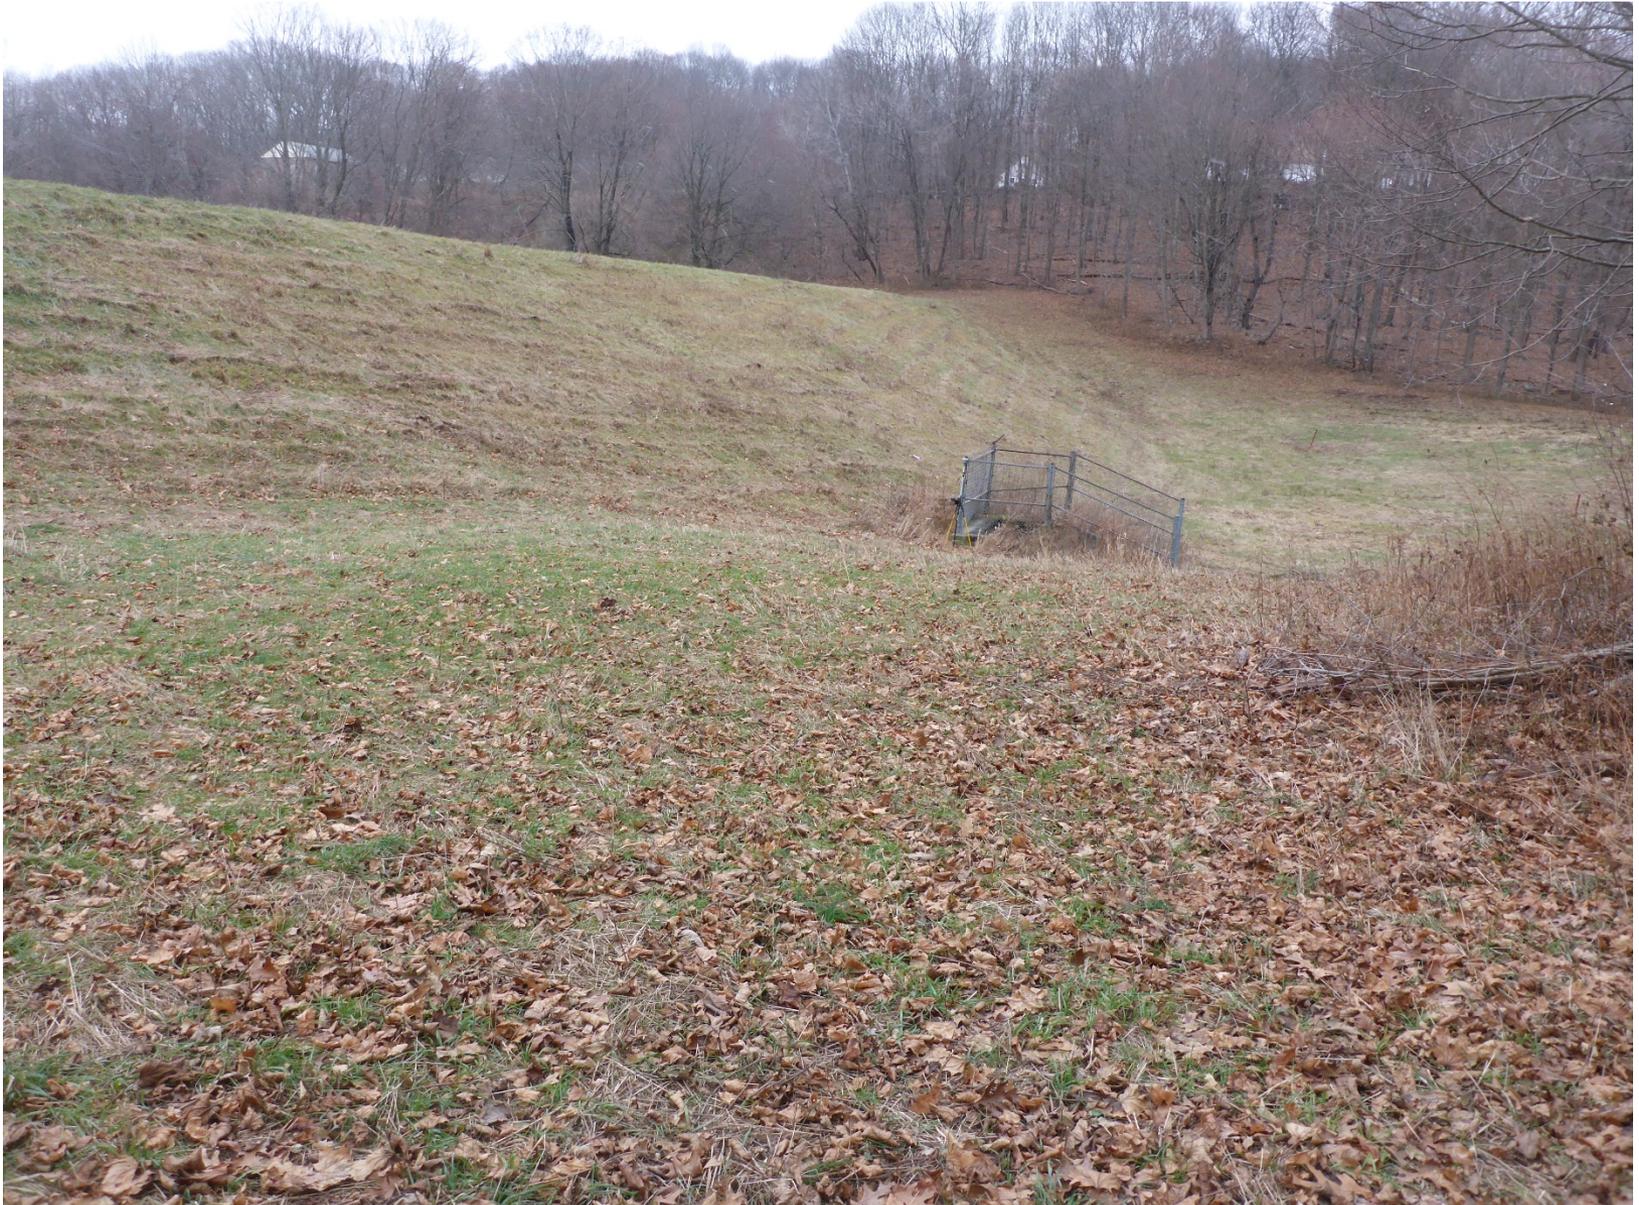
Site 2A – Downstream Slope

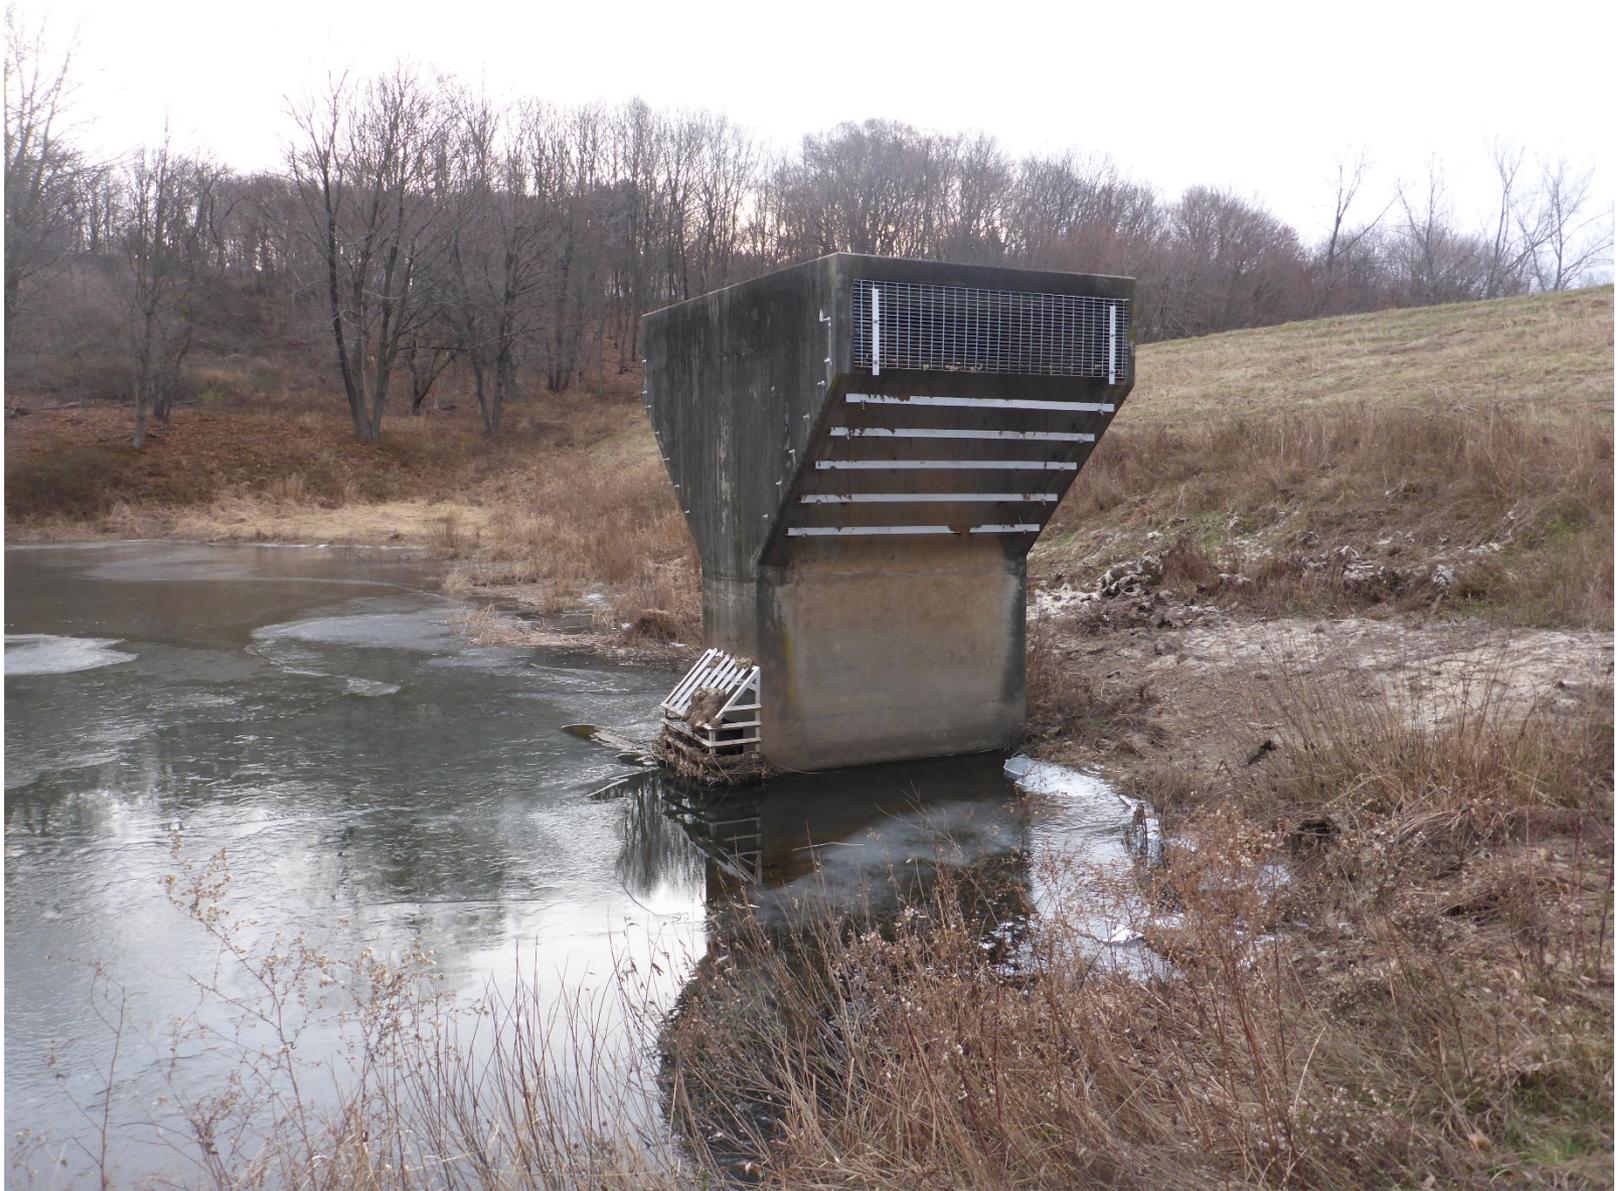
Site 2A – Principal Spillway Intake

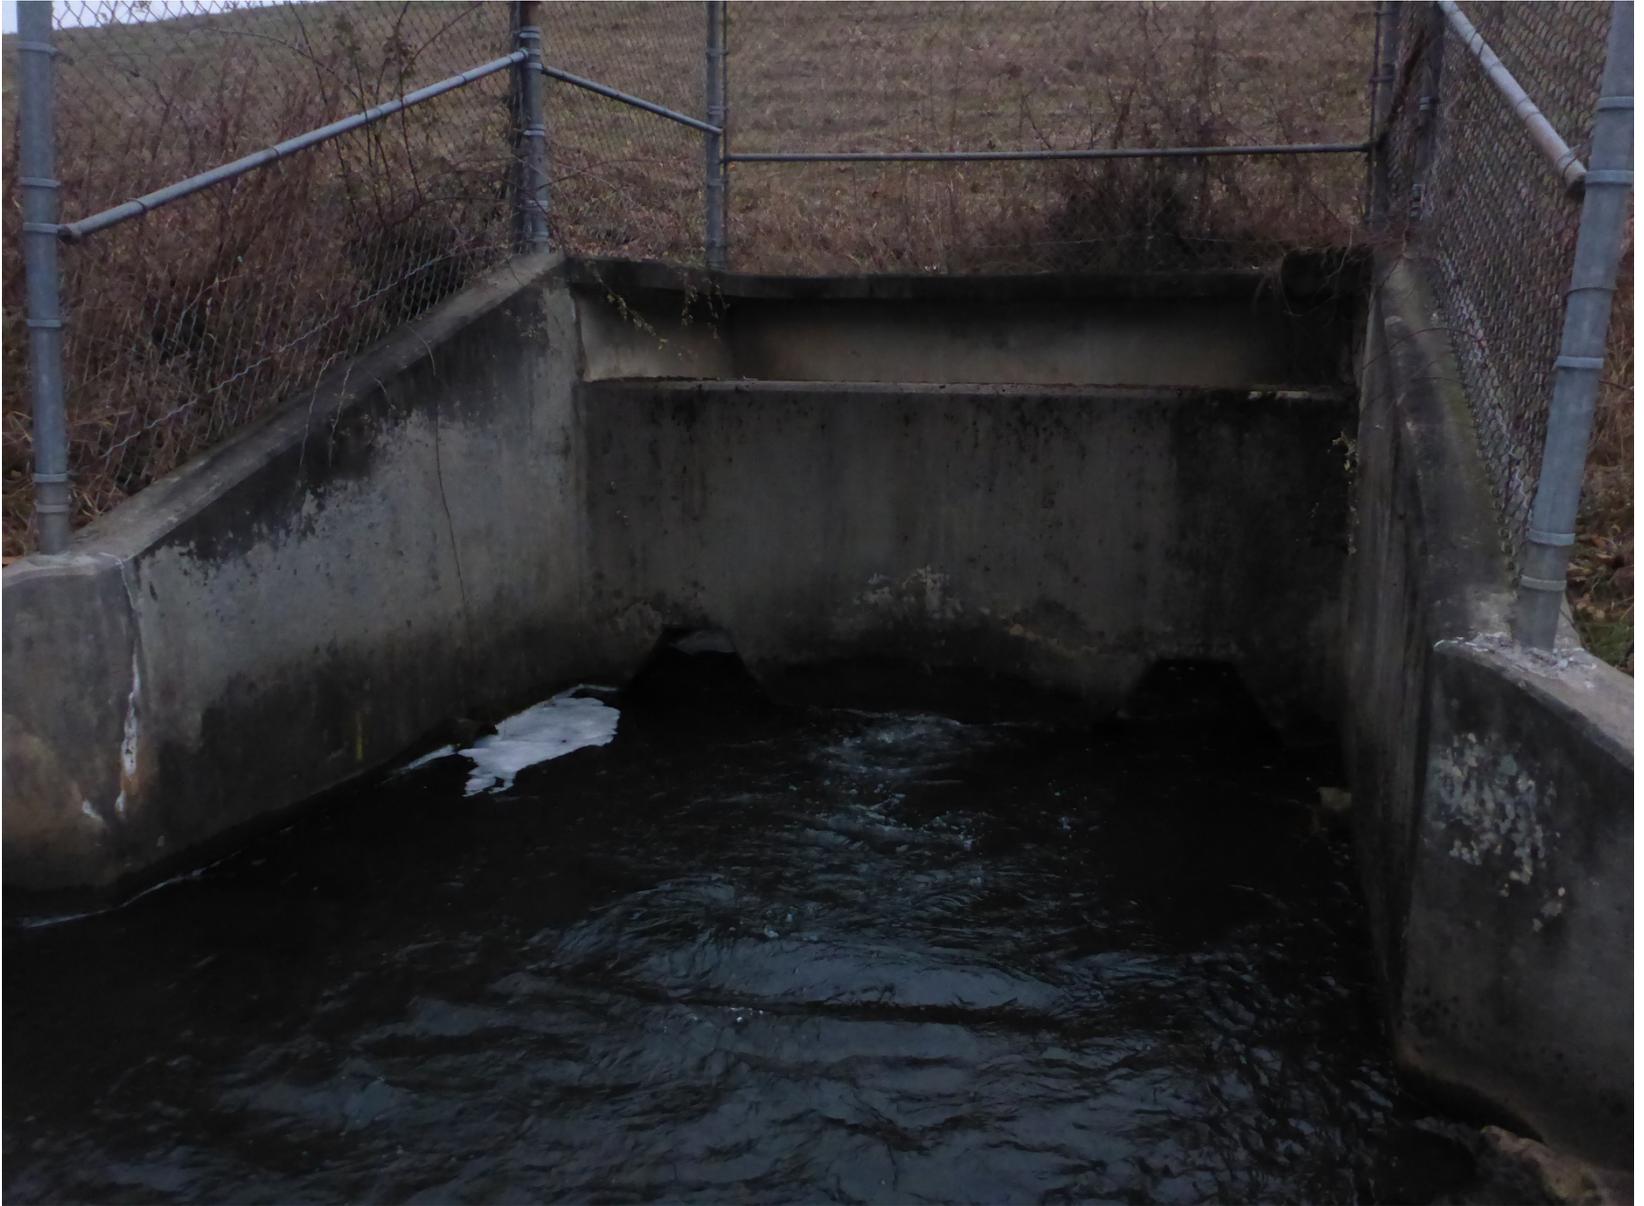
Site 2A – Principal Spillway Outlet

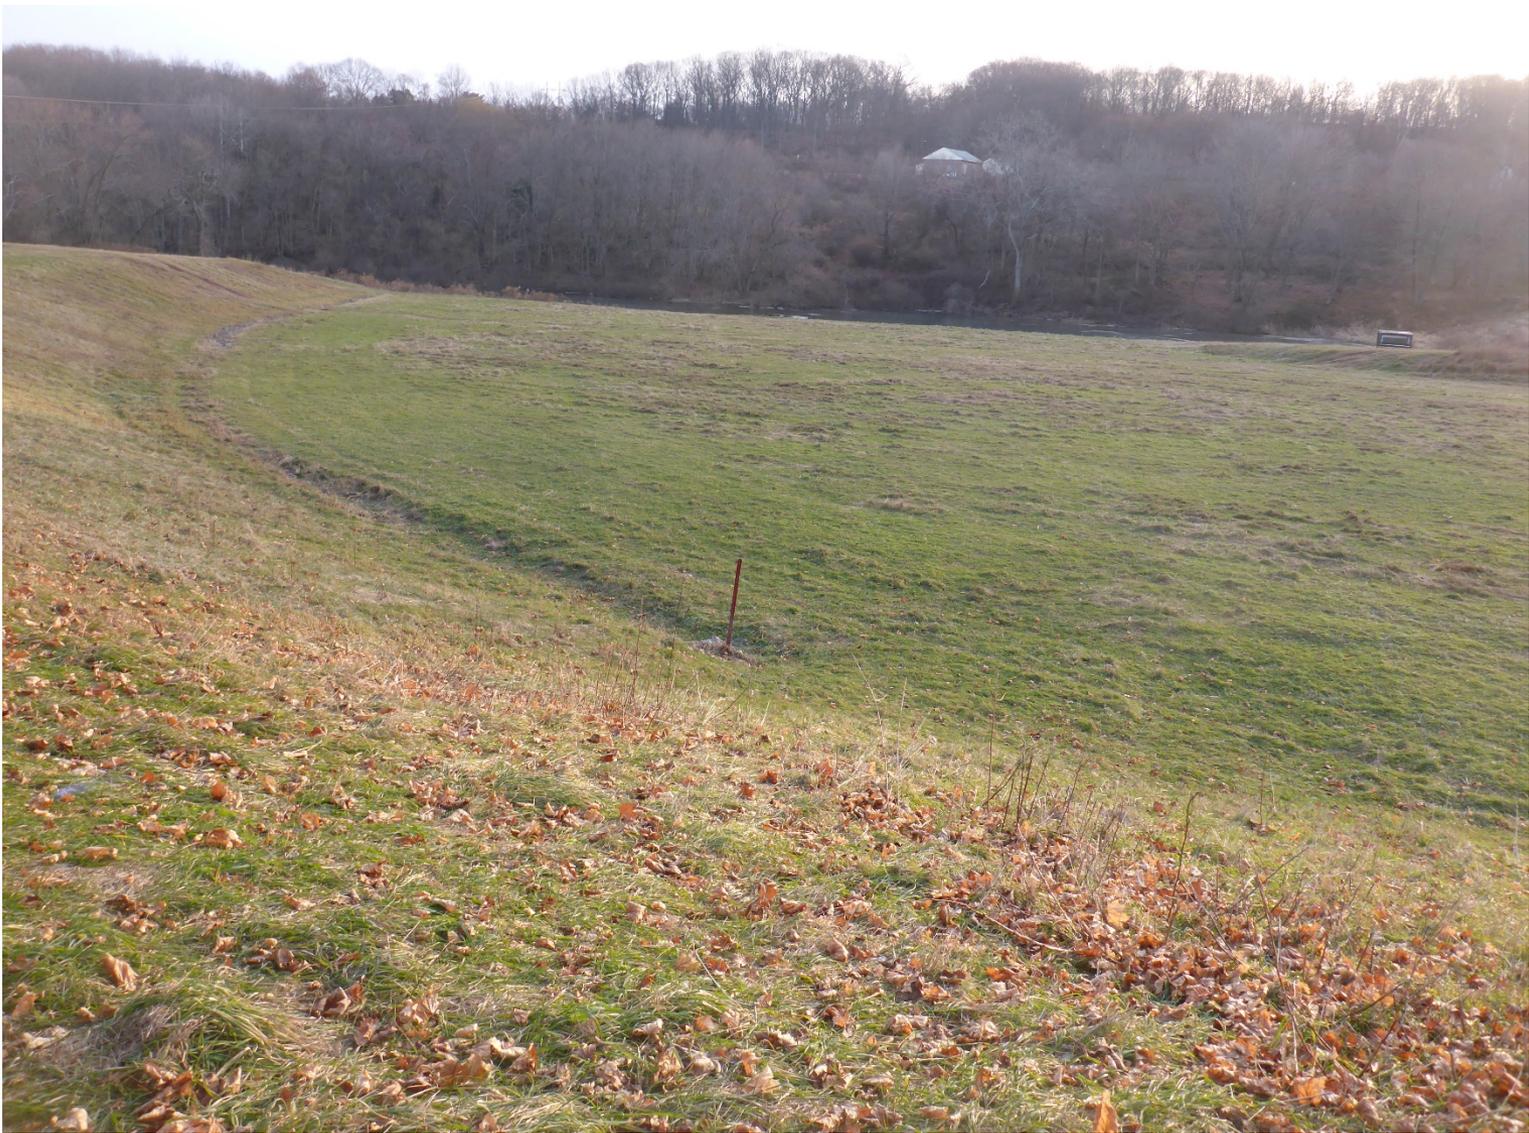
Site 2A – Upstream Portion of Auxiliary Spillway

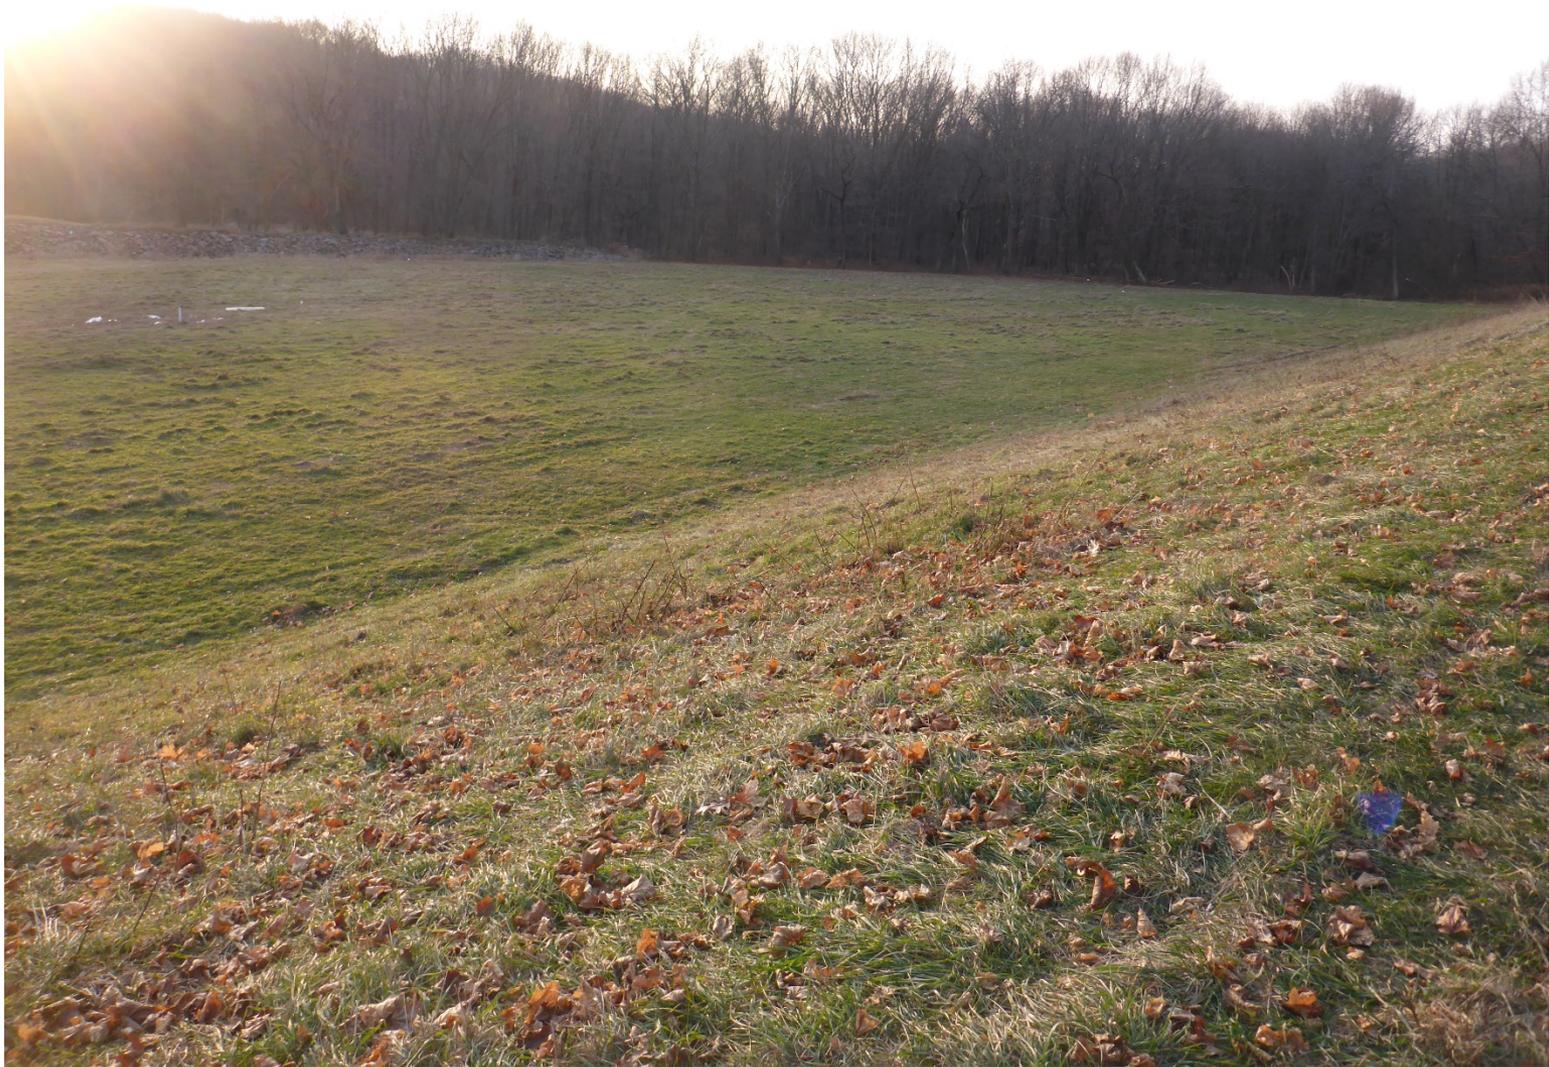
Site 2A – Downstream Portion of Auxiliary Spillway

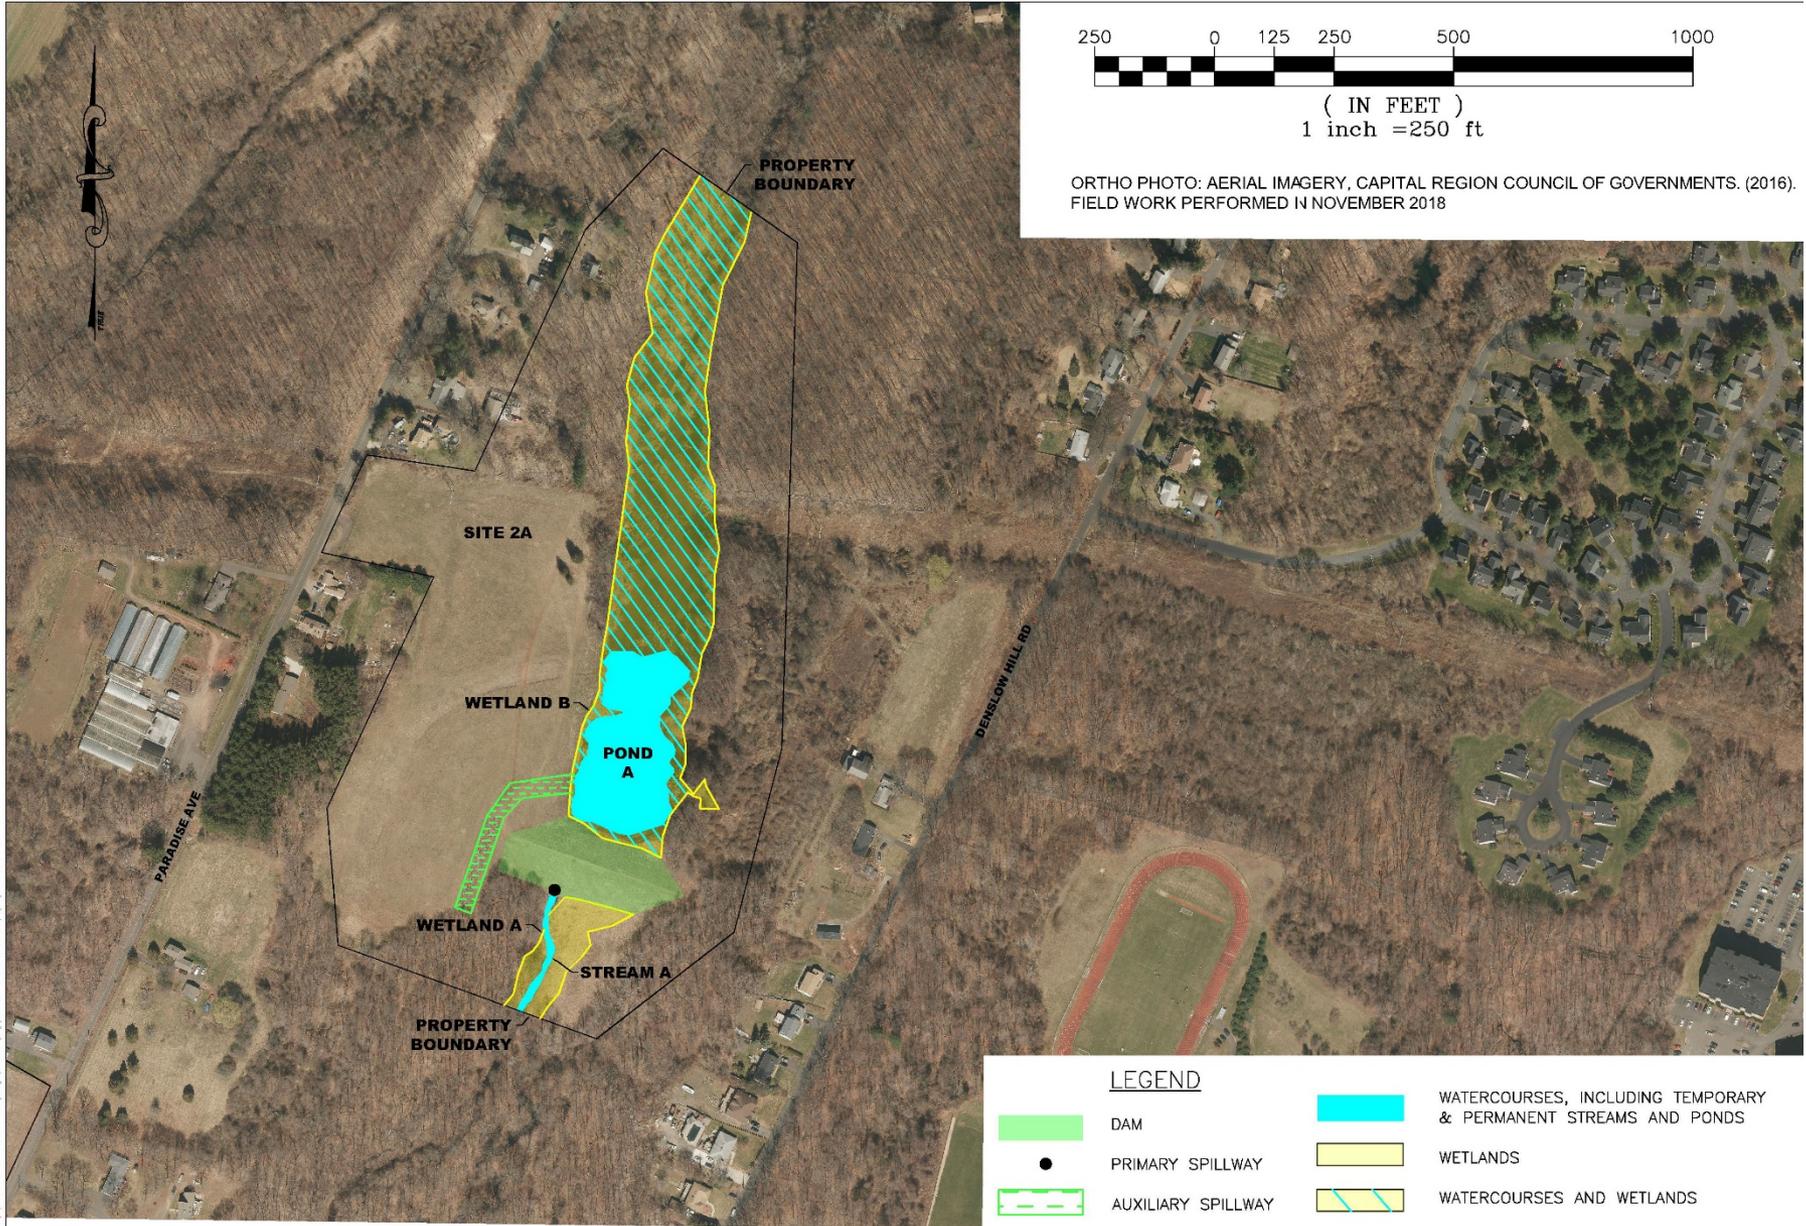
Site 2A Aquatic Resources

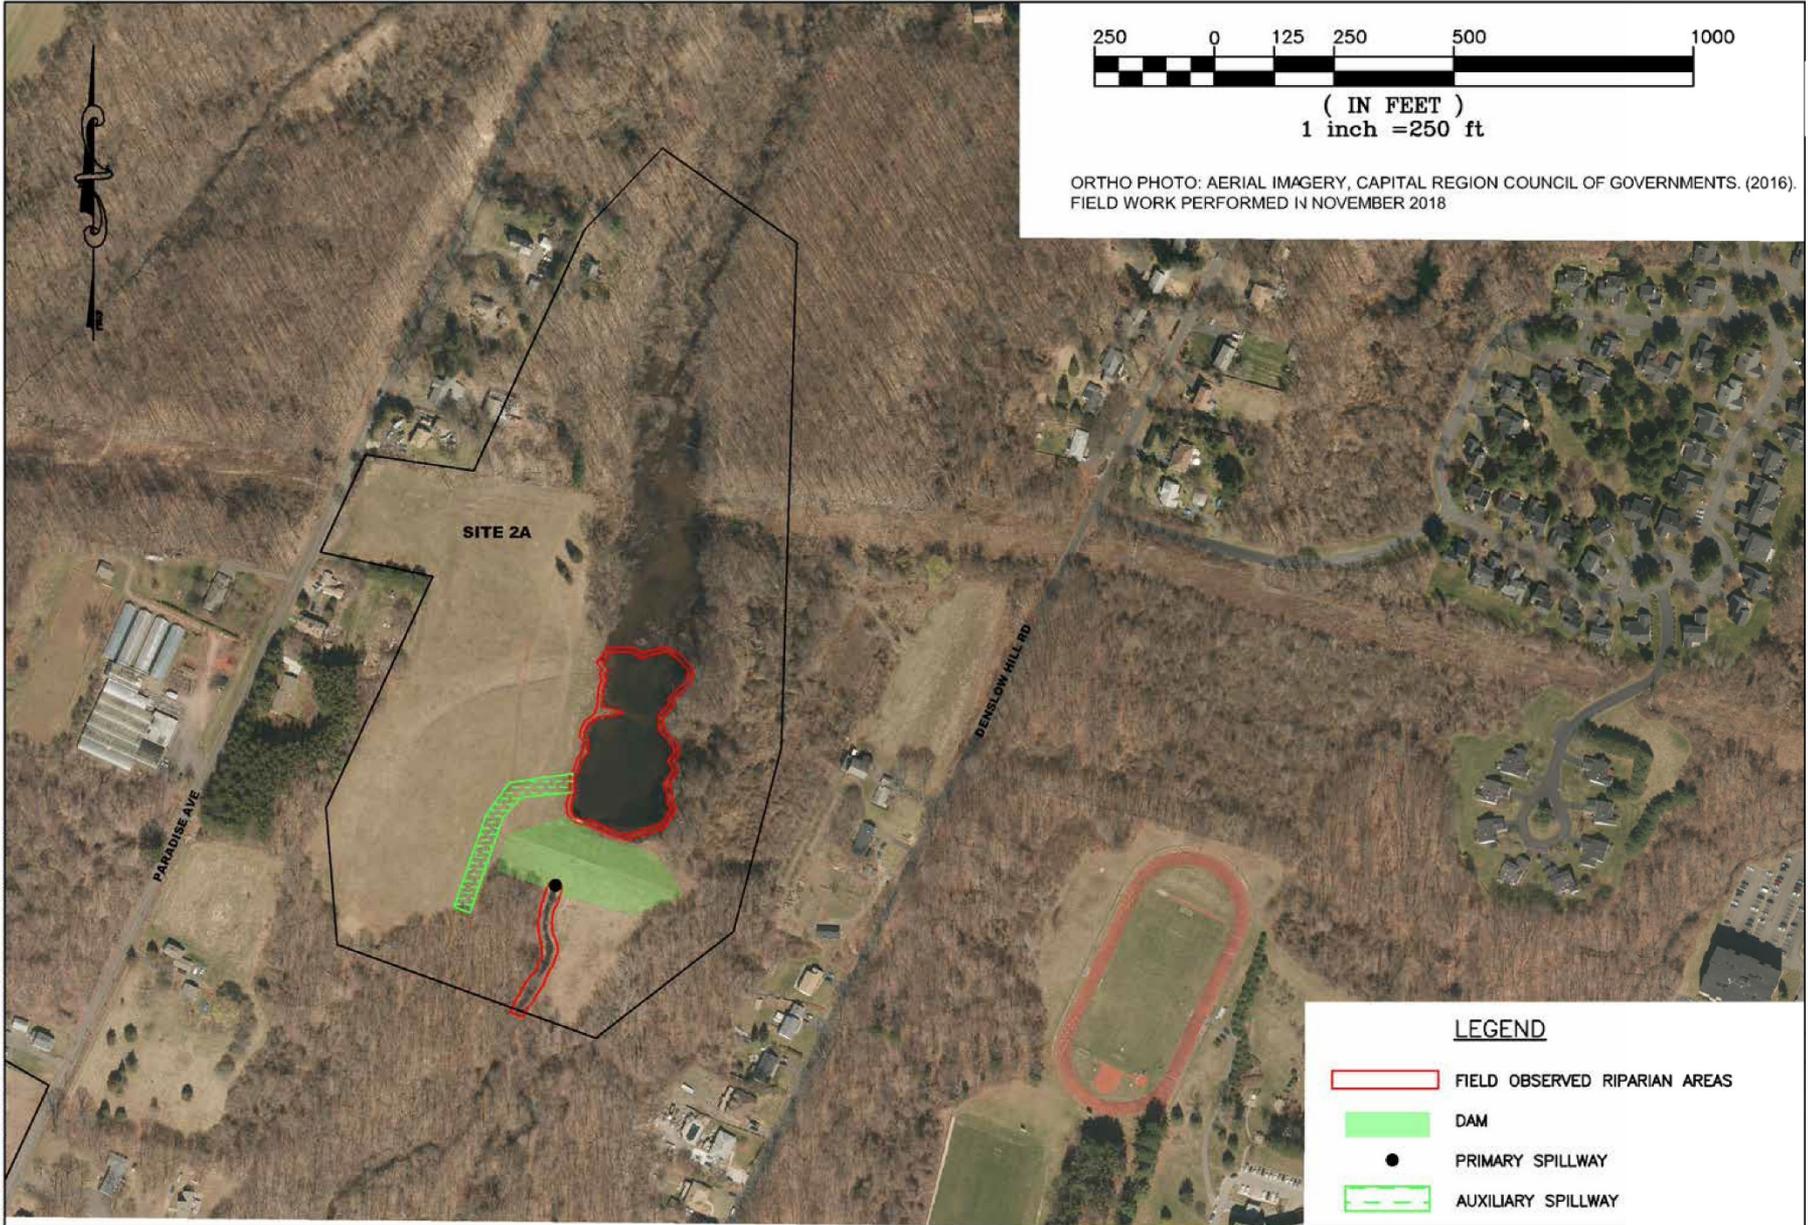
Site 2A Riparian Areas

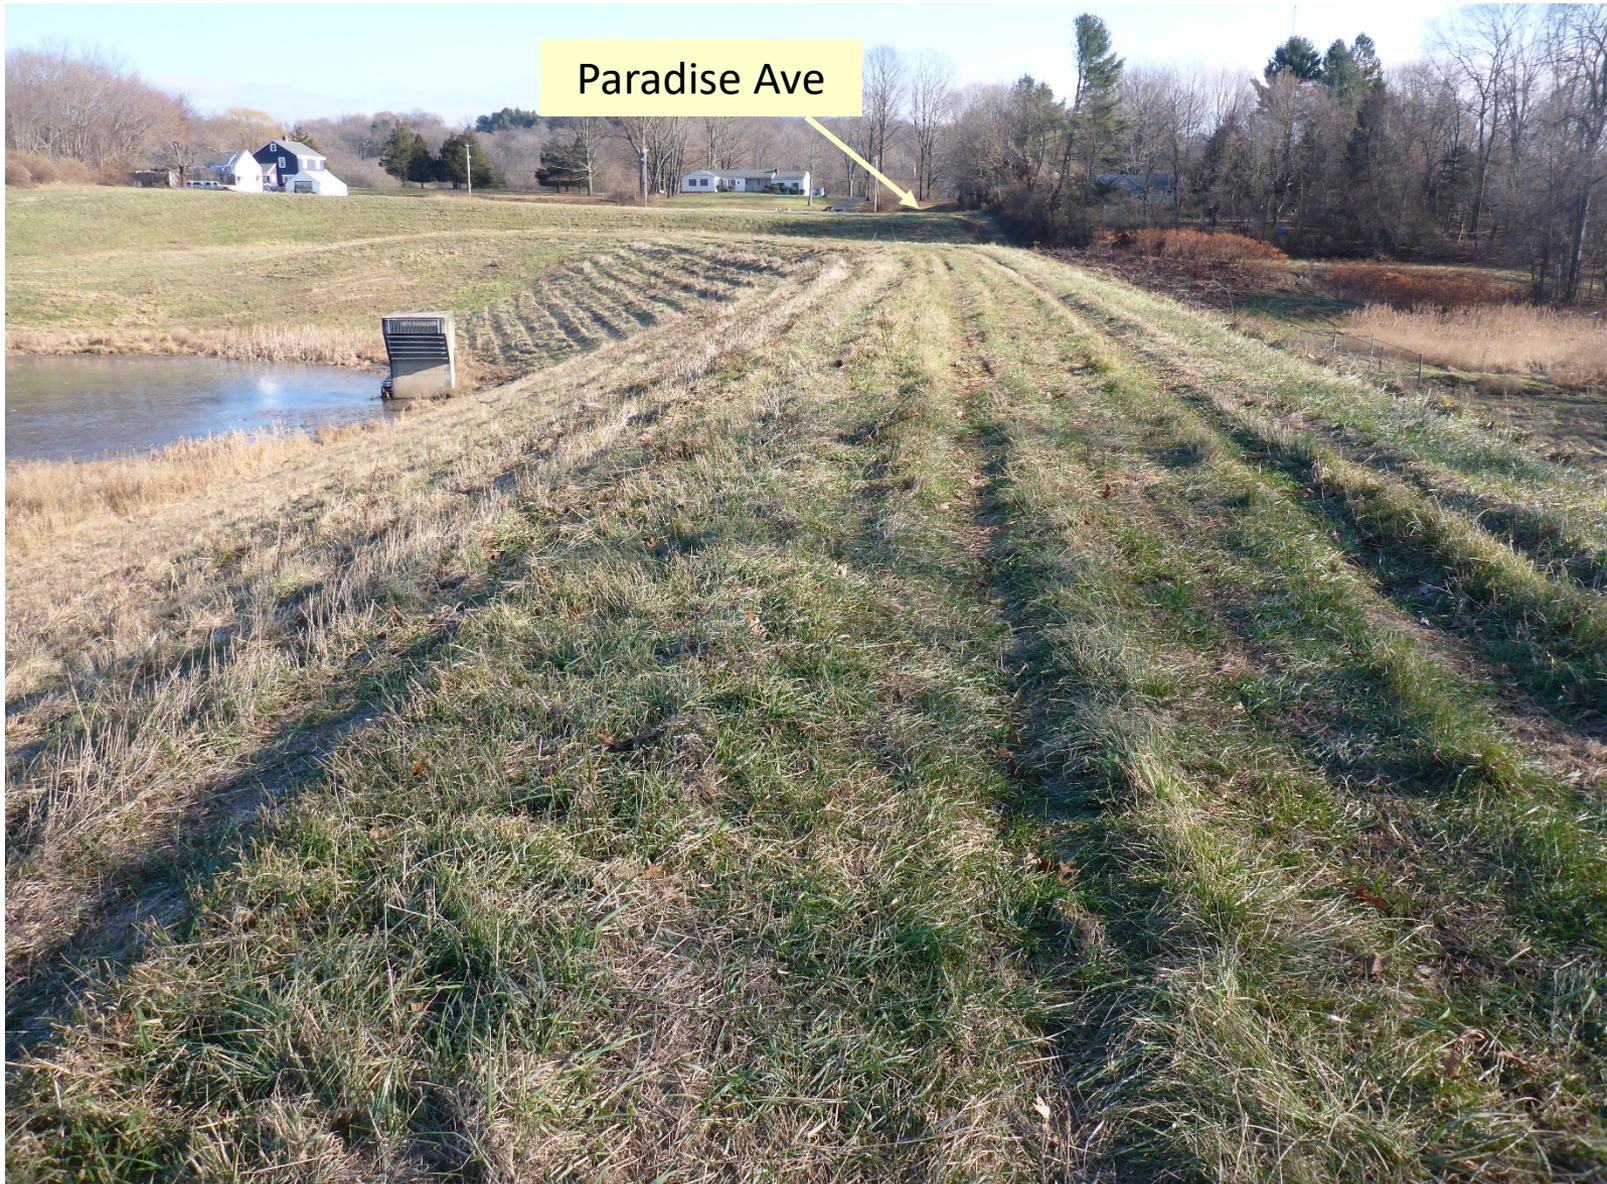
Site 2B – Crest

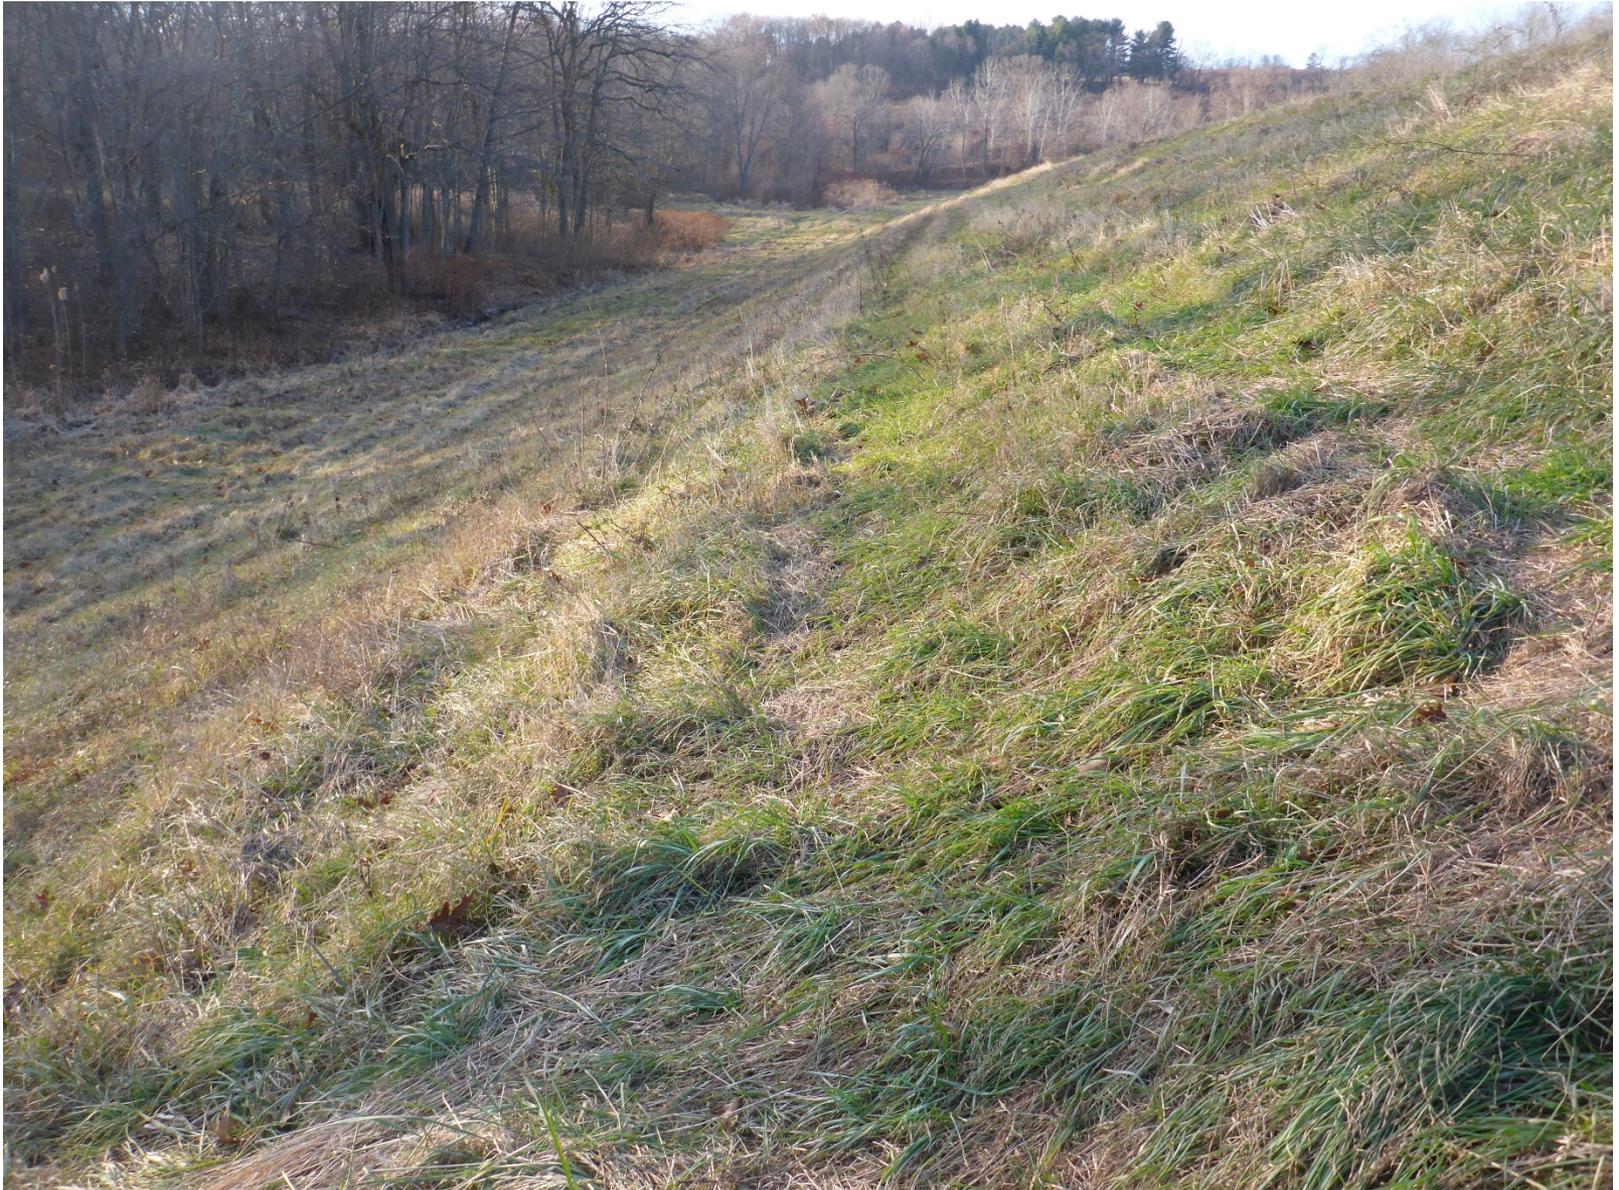
Site 2B – Downstream Slope
