Public Meeting

Farm Brook Sites 1, 2A and 2B

Watershed Planning and Environmental Assessment

Dam Rehabilitation Project
July 18, 2019

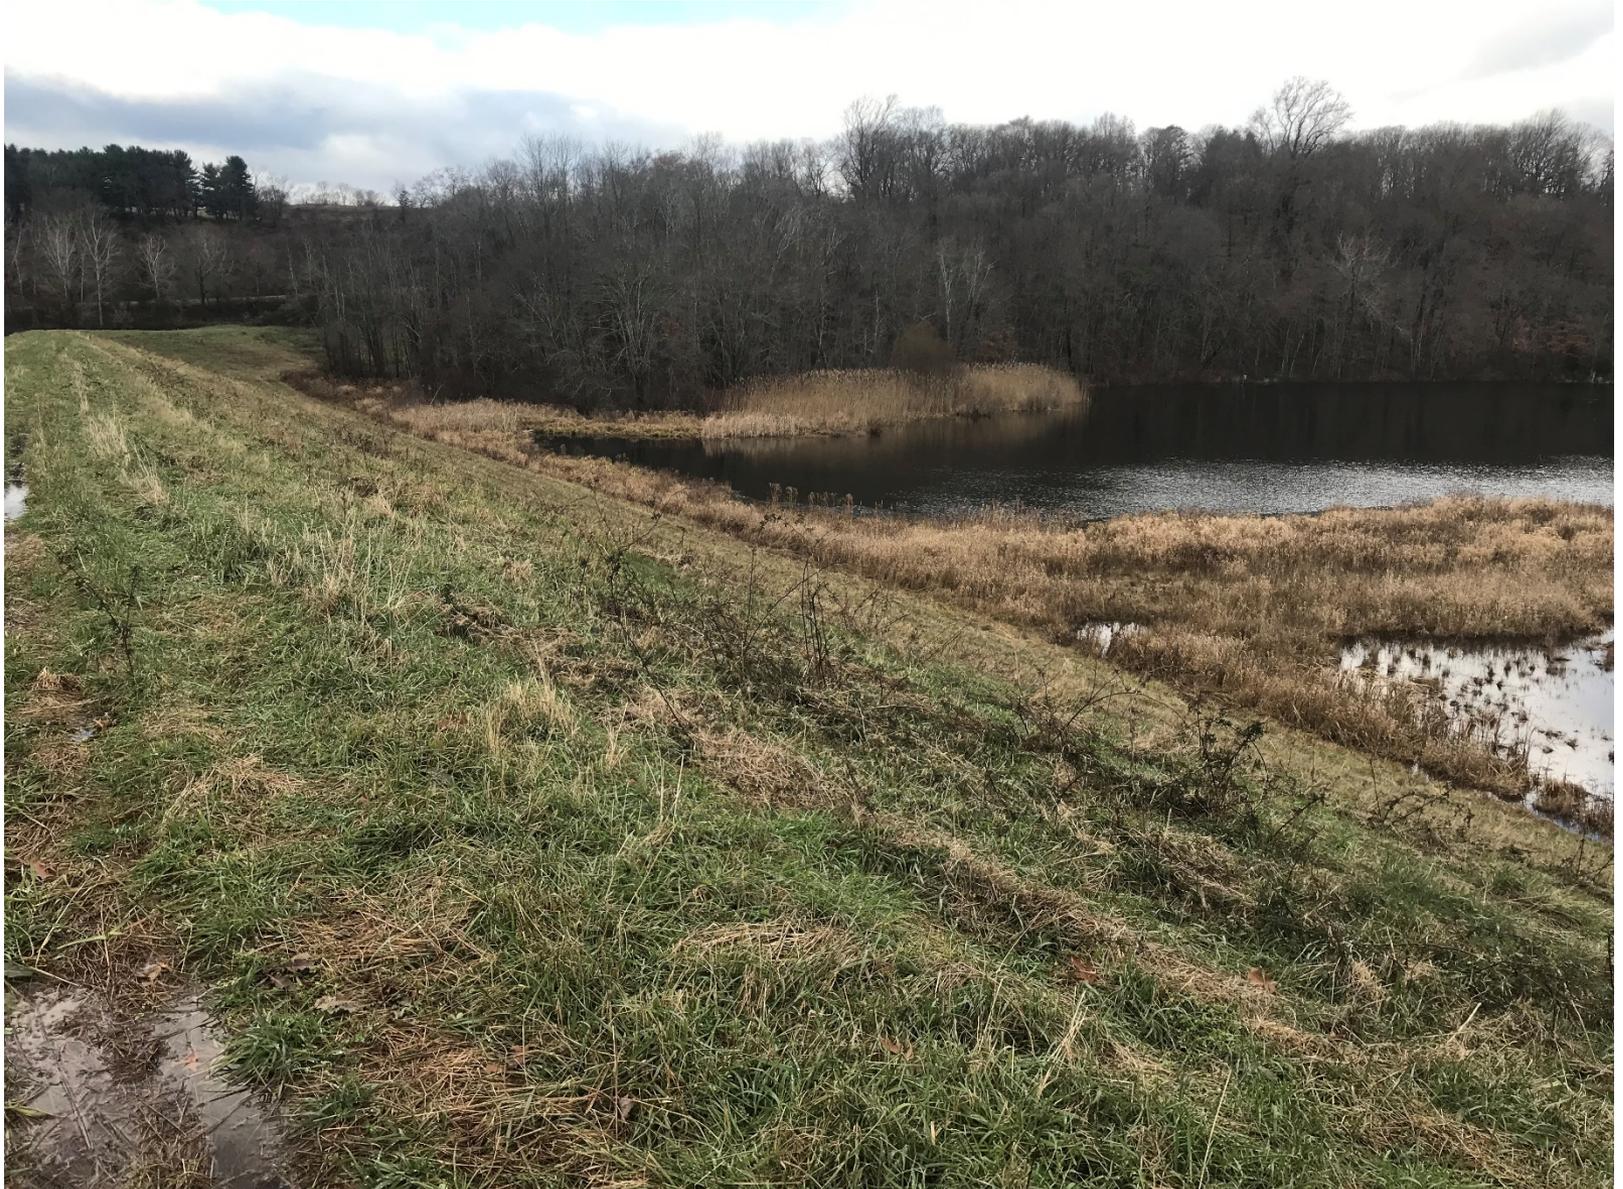
Site 2B – Upstream Slope

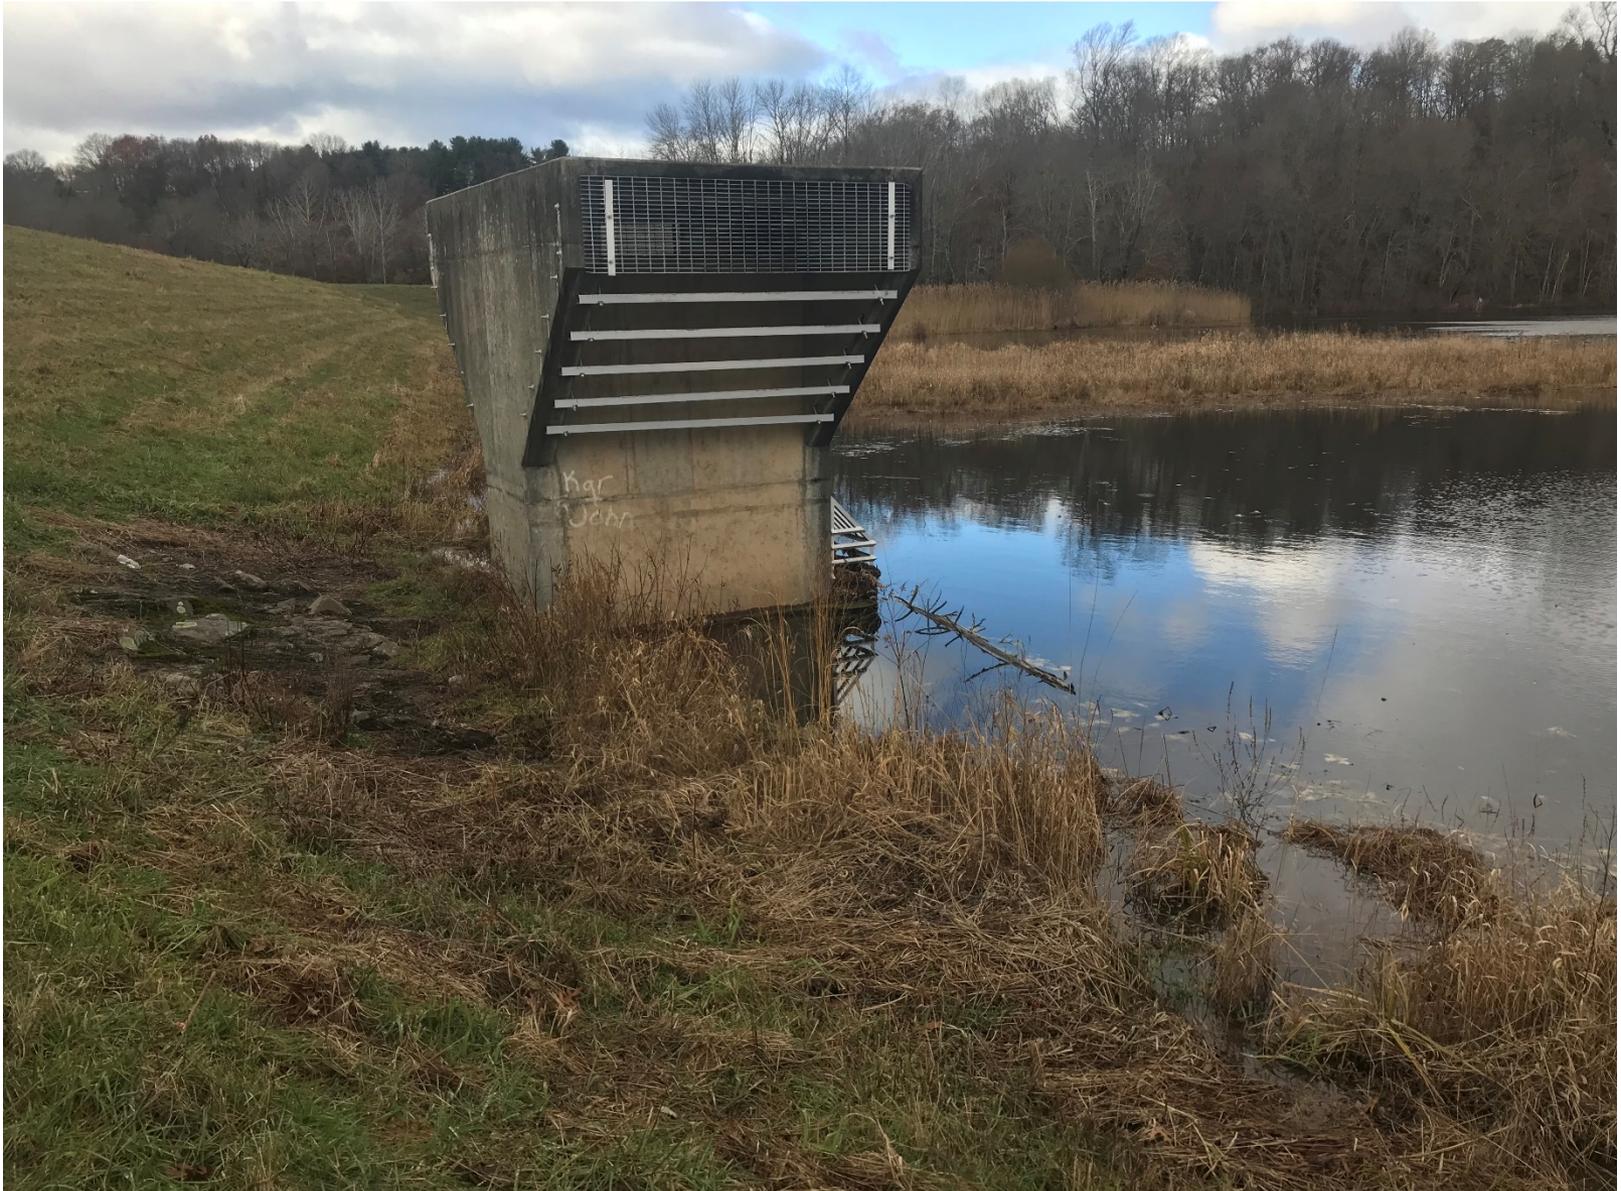
Site 2B – Principal Spillway Intake

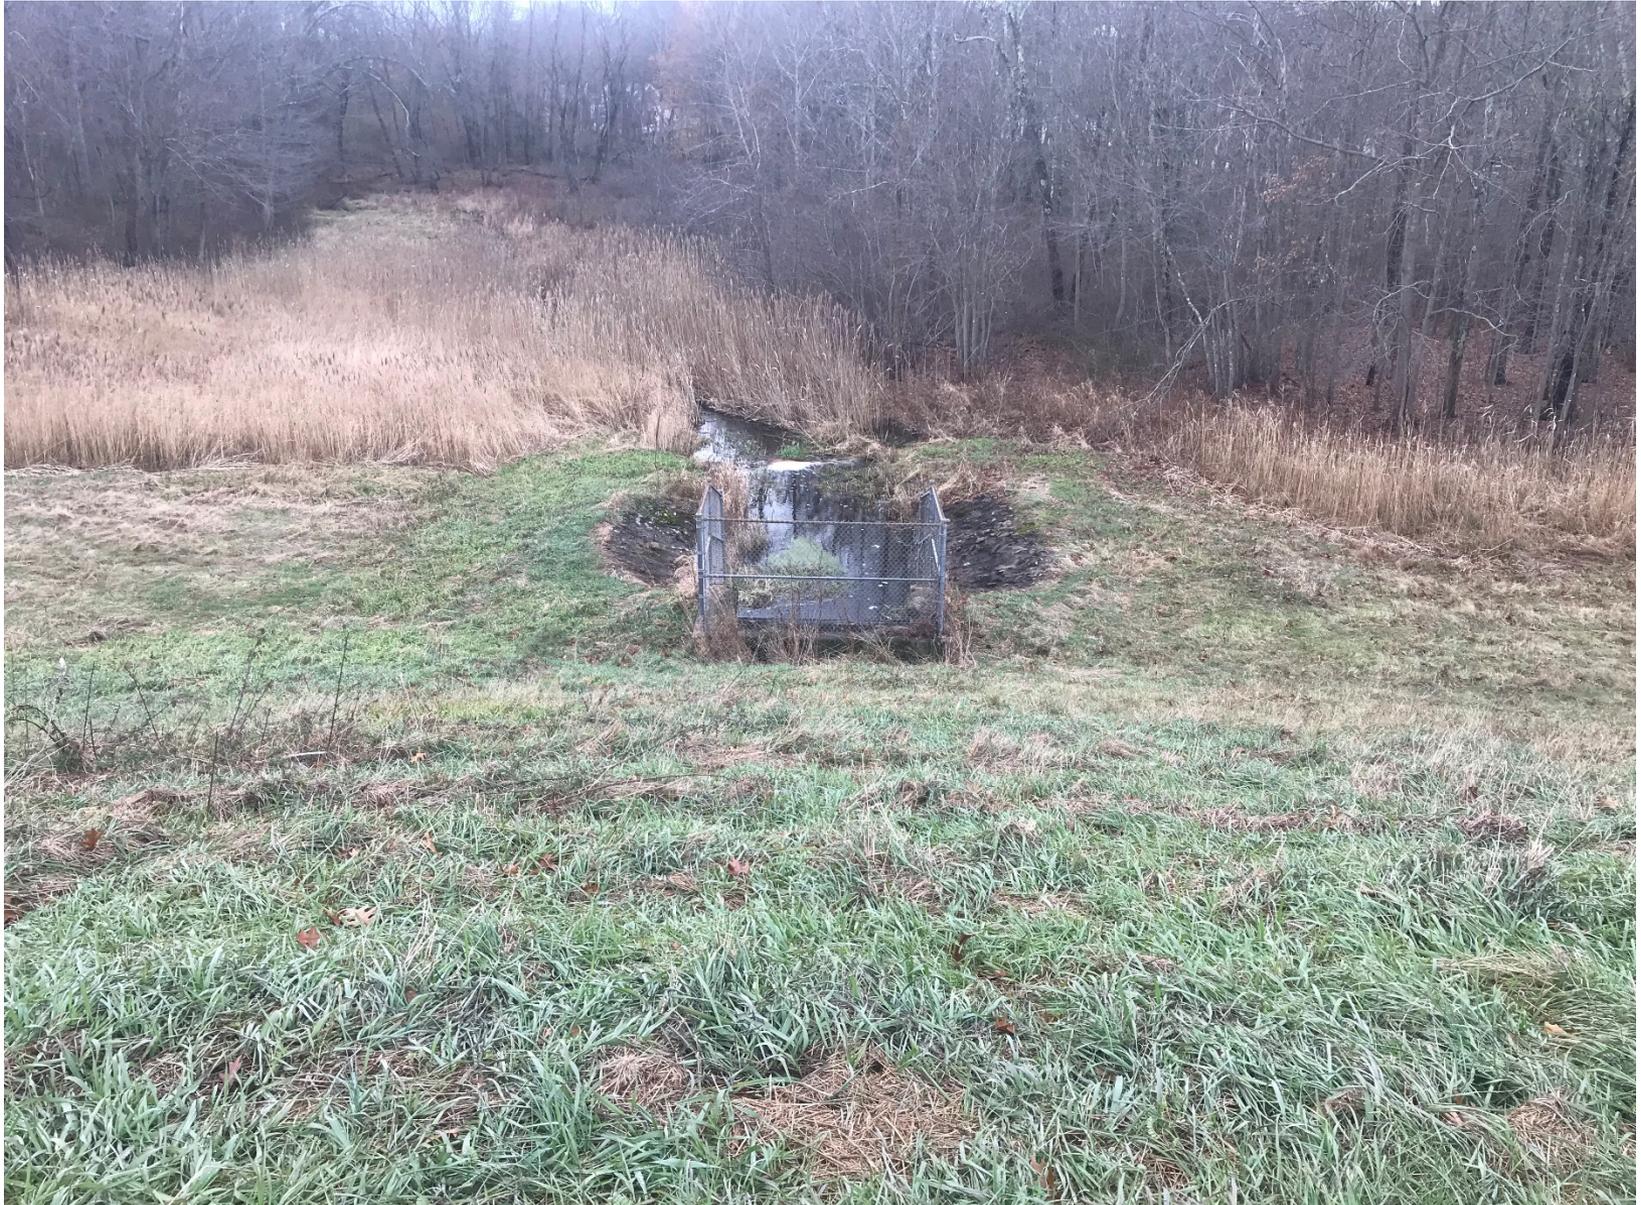
Site 2B – Principal Spillway Outlet

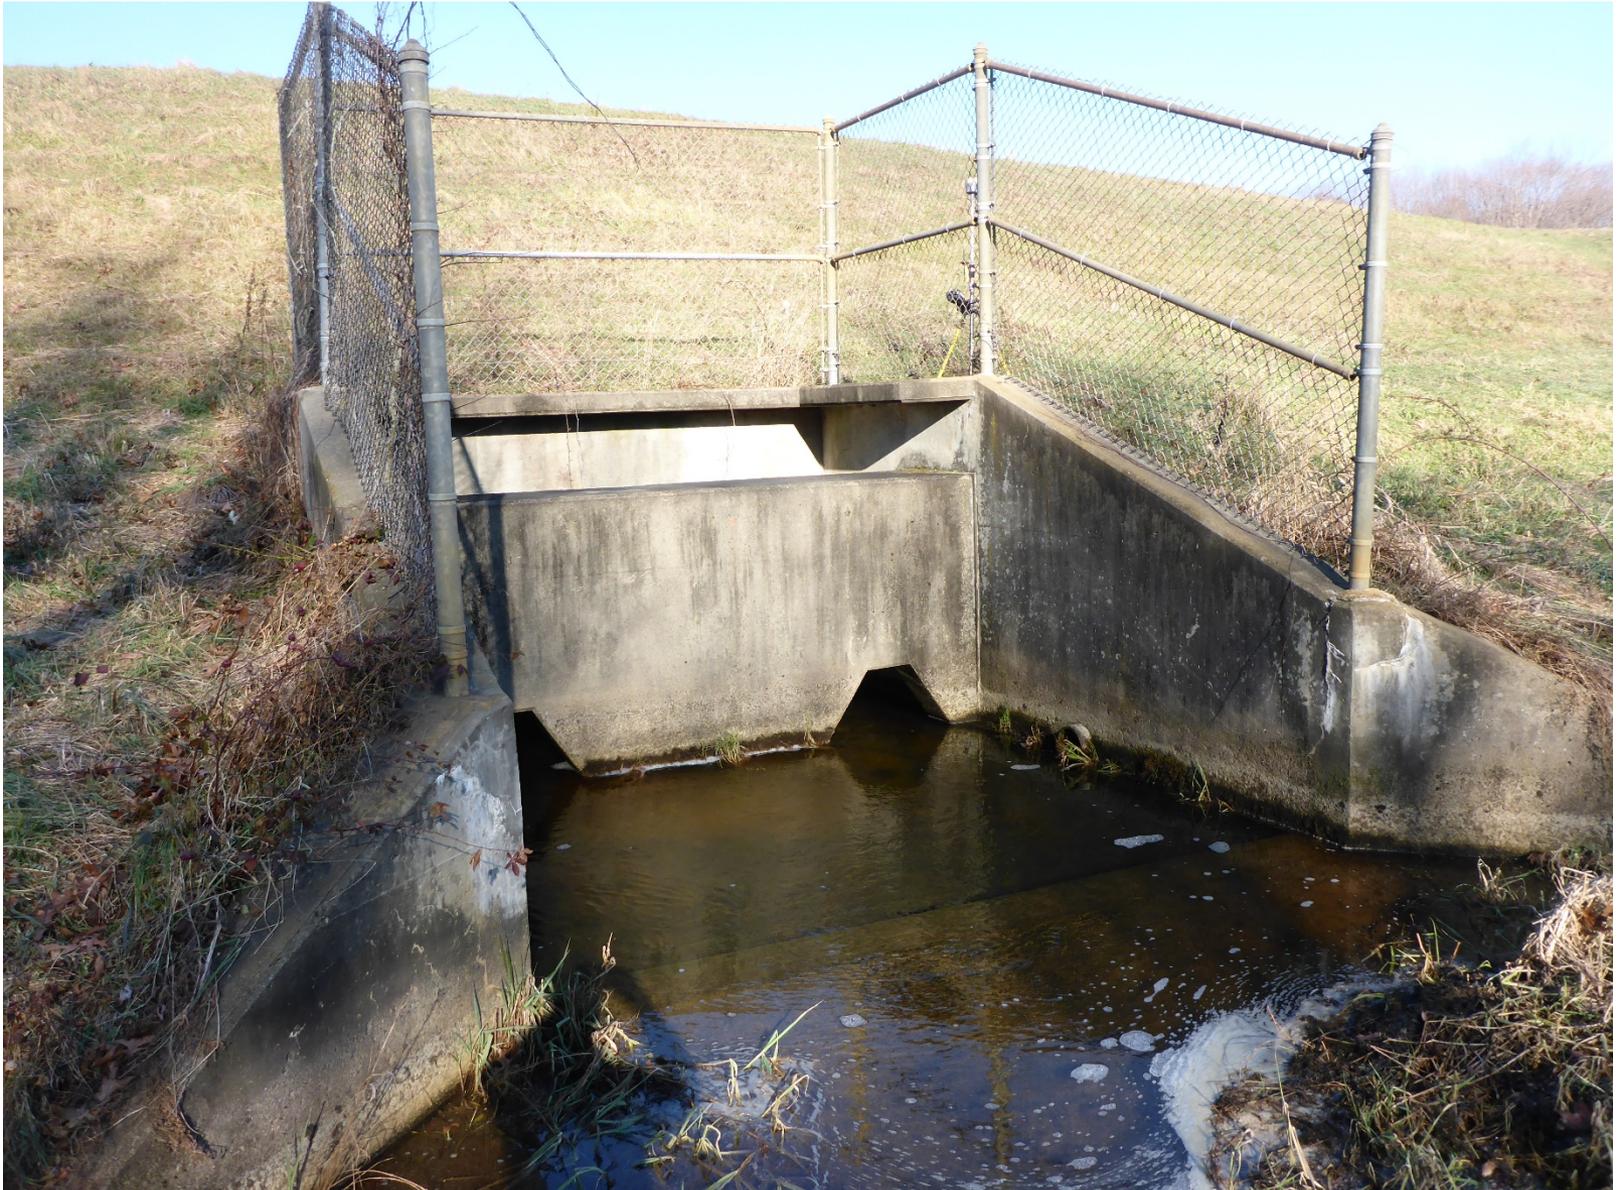
Site 2B – Principal Spillway Outlet

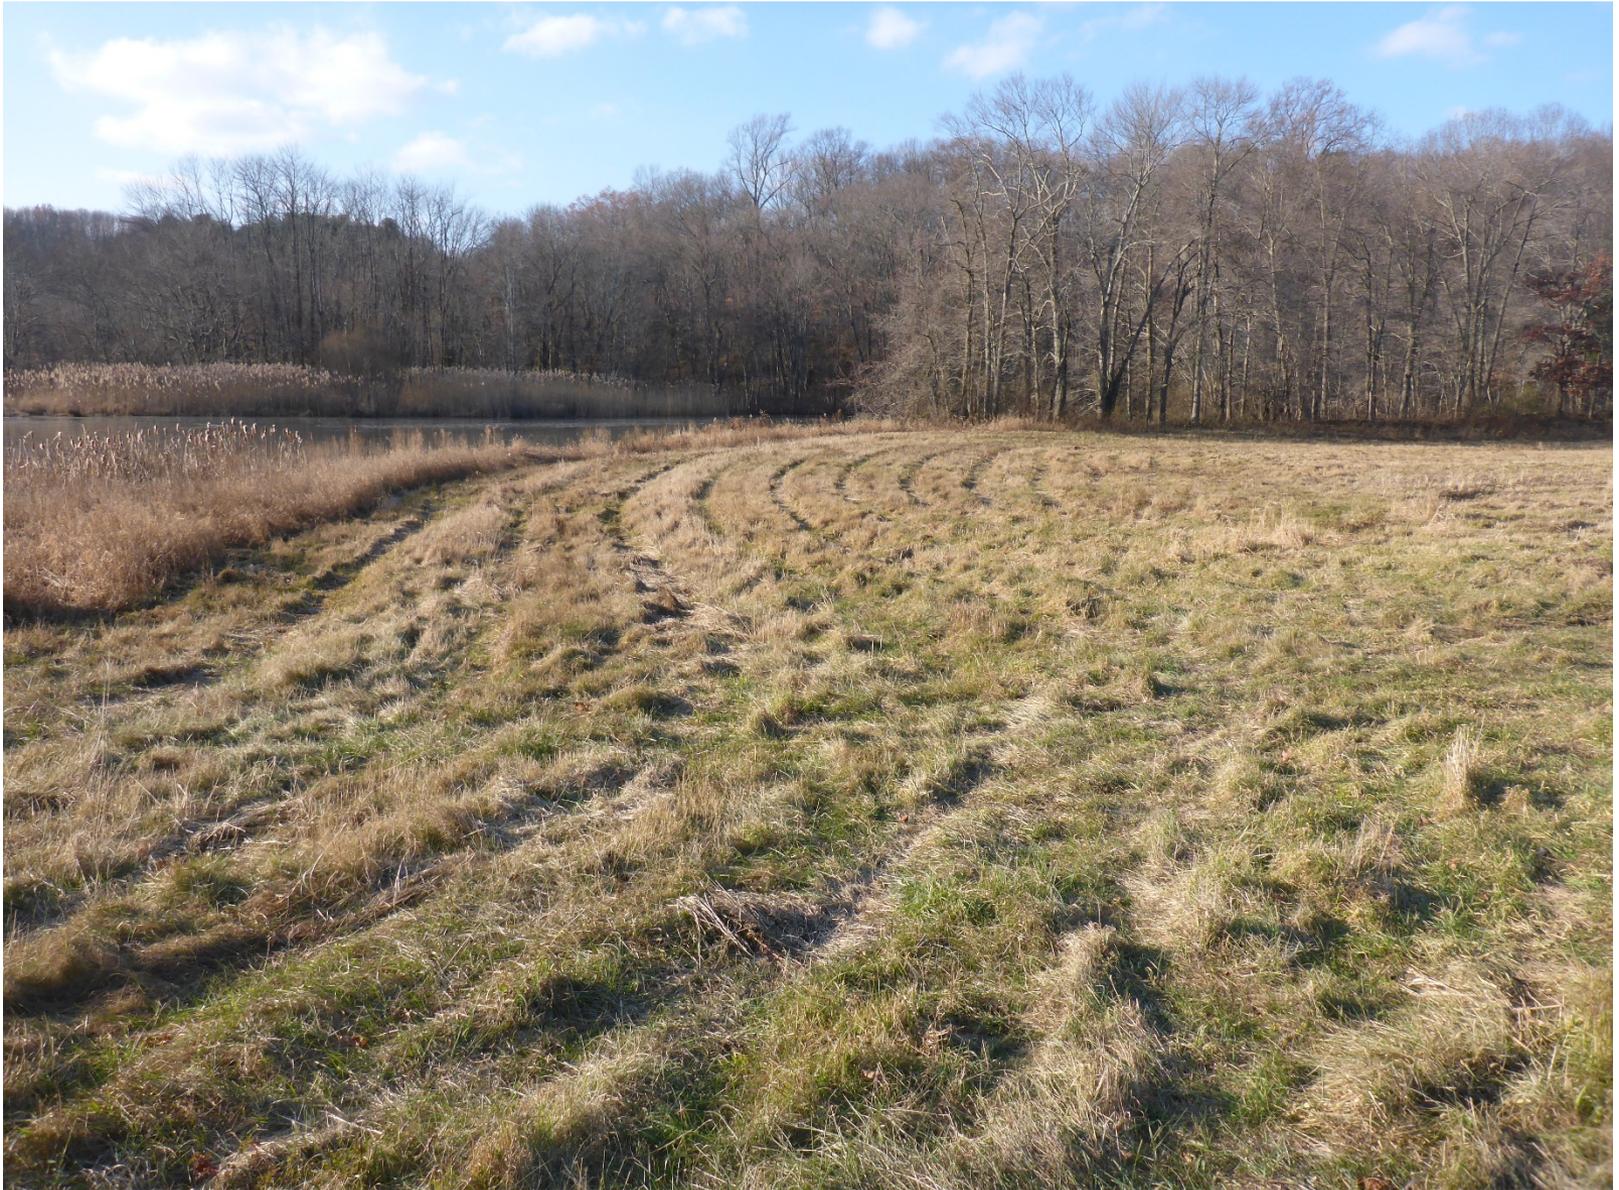
Site 2B – Upstream Portion of Auxiliary Spillway

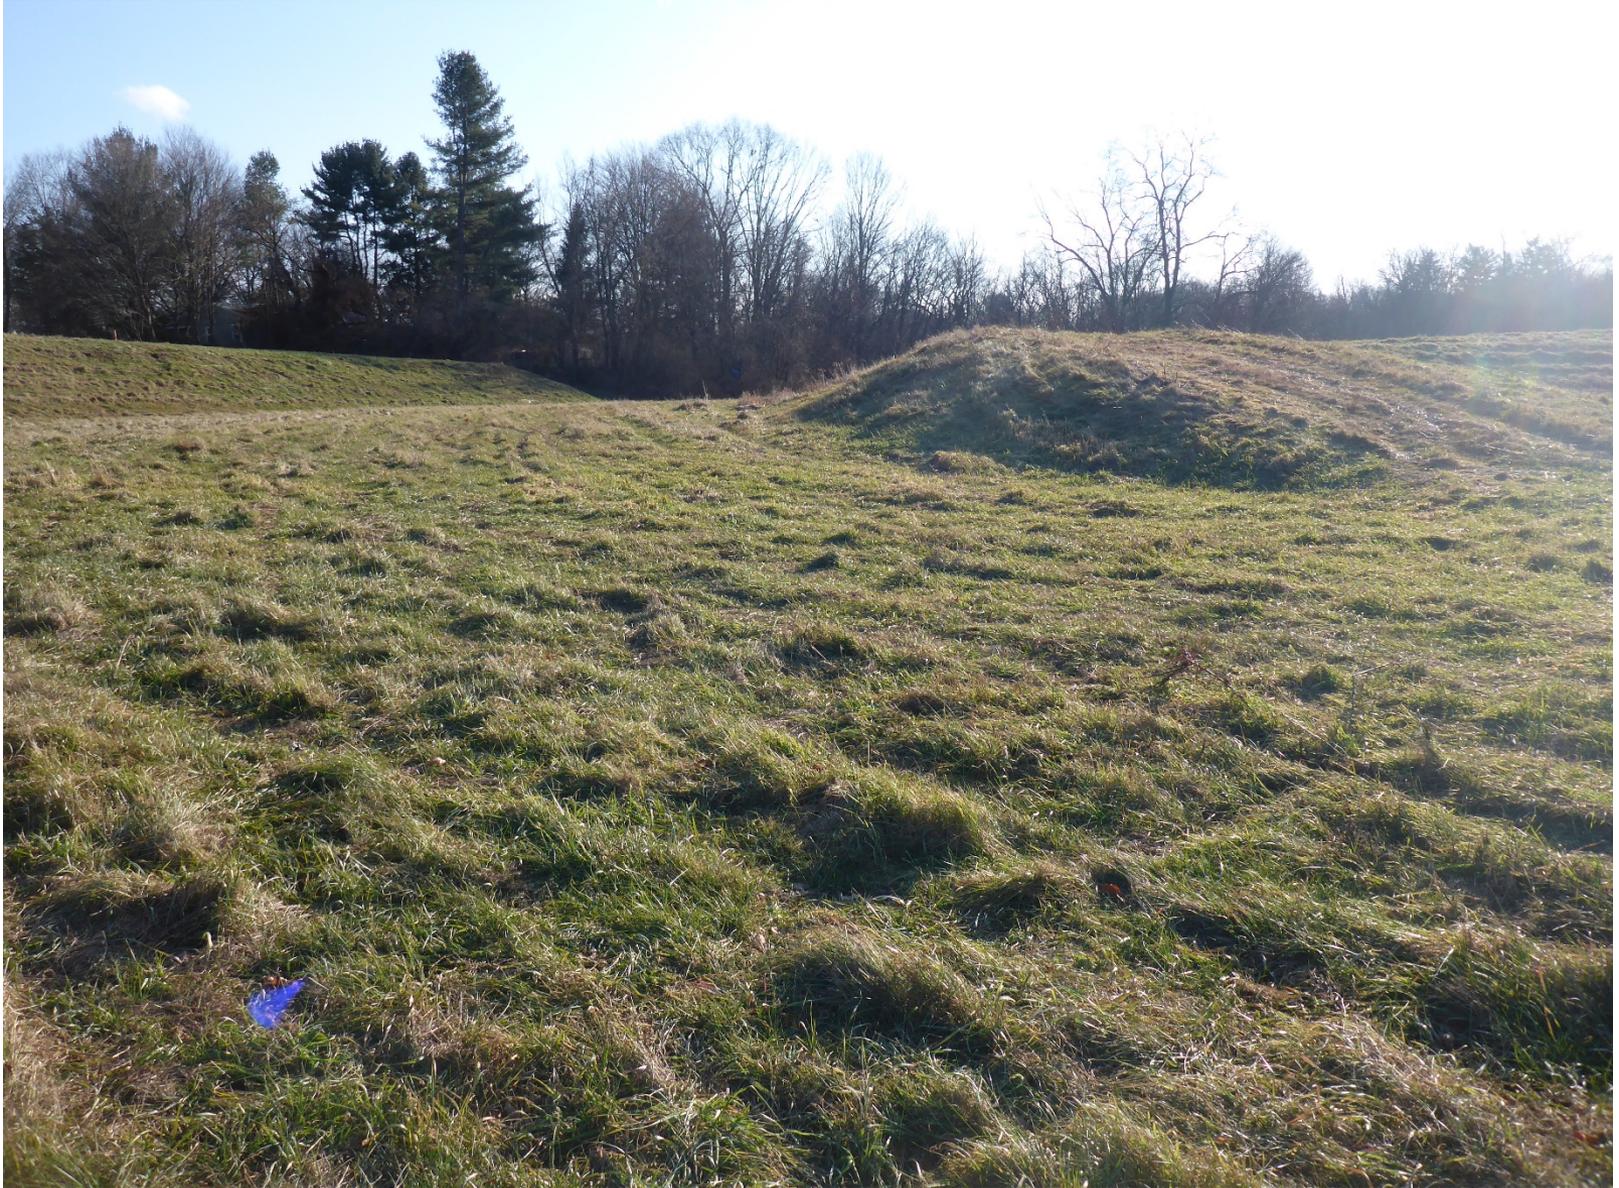
Site 2B – Central Portion of Auxiliary Spillway

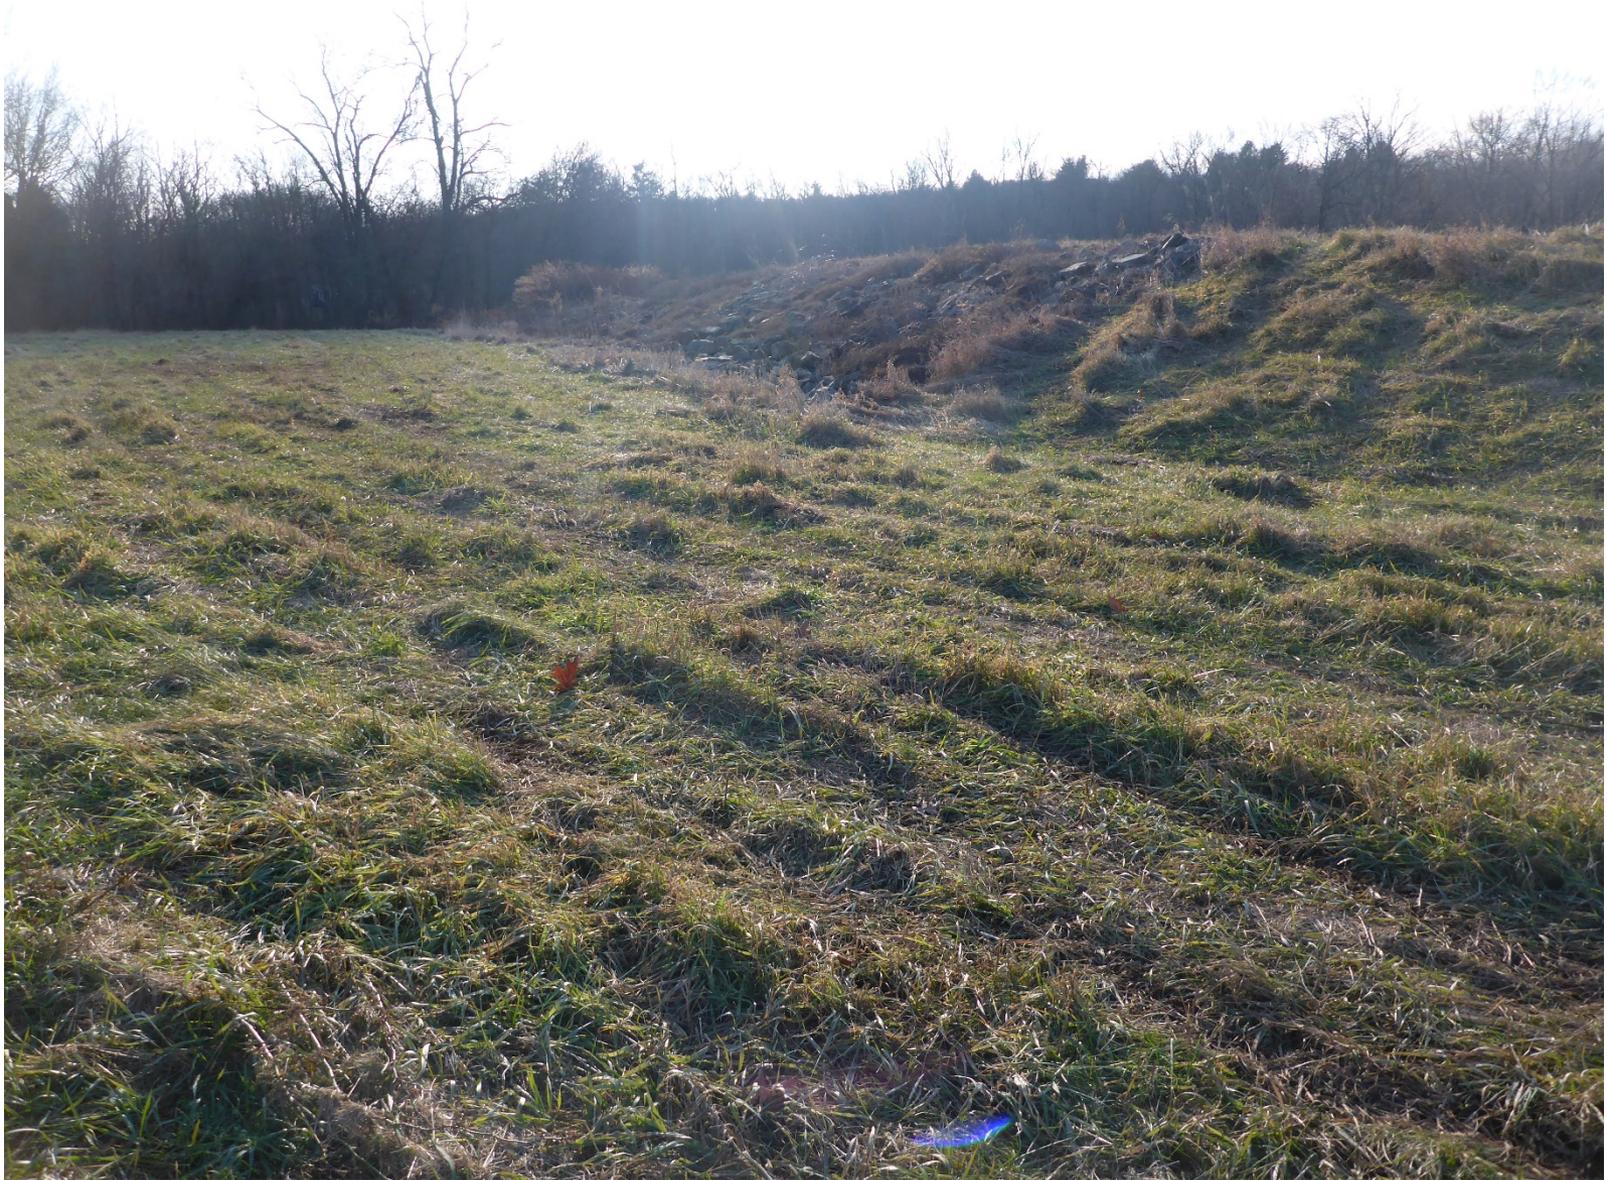
Site 2B – Downstream Portion of Auxiliary Spillway

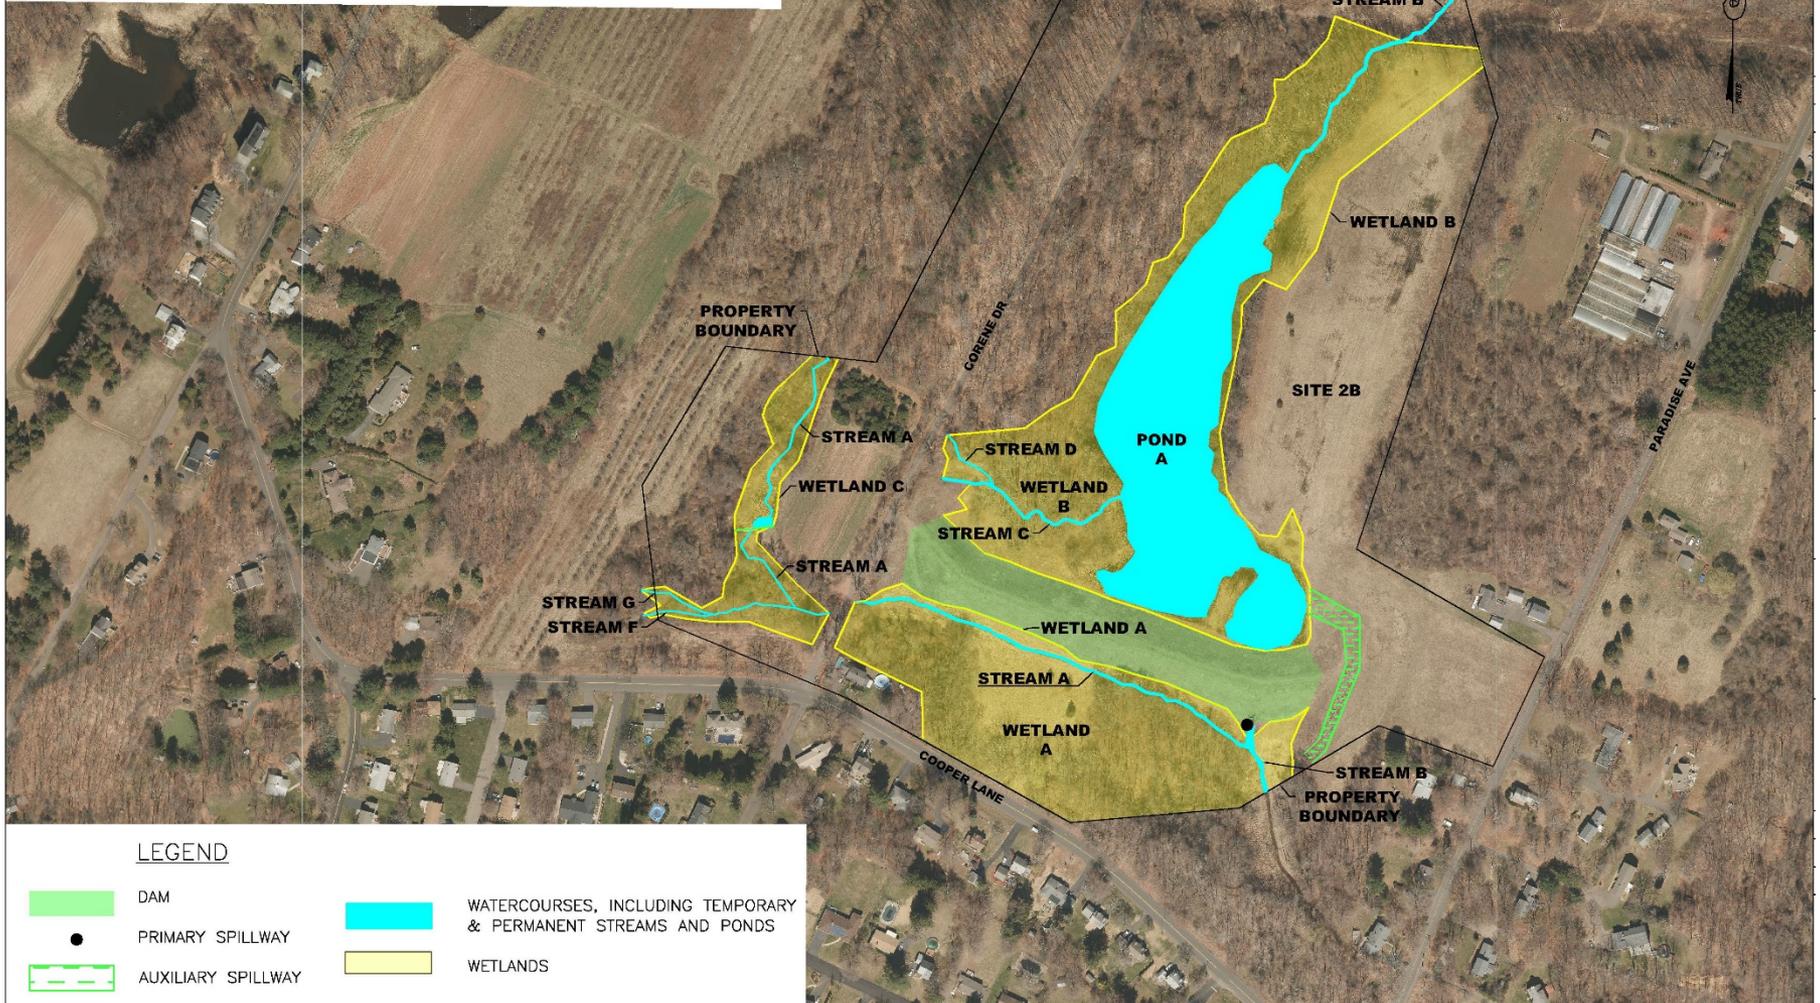
Site 2B Aquatic Resources

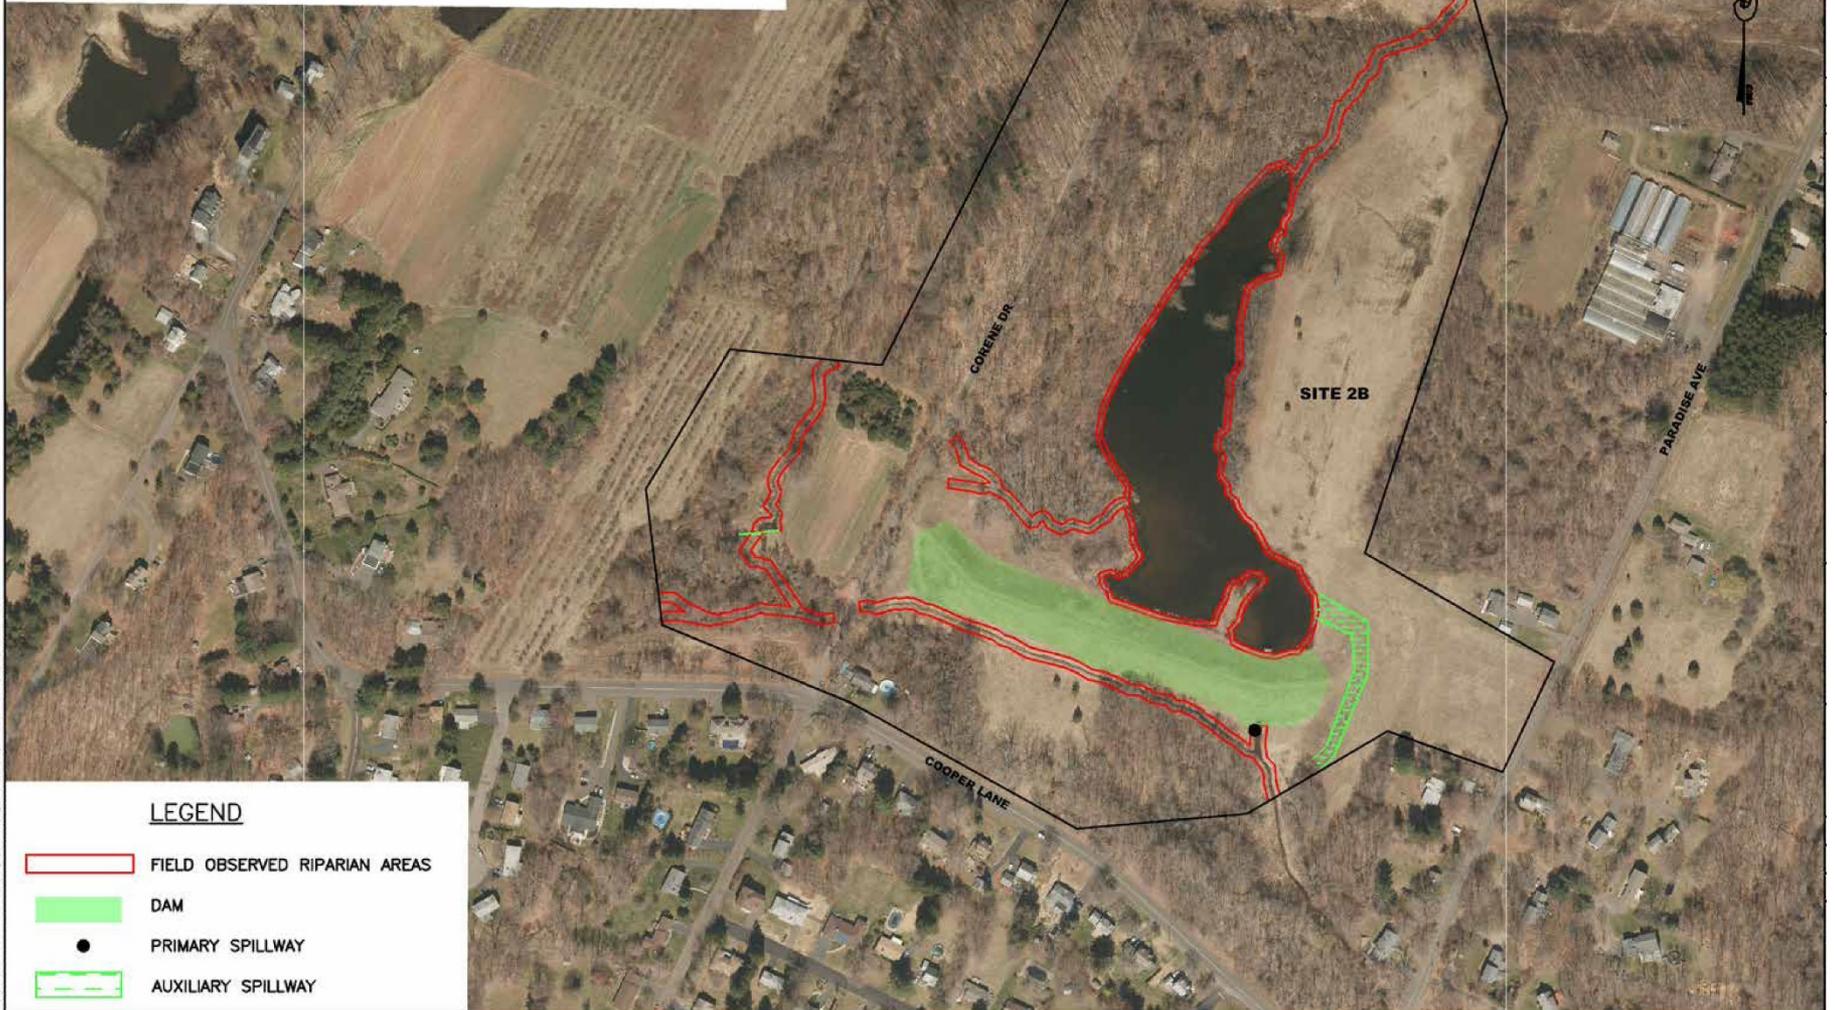
Site 2B Riparian Areas

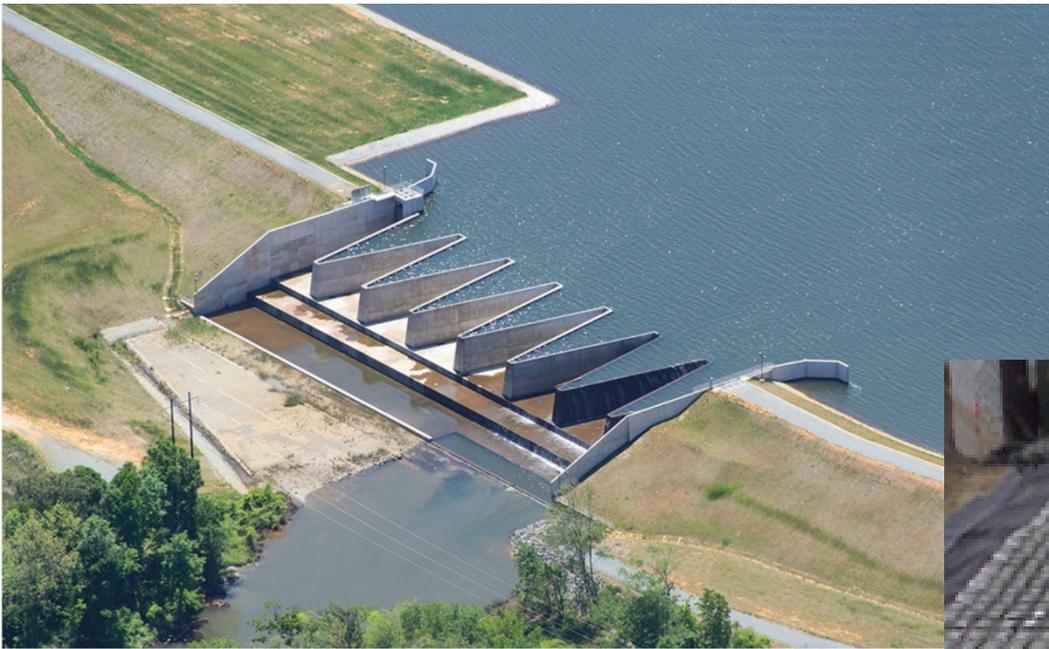
Labyrinth

- Increasing the Auxiliary Spillway Capacities
 - Enlargement or use of Labyrinth Weirs
- Armoring of Auxiliary Spillways
 - Reduces Erosion Potential and Increases Capacity
 - Articulated Concrete Blocks (ACBs)
- Removing the Dams (Decommissioning)
 - Only considered if assessments concludes presence of dam does not provide adequate downstream flooding protection to offset cost of rehabilitation
 - Not likely an option

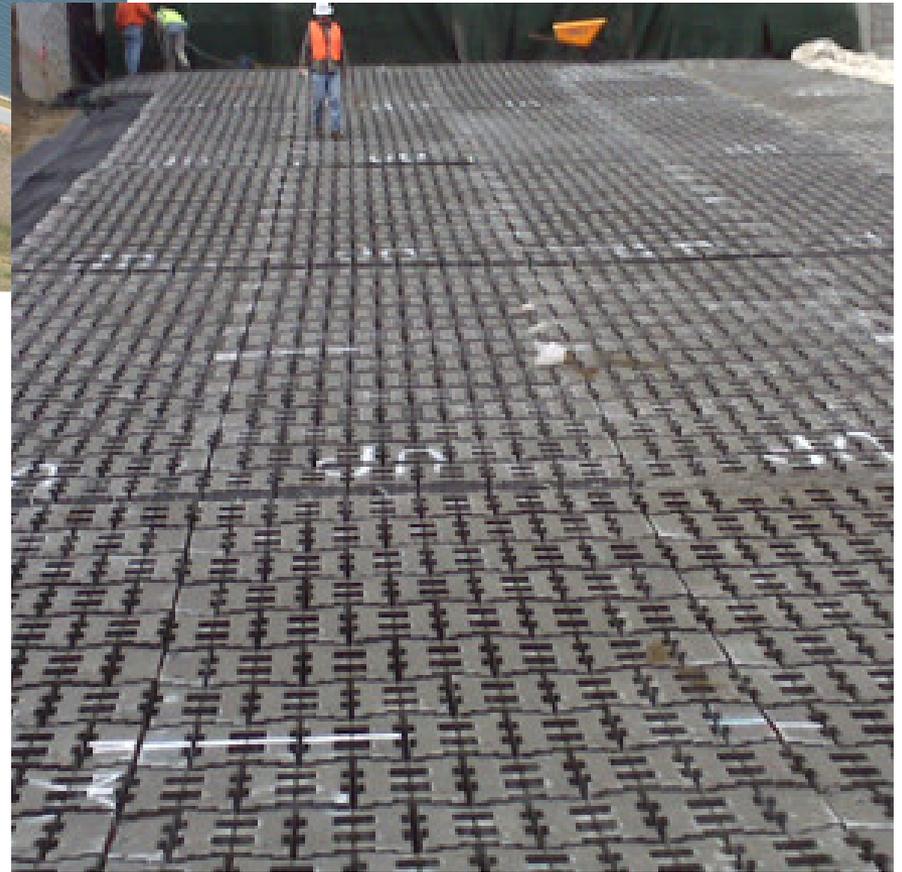
Articulated Concrete Blocks
