Connecticut Department of
**ENERGY &
ENVIRONMENTAL
PROTECTION**

Monitoring Streamflow with Trail Cameras

2019 CT Volunteer Water Monitoring Conference

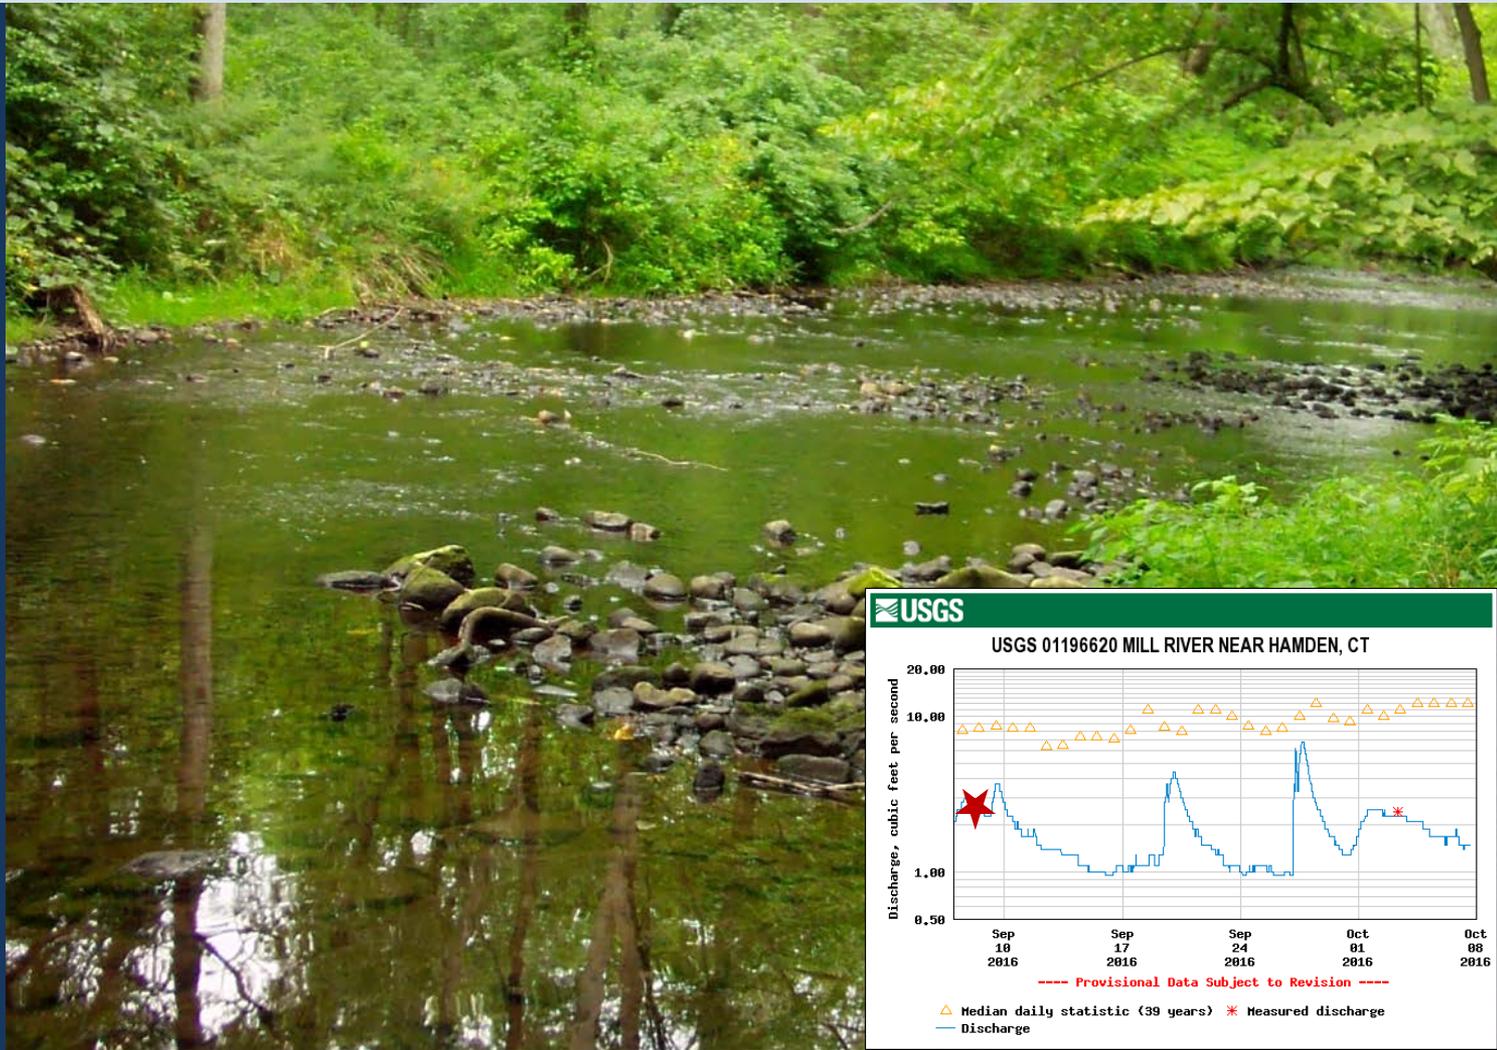
09/07/2016 – 2.70 cfs

- Set to take pictures at specific times each day
- Daily pictures
- Leave for weeks at a time
- Picture standardization

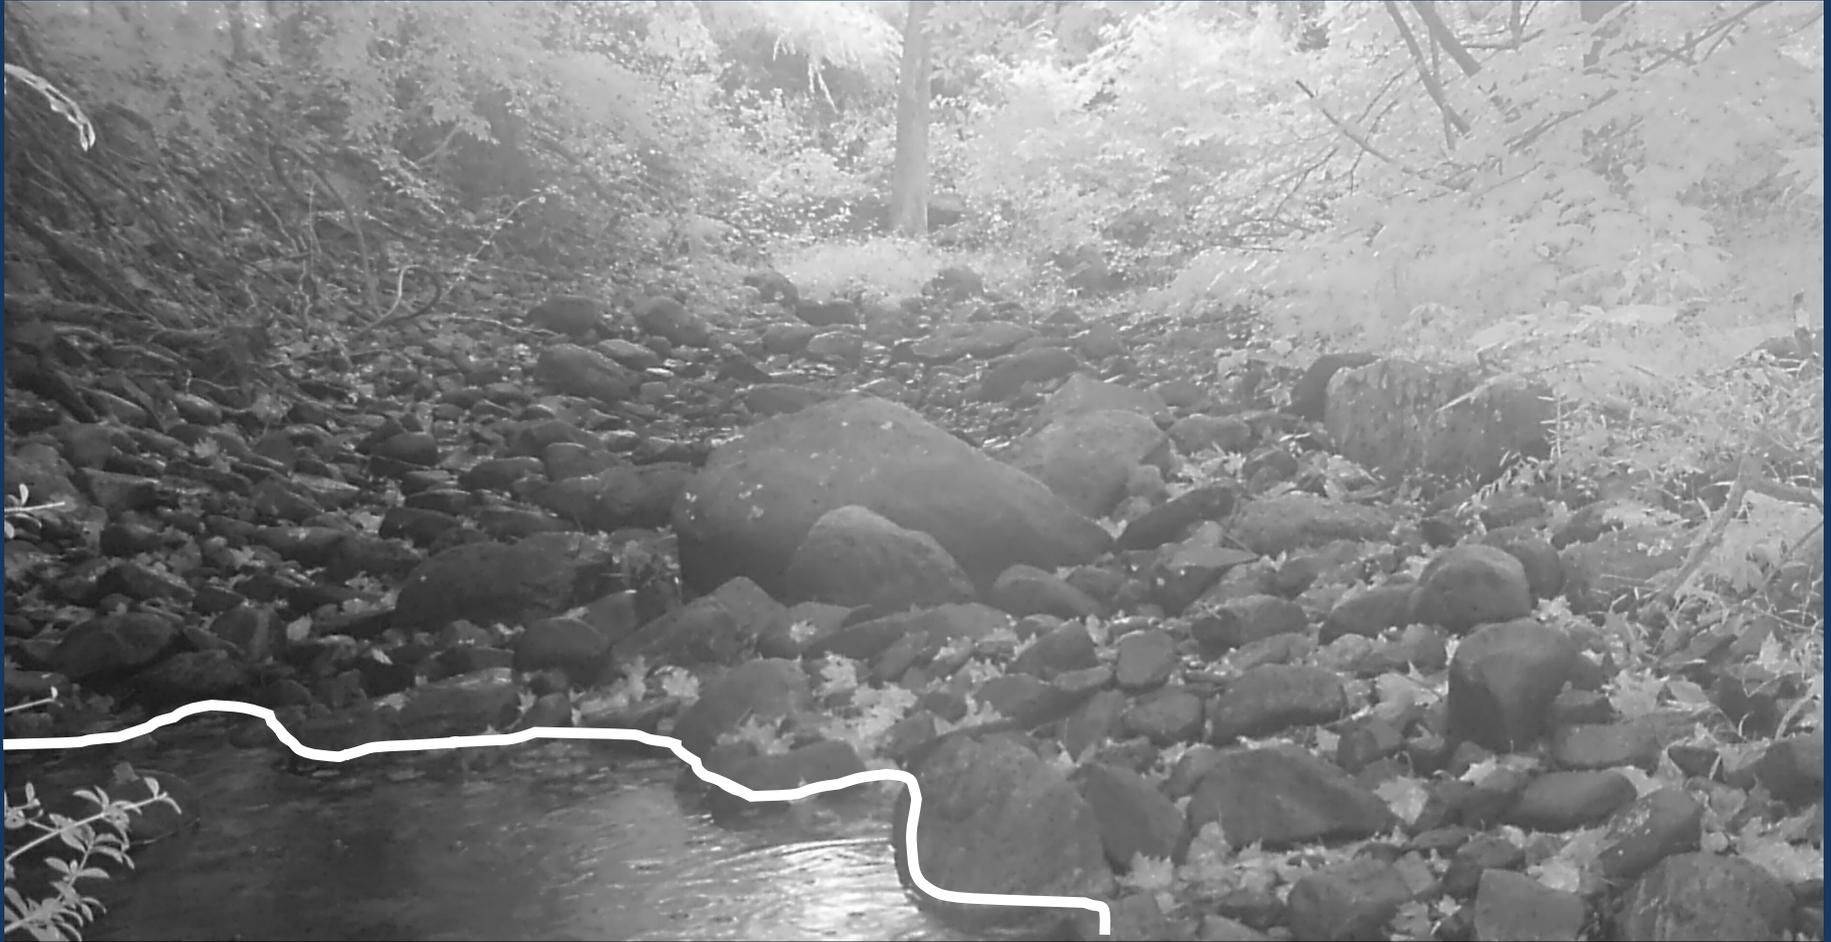
10:55 AM

Trail camera captures flood events

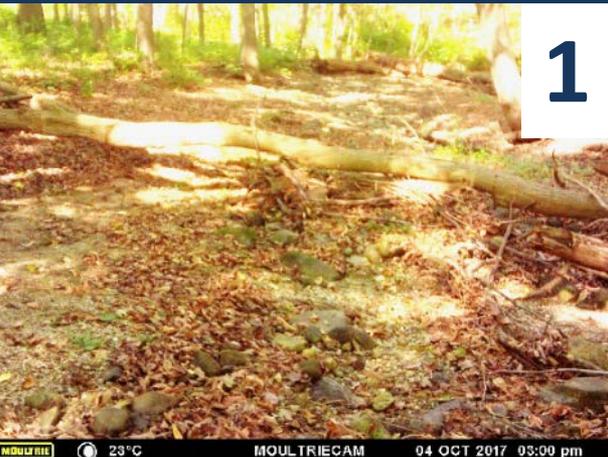
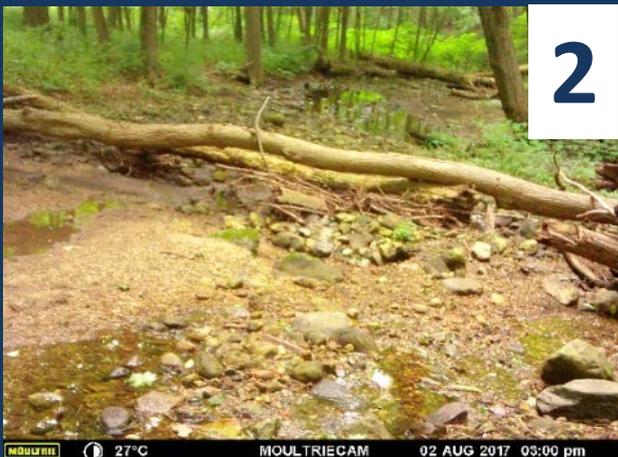
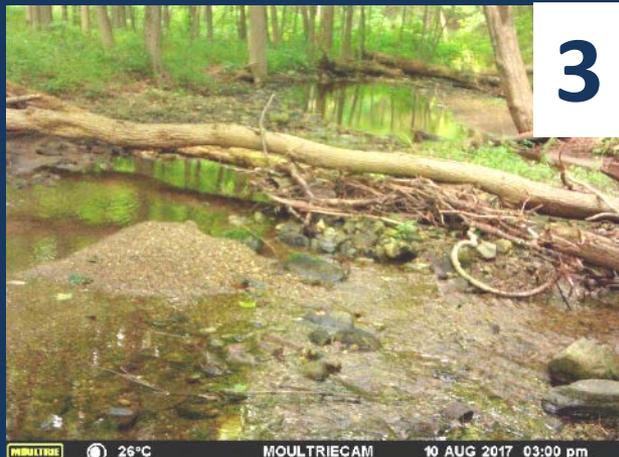
Pictures are Data! Flow Habitat Categories

Disconnected

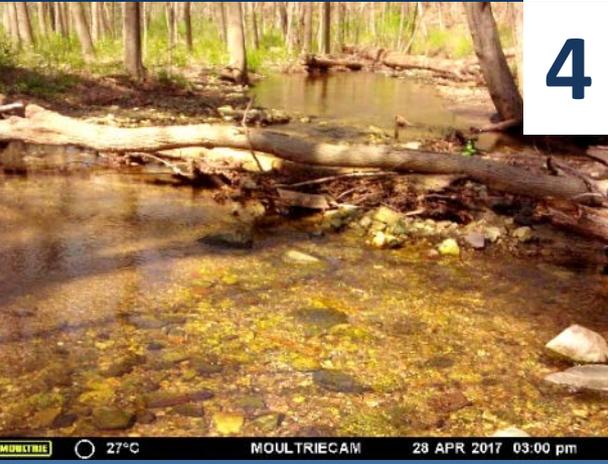
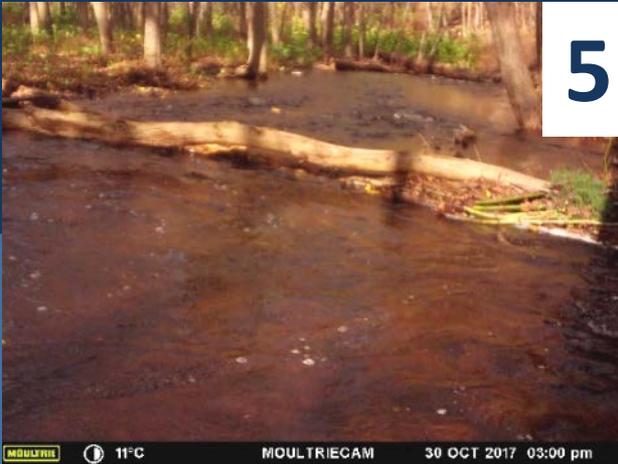
Connected

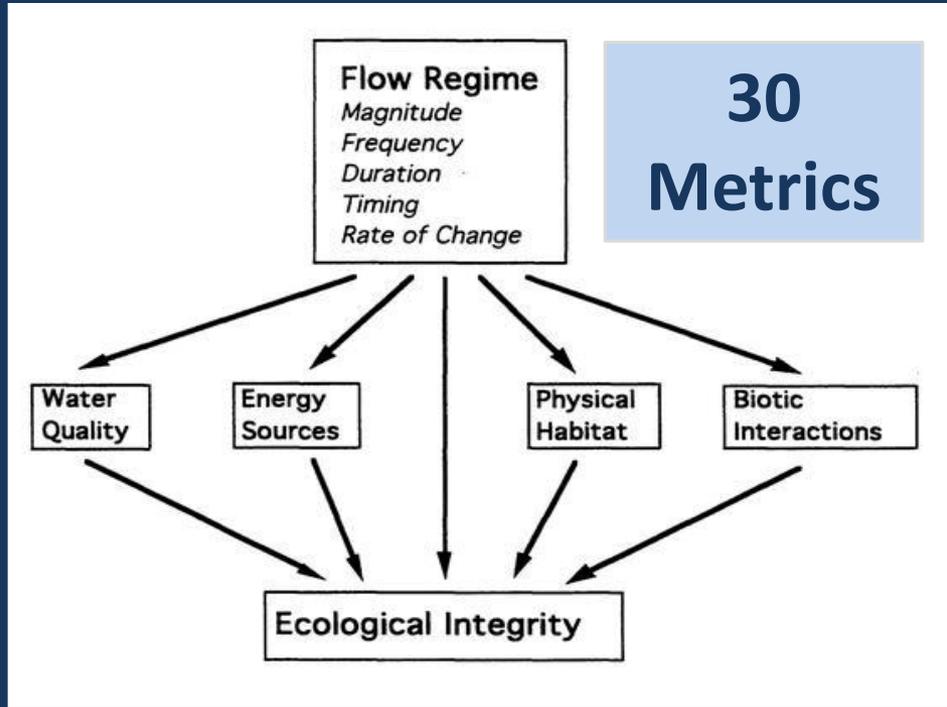
Pictures to Metrics

- Average number of days in category 3
- Number of days in category 1 when reference USGS streams had normal flows (25-75 percentile)

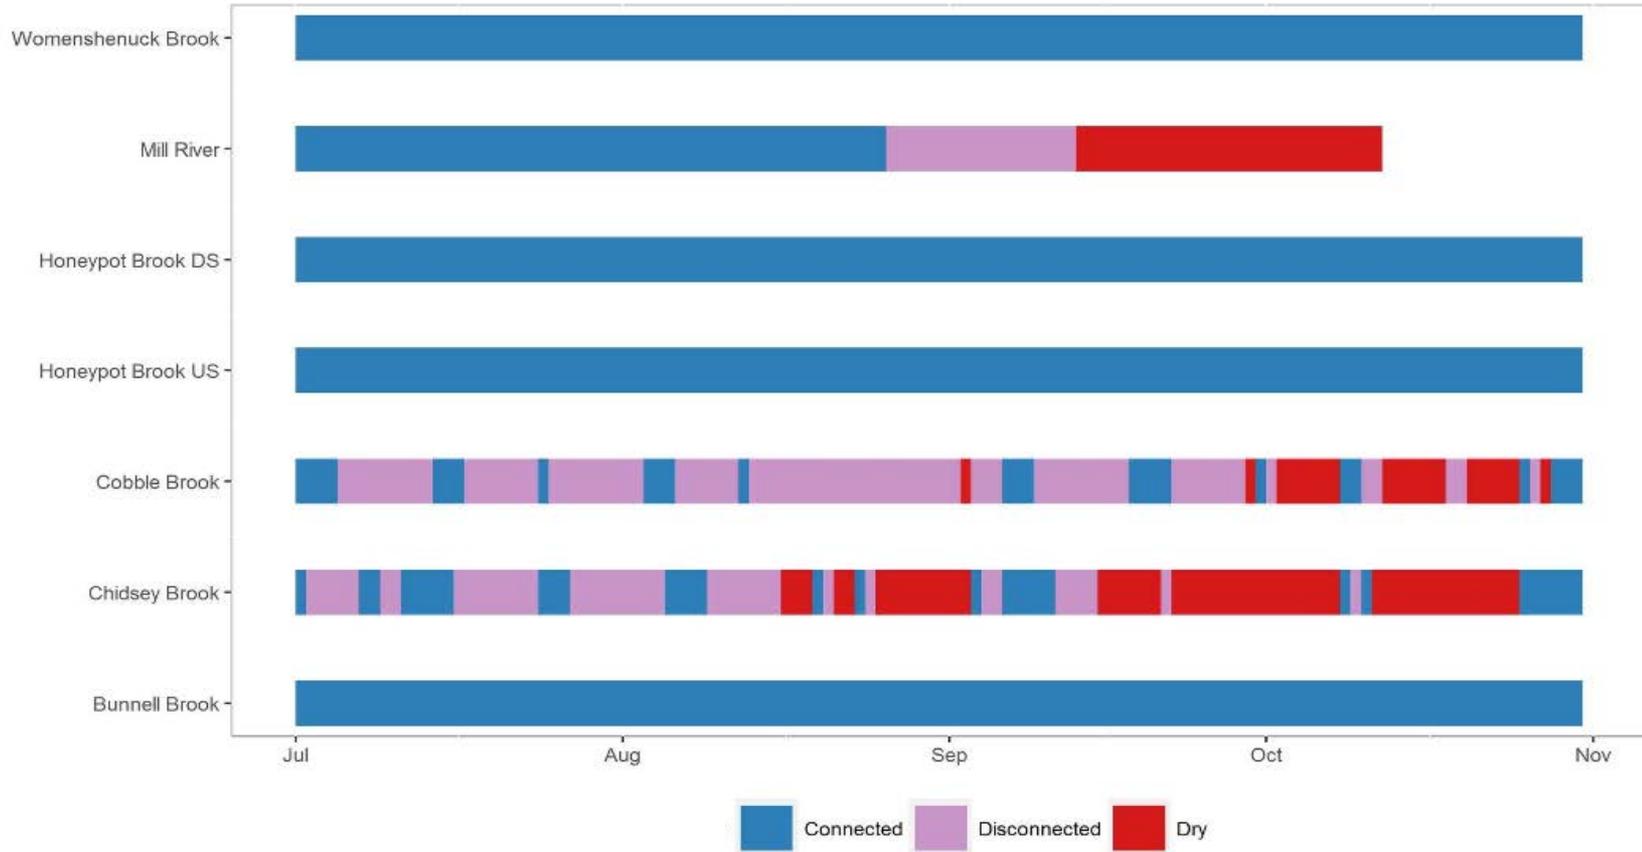
Timing & Duration Metrics

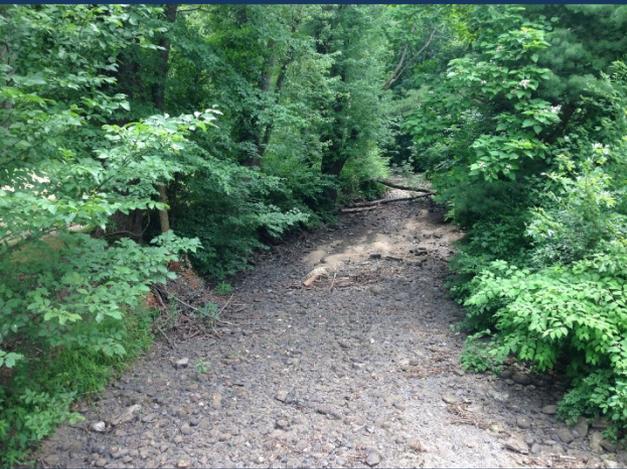
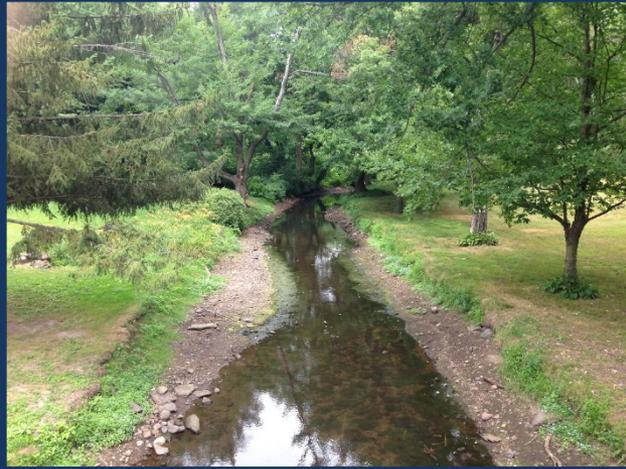
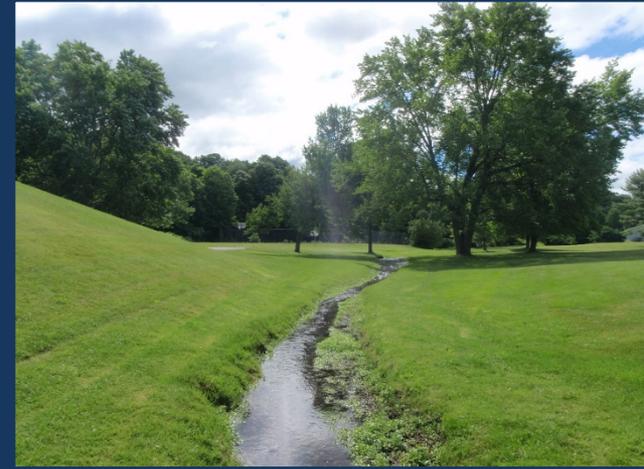
- Photos are data that provide a record of conditions
- Photos need to be clear, centered, and without any obstructions

Examples of high quality photos.

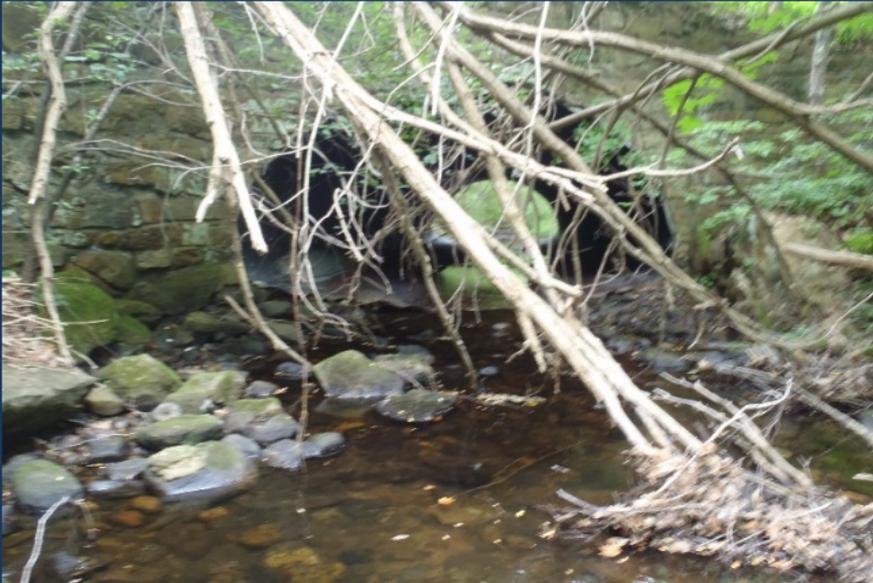
Overhanging branches obscuring the stream

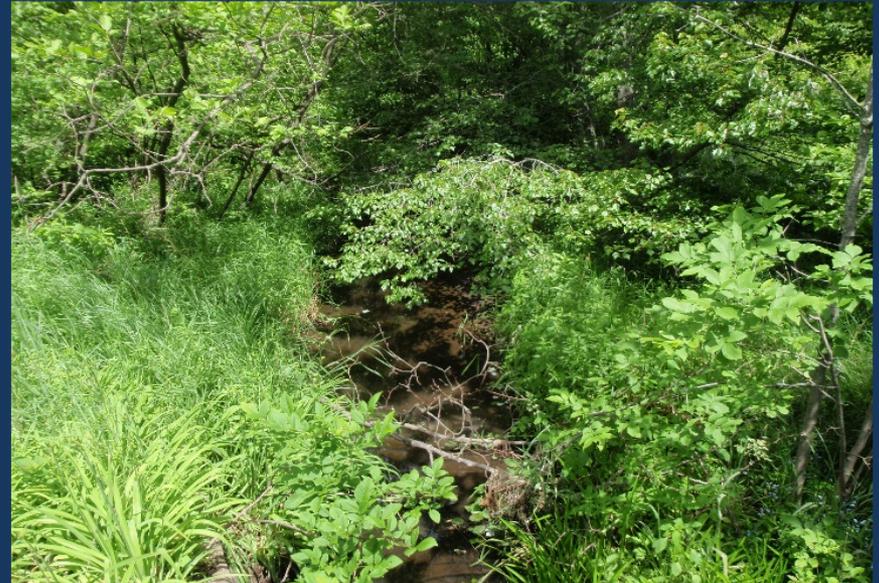
Vegetation/bushes obscuring the stream

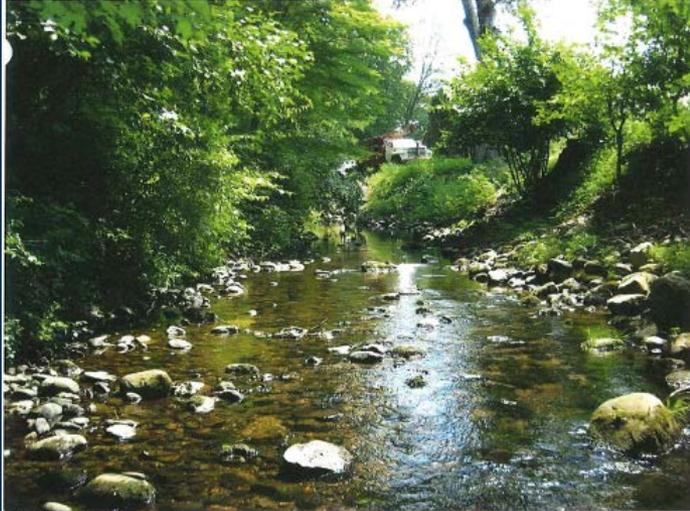
US of Trail Camera:

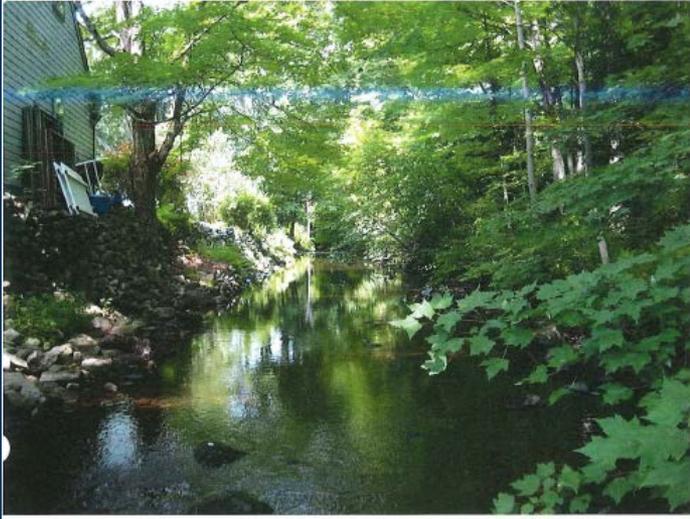
DS of Trail Camera:

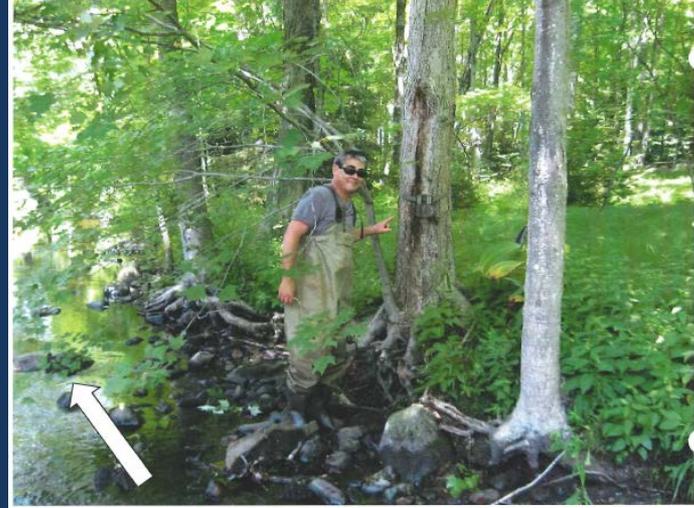
Trail Camera (arrow is in direction of flow):
