Task 1A5: Baker Cove Track Down Survey and Abbreviated Watershed-Based Plan

Prepared by the Eastern Connecticut Conservation District, Inc.

Baker Cove Trackdown Survey and Abbreviated Watershed-based Plan

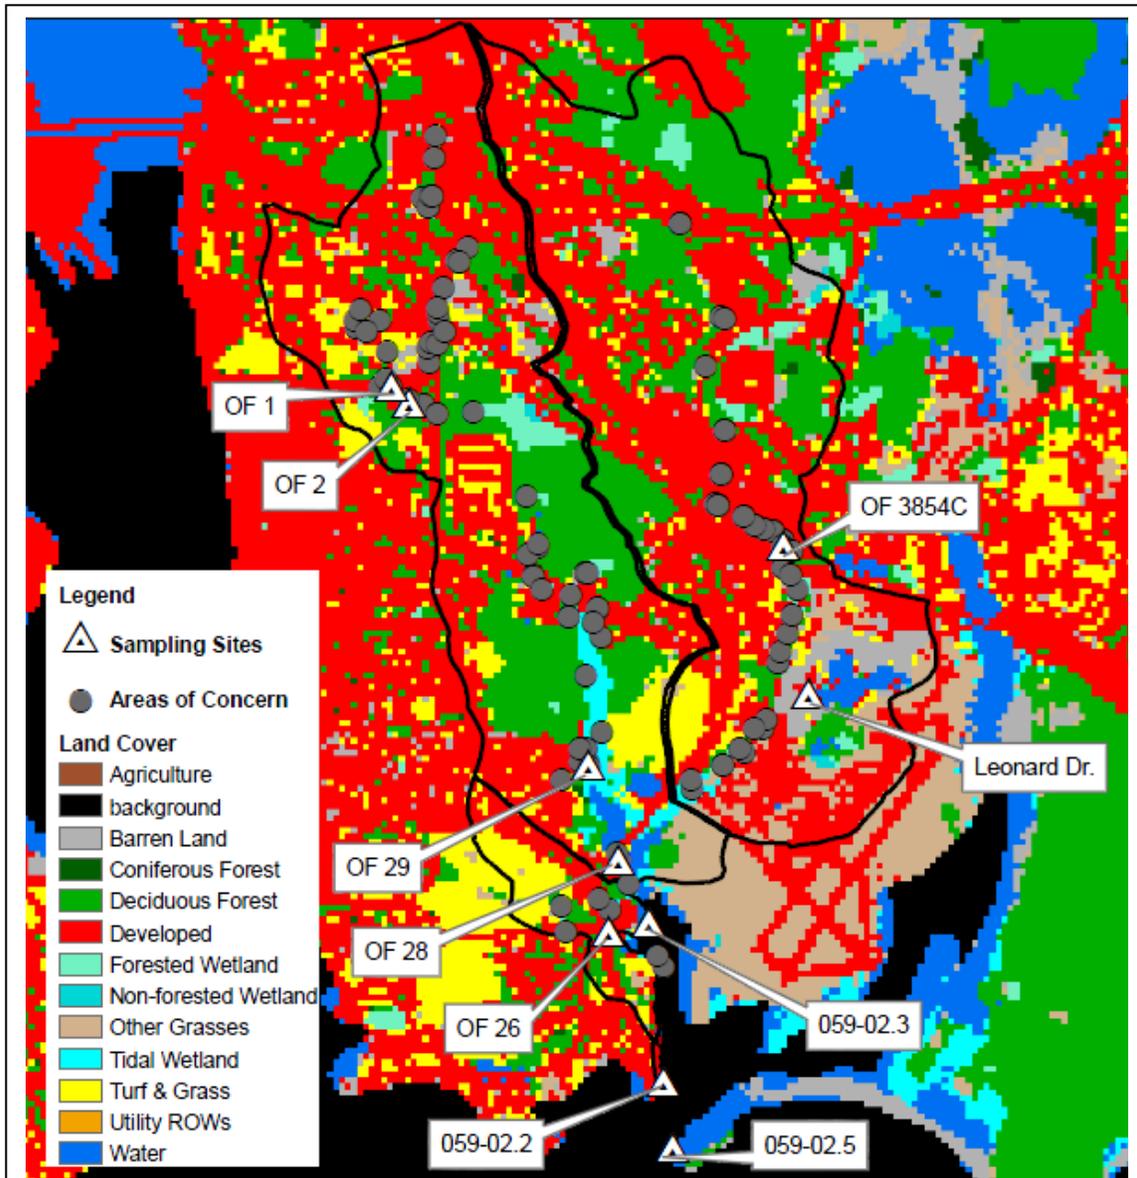
Figure 7: Streamwalk Areas of Concern and Bacteria Sampling Sites Relative to Land Cover.

A review of the bacteria data summary table below indicates several areas as bacterial “hot spots.” Figure 7 above depicts the locations of the monitoring stations relative to stream walk-identified Areas of Concern and land use. These locations include stormwater outfalls 26 and 29, which drain residential neighborhoods on Shennecossett Road and Madison Place in the City of Groton, and which both failed in 2008; the stormwater outfall at Groton Airport Business Park on Leonard Drive, which failed from 2006 to 2008; the stormwater outfall behind the Big Y shopping plaza on Route 1, which failed from 2004 to 2008; stormwater discharges B and D at the Groton-New London Airport, which failed in 1997; and DA/BA shellfish monitoring station 059-02.3, adjacent to the Elks Club Marina, which had four exceedances between 2000 and 2004.

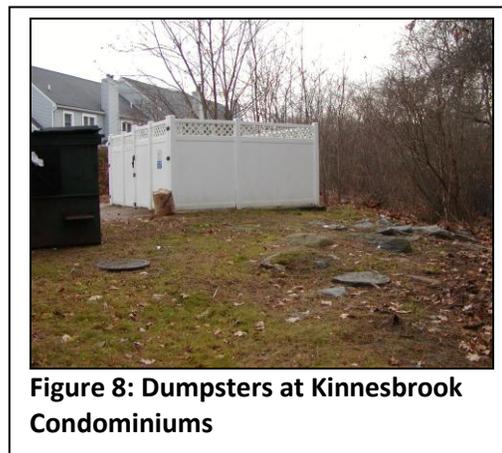
Figure 8: Dumpsters at Kinnesbrook Condominiums

operations can be notorious breeding grounds for bacteria. The dumpster in Figure 8, located at the Kinnesbrook Condominium complex, is located on a concrete pad which is graded to a storm drain in the parking area that drains to Birch Plain Creek, approximately twenty-five feet away.

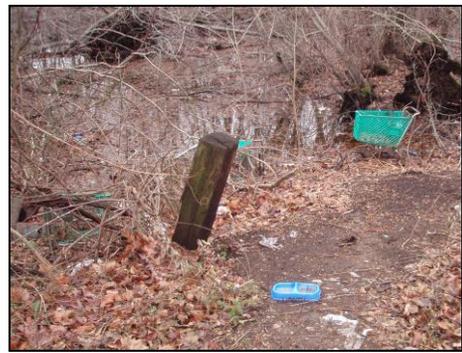
Figure 9: Feral Cat Area

Pet waste was observed in many areas including Washington Park and Kinnesbrook Condominiums. A feral cat area was noted adjacent to a wetland behind the Big Y shopping plaza on Route 1 (Figure 9). Although the number of cats in the colony is not known, encouragement of a large cat population could contribute to bacteria loading to waterways leading to Baker Cove.

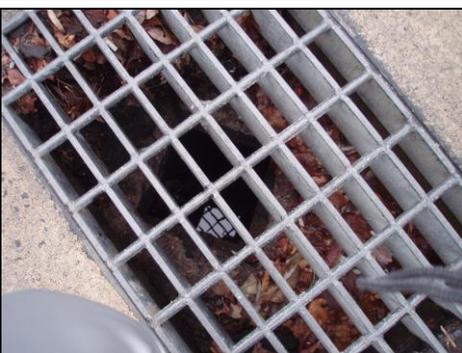
Figure 10: Storm drain over unnamed stream 2 in a shopping plaza on Rt 1.

local watershed 2000-26, is culverted under two shopping plaza parking lots on Route 1, and functions as the stormwater conduit for those parking areas. Multiple storm drains open directly over the stream channel, allowing untreated runoff from the extensive parking area to discharge directly into the buried stream (Figure 10).

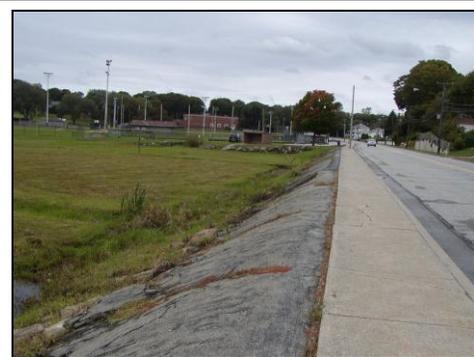
Figure 11: Extensive asphalt leak-off into Lake George from Meridian St.

Lake George, located in Washington Park in the City of Groton, is the headwater for the west branch of Birch Plain Creek. Lake George is also the receiving waterbody for stormwater runoff from the surrounding area, including roads, businesses and apartment and condominium complexes. Lake George is a grassy wetland through which numerous channels have been excavated, which convey water quickly into Birch Plain Creek. The riparian vegetation along the easterly limit of Lake George has been removed and replaced with asphalt armoring (Figure 11).

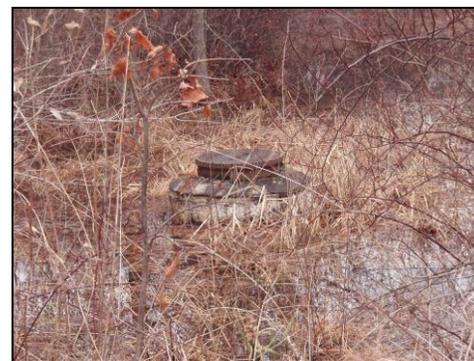
Figure 12: Sewer manhole in wetlands near Tower Road

During the stream walk surveys, ECCD staff and volunteers noted two sewer manholes located in a wetland area associated with unnamed stream 2 (Figure 12), east of the Tower Road railroad crossing. Sewer leaks and overflows, especially after flood events, which can be common in coastal areas, can contribute to bacterial contamination of nearby surface and ground waters. ECCD staff and volunteers also identified a sewer manhole near the City Highway garage with a broken concrete collar.

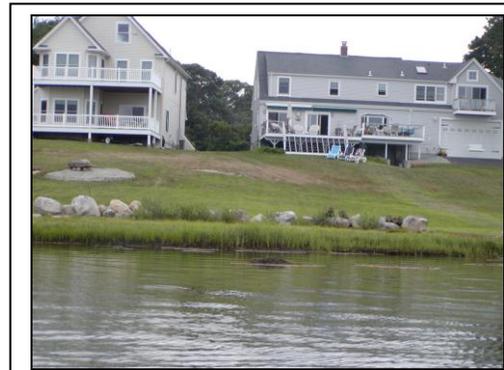
Figure 13: Lack of riparian buffer along Baker Cove.

Sixteen instances of degraded riparian buffers were noted during the stream walks. The types of degraded riparian buffers included minimal buffer width (seven instances), minimal riparian vegetation (ten instances) and presence of invasive species (twelve instances). In one instance (the west branch of Birch Plain Creek by the Highway garage and Washington Park), the noted degraded buffer condition was reach-wide. In several areas, landowners had cleared and/or maintained lawn to the edges of the various waterbodies (Figure 13). In several areas the riparian buffer was degraded by invasive plants. For example, along the edge of Birch Plain Creek just north of Thomas Road, the buffer was heavily dominated by Phragmites (Figure 14).

Riparian buffers of minimal width and minimal vegetation reduce the capacity of the vegetative buffer to slow surface run-off of stormwater, and absorb any nutrients or contaminants contained in the run-off. Invasive plant species often out-compete native plants and reduce the habitat benefits that native plants provide for native biota.

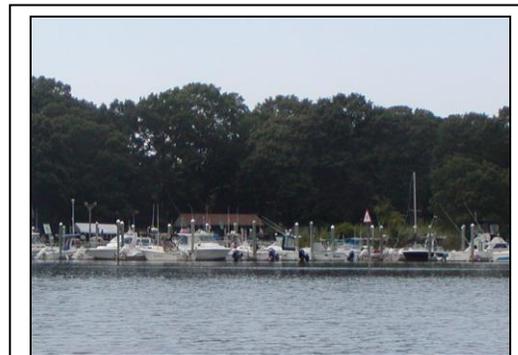
Figure 15: Elks Club Marina in Baker Cove.

There are two marinas located in Baker Cove. The first is owned and operated by the Elks Club (Figure 15). Discussion with the manager of the Elks Club Marina indicated that the majority of the crafts are small and do not have on-board toilets. The marina also does not have facilities to conduct maintenance or repairs. The second marina is Chapman’s Boat Yard, which according to CT DEEP personnel, is in the process of upgrading its facility.

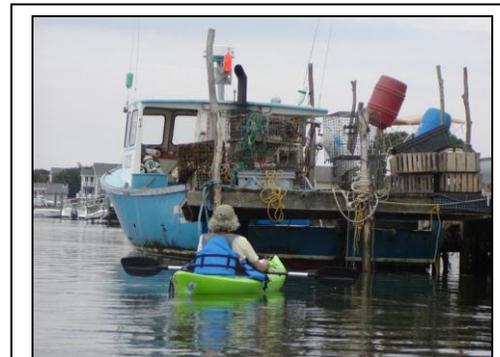
Figure 16: Lobster boat moored along Jupiter Point.

A number of private watercraft are also moored along the shore of Jupiter Point, including several commercial fishing boats (Figure 16).

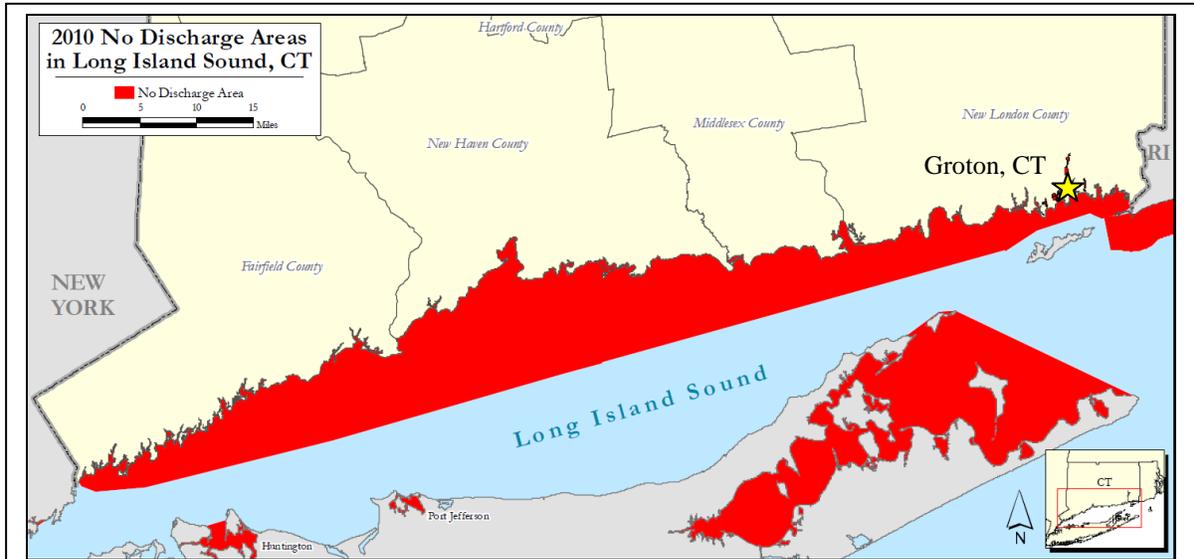
Figure 17: 2010 No Discharge Areas in Long Island Sound (CT DEP).

Baker Cove is located in the Groton/Guilford No Discharge Zone, which was designated in 2006 (Figure 17). No Discharge areas prohibit the discharge of treated and untreated boat sewage within three miles of the shore. Numerous pumpout facilities, at which onboard waste tanks can be emptied, are available to boat owners in the Groton area, including the Mystic Pumpout Boat, Mystic Shipyard, LLC., Noank Shipyard, Noank Village Boatyard, Pine Island Marina, Shennecossett Yacht Club, and Spicer's Noank Marina.

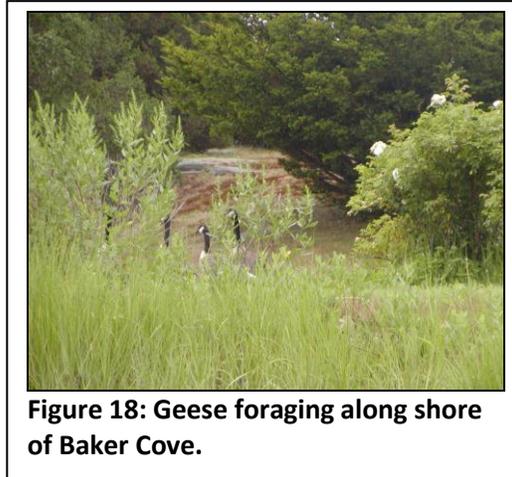
Figure 18: Geese foraging along shore of Baker Cove.

Due to the high level of development of the Baker Cove watershed, terrestrial wildlife species were not considered a significant source of fecal coliform bacteria. However, several non-migrating Canada geese were noted in Baker Cove during the investigation (Figure 18). An adult Canada goose can deposit 1 – 2 pounds of feces per day, which contain fecal bacteria and nutrients that contribute to water quality degradation.

The effect of the disjointed effort to control the nuisance goose population is that the flock rotates from one location to the next, but the overall result is no decrease in flock size. A regional management approach to reduce the flock size and discourage repopulation of the area in the future with habitat management is necessary.

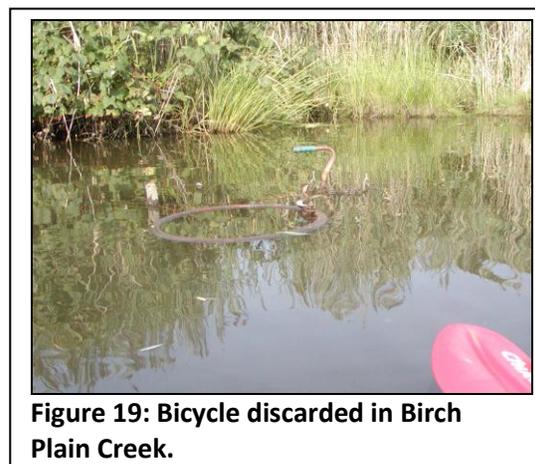
Figure 19: Bicycle discarded in Birch Plain Creek.

Seven instances of trash and debris were observed during the stream walks. Bicycles, plastic crates and other items were noted in Birch Plain Creek north of Thomas Road (Figure 19). Windblown and waterborne debris, such as plastic bags, plastic beverage bottles and paper products, were noted along reach 1 of unnamed stream 2. A large pile of yard waste was deposited along the edge of a wetland associated with unnamed stream 2, adjacent to the Big Y shopping plaza on Route 1 (Figure 20). This yard waste pile included grass clippings, leaves and branches, and other plant materials. It

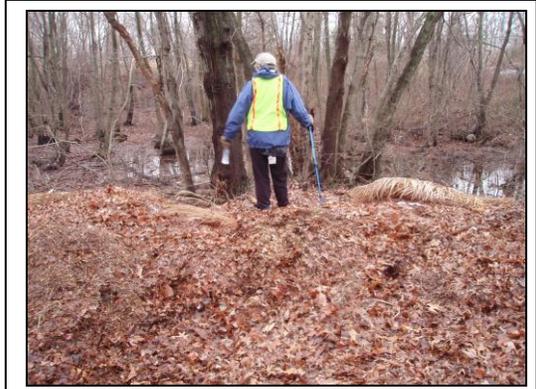
Figure 20: Large yard waste pile at edge of wetland associated with unnamed stream 2.

While trash and debris do not directly contribute to bacterial contamination of Baker Cove, it has the capacity to introduce a number of other pollutants into Baker Cove via the various watershed streams. Decomposition of the yard waste releases nutrients, including nitrogen from the plant tissues, into the streams. Influx of these organic materials can cause algal blooms and the subsequent depletion of dissolved oxygen in the streams as the algae dies and is decomposed, degrading habitat quality for in-stream biota.

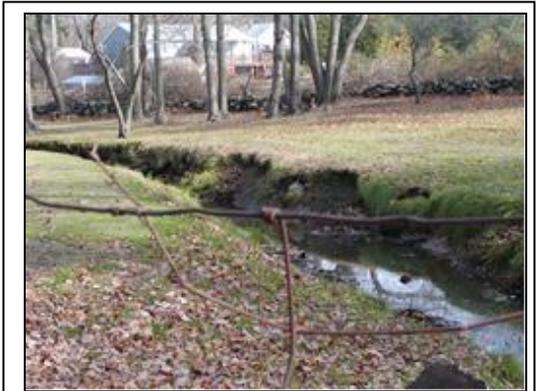
Figure 21: Stream bank erosion along Birch Plain Creek near Meridian Street.

Three instances of bank erosion were noted during the stream walks. All three areas of bank erosion were associated with a lack of vegetated riparian buffer. Stream bank erosion delivers sediment to the stream, and ultimately to the receiving waterbody, along with any nutrients or contaminants that may be adsorbed to the eroded sediments.

The first documented area represented a 250 foot stretch of eroded stream bank near Meridian Street (Figure 21). A second area was located along reach 1 of unnamed stream 2, in close proximity to a storm drain outfall from the vicinity of H Street and was likely caused by high velocities during storm events. The third area was associated with surface run-off from a stockpile yard near the City Highway facility.

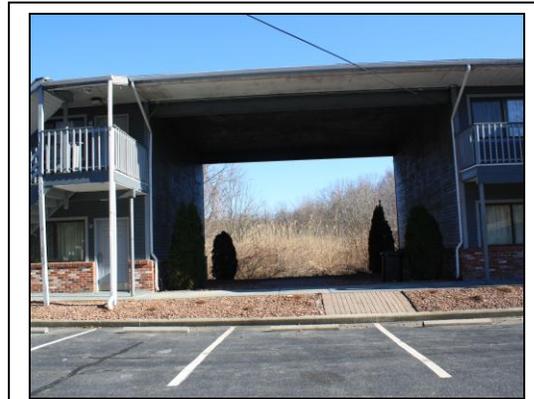
Figure 22: Birch Plain Creek is culverted under this motel on Bridge Street.

Ten instances of modified channels were noted during the stream walks. In most instances, the modifications involved stream culverts under roads. In several instances, the modified channel involved the channelization of the stream under highways (Routes 1, 95 and 349), and buildings and parking areas (Bridge Street, Washington Park, and Route 1 shopping centers). Figure 22 depicts a gap in a local motel where Birch Plain Creek is channeled underground between the two segments of the building.

Approximately 5475 feet, or 16% of the 33,500 feet of stream surveyed throughout the Baker Cove watershed was channelized. Channelization and other hydro-modifications can contribute to NPS by disconnecting streams from their flood plains, which reduces the attenuation of storm flow and the bio-retention of pollutants by flood plain vegetation. Channelization also increases storm flow velocities and can result in channel scouring and bank erosion, further degrading water quality and in-stream habitat.

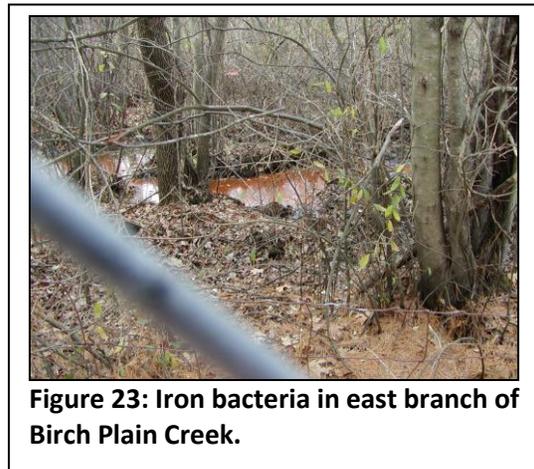
Figure 23: Iron bacteria in east branch of Birch Plain Creek.

Twelve instances of visual water conditions were noted. The entirety of the west branch of Birch Plain Creek was observed to have a cloudy appearance. This may have been caused by a high level of suspended solids in the water column, possibly by high clay content in the soil. The east branch of Birch Plain Creek exhibited high amounts of iron bacteria, with the rusty red bacteria floc completely covering the substrate in many areas (Figure 23). “Oily” deposits associated with iron bacteria were also noted on the water surface in many areas. This condition extended from RT 95 to Meridian Street.

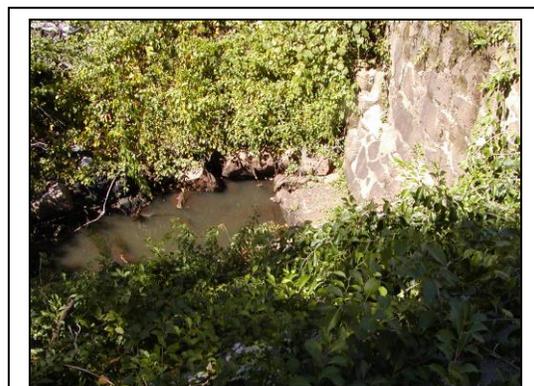
Figure 24: Trails Pond dam.

While fish barriers do not contribute to nonpoint source pollution, they do inhibit the passage of fish up and downstream, and result in degradation of habitat. In coastal areas this can be especially critical for fish species such as trout, alewife and herring that require access to inland spawning habitats. Fourteen fish barriers were noted during the stream walks, including a stone dam at Trails Pond (an impoundment of Birch

Plain Creek) north of Poquonnock Road (Figure 24) and numerous culverts throughout the watershed that acted as velocity or habitat barriers.

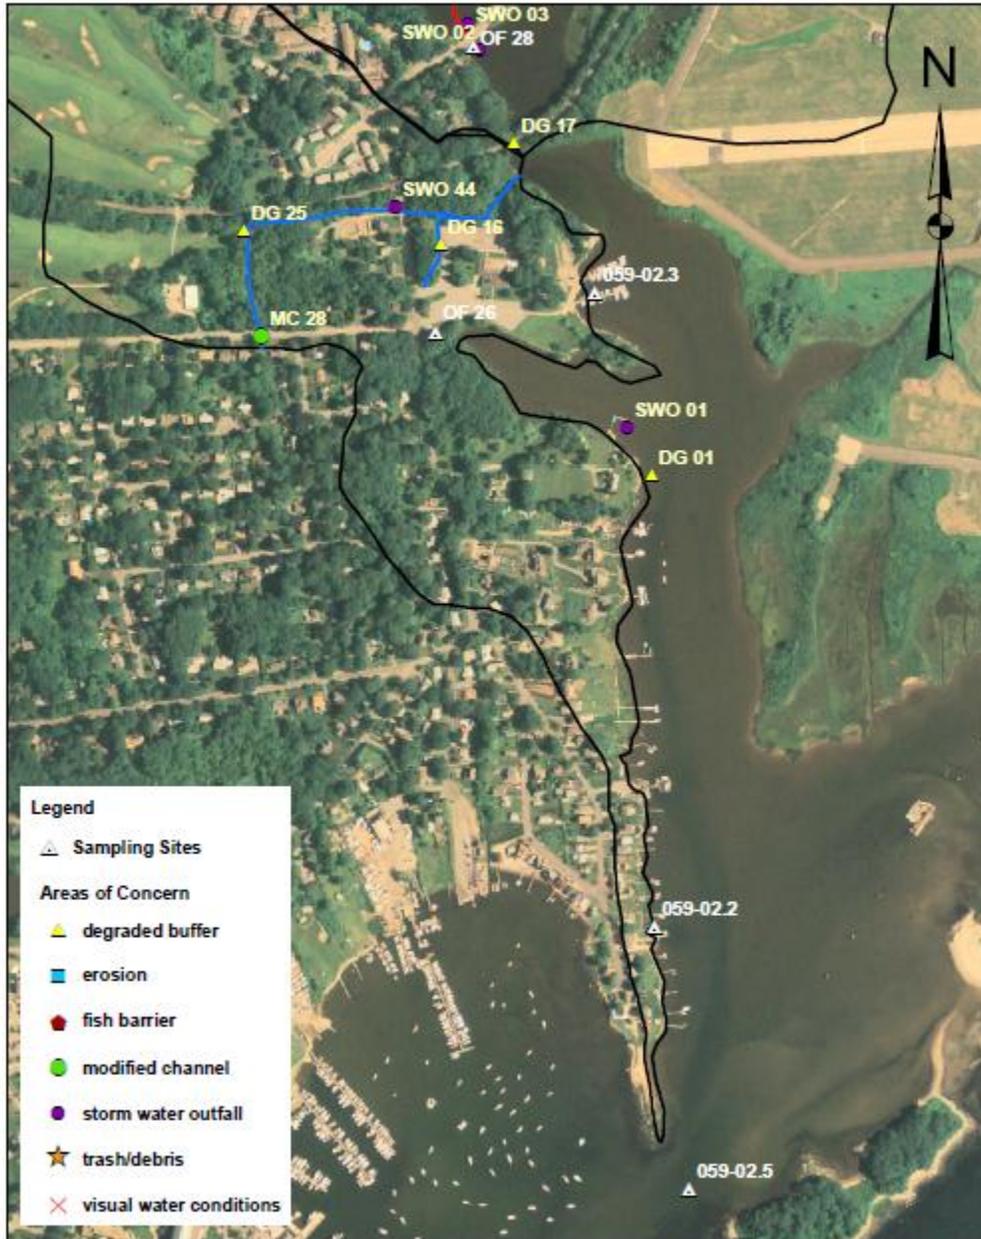
Baker Cove and Jupiter Point
 Areas of Concern
