Contract #2013-13096

Lower Natchaug River Abbreviated Watershed-Based Plan

Prepared by the Eastern
Connecticut Conservation
District, Inc.

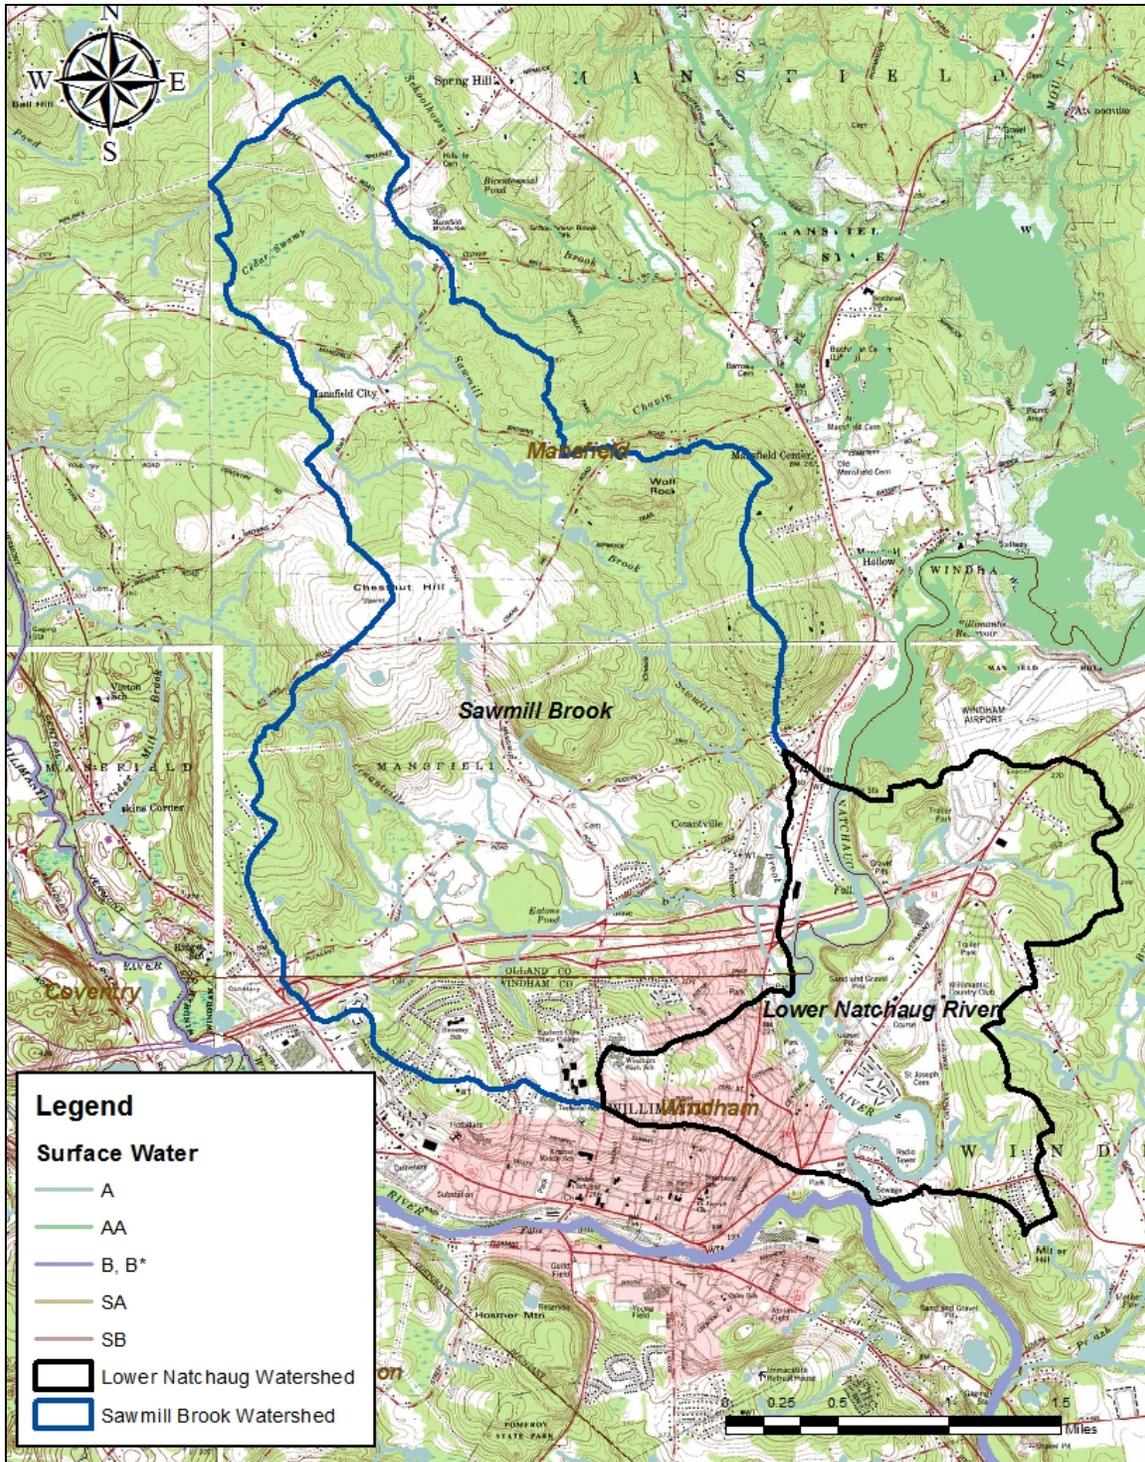
Figure 2: Lower Natchaug River and Sawmill Brook watersheds surface water classification (CT DEEP).

The lower Natchaug River and the tributary streams in the Sawmill Brook watershed have surface water quality classifications of A (Figure 2). Water quality classifications

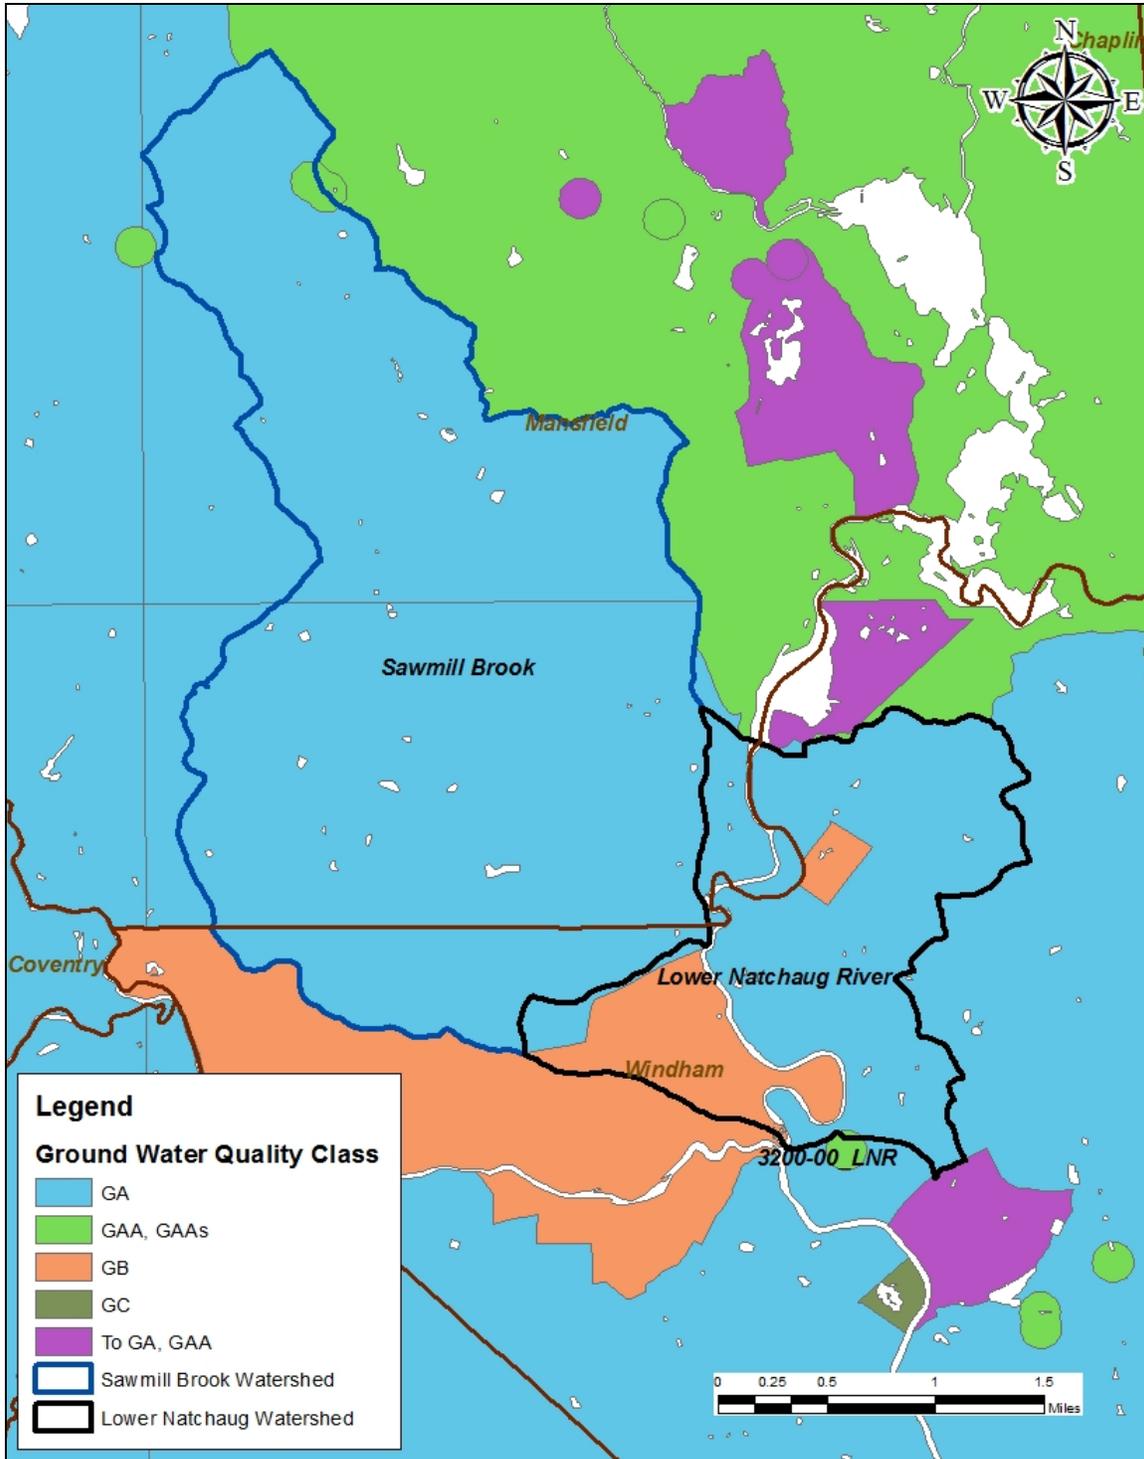
Figure 3: Lower Natchaug River and Sawmill Brook watersheds ground water classification (CT DEEP).

Groundwater within the lower Natchaug River watershed is classified as GA, with areas classified as GB (Figure 3). Groundwater in the Sawmill Brook watershed was classified GA. Designated uses for Class GA groundwater include existing private and potential public or private supplies of water suitable for drinking without treatment; and base flow for hydraulically-connected surface water bodies. Groundwaters designated GB are assumed to be degraded due to a variety of pollutant sources. Designated uses for Class GB groundwater include industrial process water and cooling waters; baseflow for hydraulically-connected surface water bodies; presumed not suitable for human consumption without treatment.

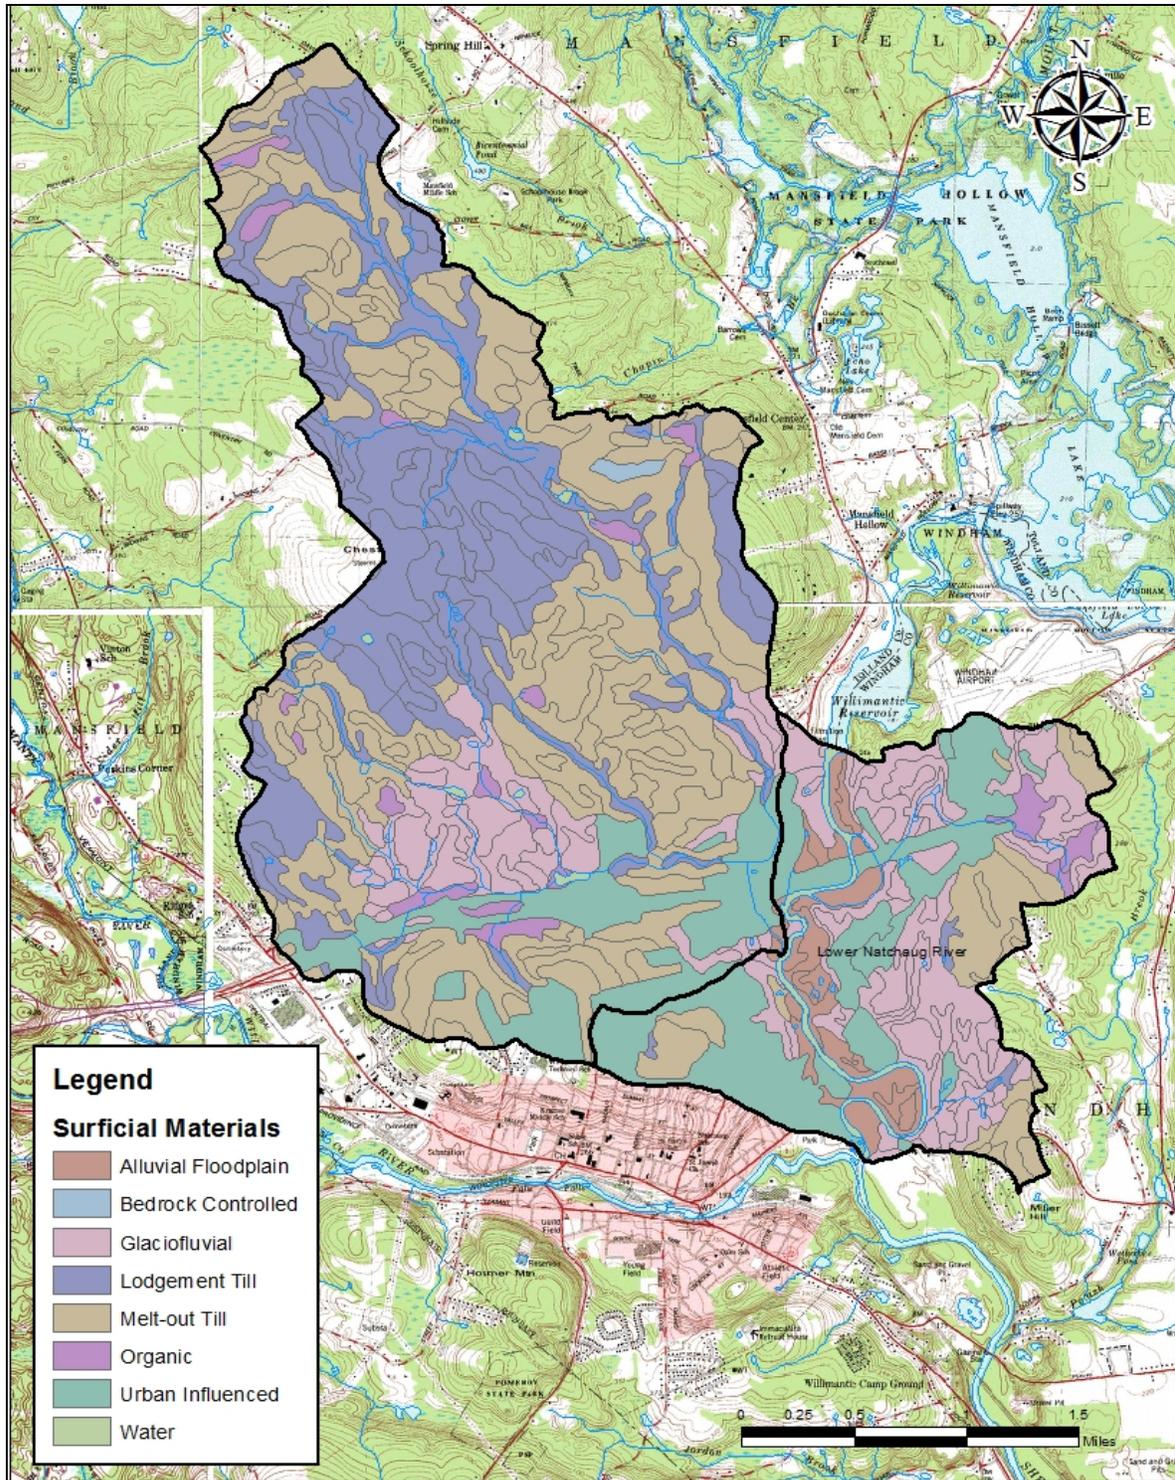
Figure 4: Surficial materials in the lower Natchaug River and Sawmill Brook watersheds (SSURGO 2011).

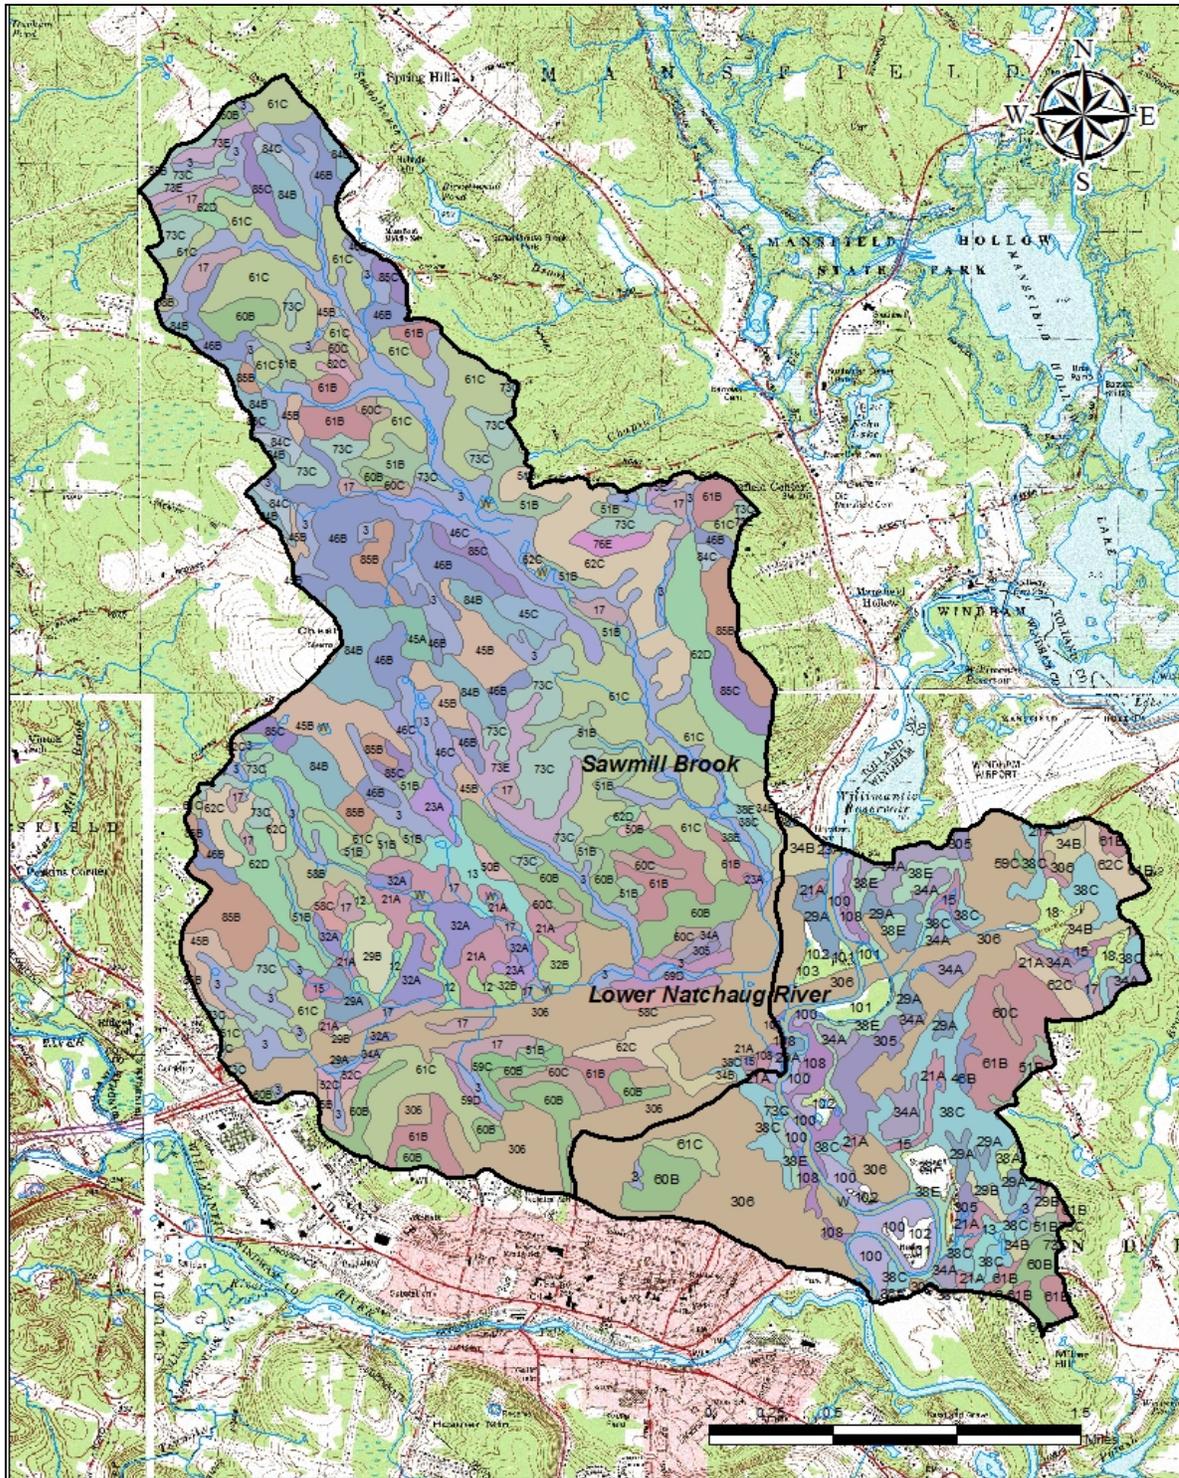
Figure 5: Soils in the lower Natchaug River and Sawmill Brook watersheds (CT DEEP).

Soils in the lower Natchaug River watershed are comprised of melt-out tills in the upper elevations, and glaciofluvial and alluvial floodplain soils in the lower elevations, with extensive placement of udorthent (urban land complex) soils along transportation corridors (Routes 6 and 195), in commercial areas, and in the vicinity of downtown Willimantic (Figure 4). Dominant soils include udorthents - urban land complex (27%), Hinckley gravelly sandy loams (18.5%), and Canton and Charlton soils (15%) (Figure 5).

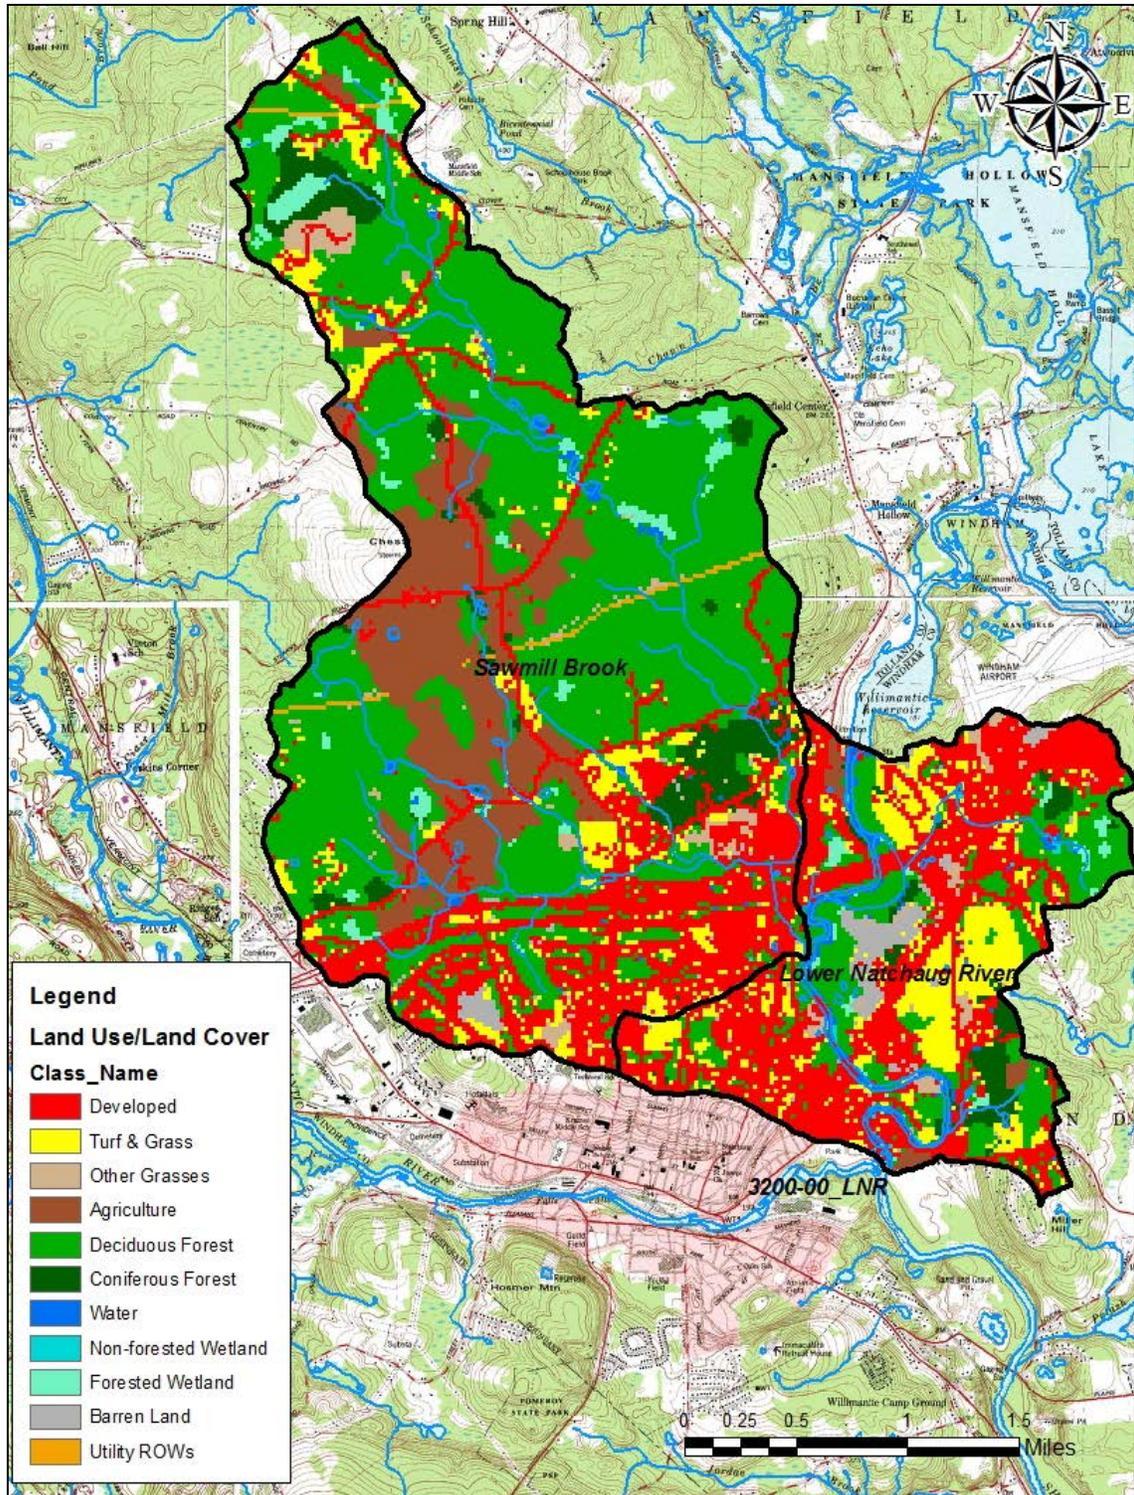
Figure 7: Land use and land cover in the lower Natchaug River and Sawmill Brook watersheds (CLEAR 2006).

Land cover in the lower Natchaug River watershed is dominated by suburban and urban development (44%). Developed land is concentrated along the Route 195 and Route 6 corridors and extends southward to downtown Willimantic. Development varies from commercial and light industrial to densely settled residential areas, and includes mixed urban residential/commercial areas in Willimantic; and commercial and industrial development on Boston Post Road (State Route 6), such as the Windham Airport and the western edge of the North Windham shopping center area. Residential development varies from suburban single family dwellings in the northern and eastern extents of the watershed, to densely developed, multiple occupancy dwellings in the southern extent of the watershed. Forests comprise 26% of the watershed; turf grasses and other grasses, which include managed turf and landscaped areas, such as the Willimantic Country Club, landscaping around housing complexes and commercial/retail complexes, and residential neighbors, accounted for 20% of the watershed; 4% of the watershed was barren land; 5% of the watershed is comprised of wetlands and waterbodies; and only 1% was under agricultural use (Center for Landuse Education and Research 2006 - Figures 7 and 8).

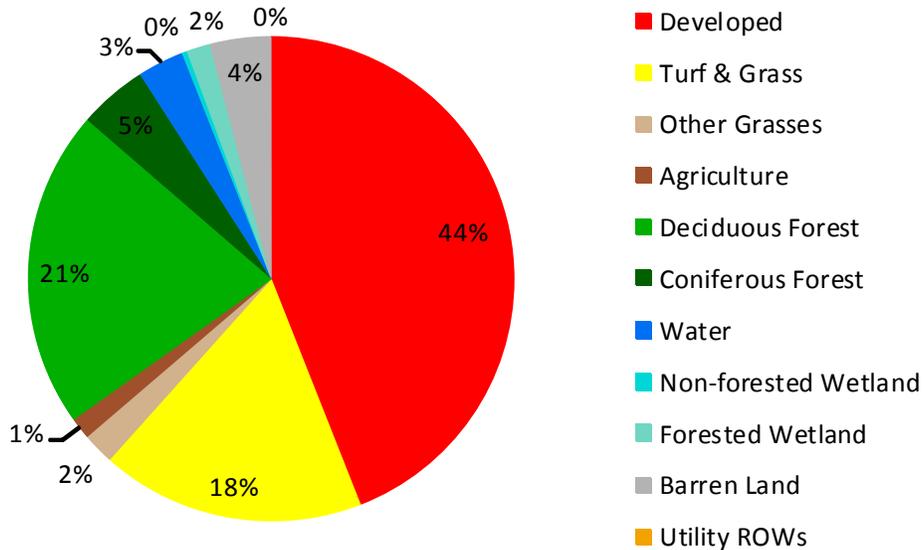
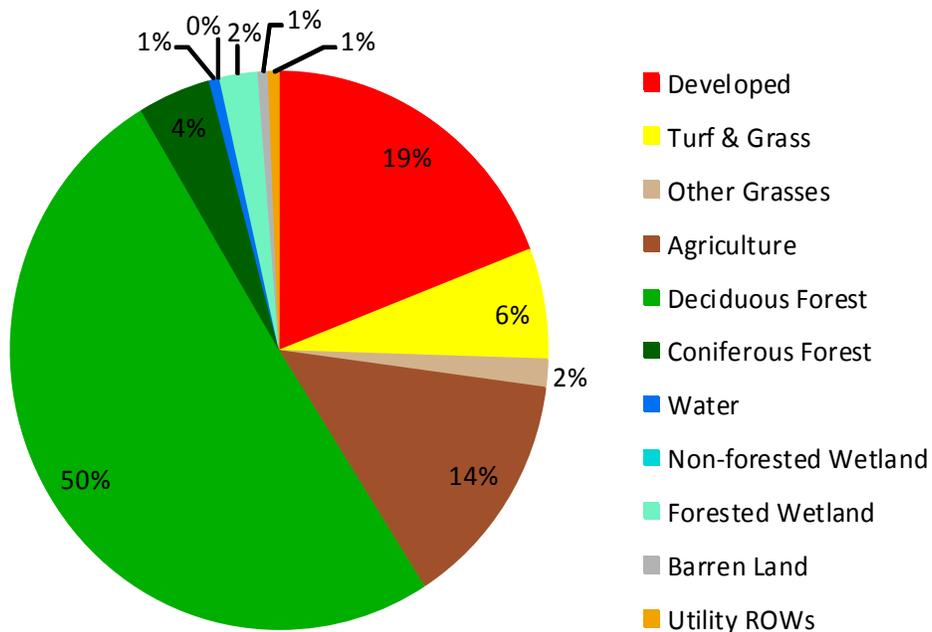
Figure 8: Percent land cover type for the lower Natchaug River and Sawmill Brook watersheds (derived from 2006 Center for Landuse Education and Research land cover data).

By comparison, the Sawmill Brook watershed is primarily forested (55%). Developed land comprises 19% of the watershed, including urban residential along and extending south of the Route 6 corridor, suburban and rural residential north of the Route 6 corridor, and commercial/retail development along Route 195; agriculture 14%, especially in the western portion of the watershed; turf and other grasses, which include managed turf and landscaped areas, such as the Eastern Connecticut State University Athletic Complex, landscaping around housing complexes and commercial/retail complexes, and residential neighbors 8%; wetlands and waterbodies 3%; and less than 1% is barren land. Significant agricultural activity was noted in the Sawmill Brook watershed (643 acres, or 14%). Numerous small private farms were noted, as was extensive hay and cropland (corn). Two commercial farms were noted, including one large dairy farm.

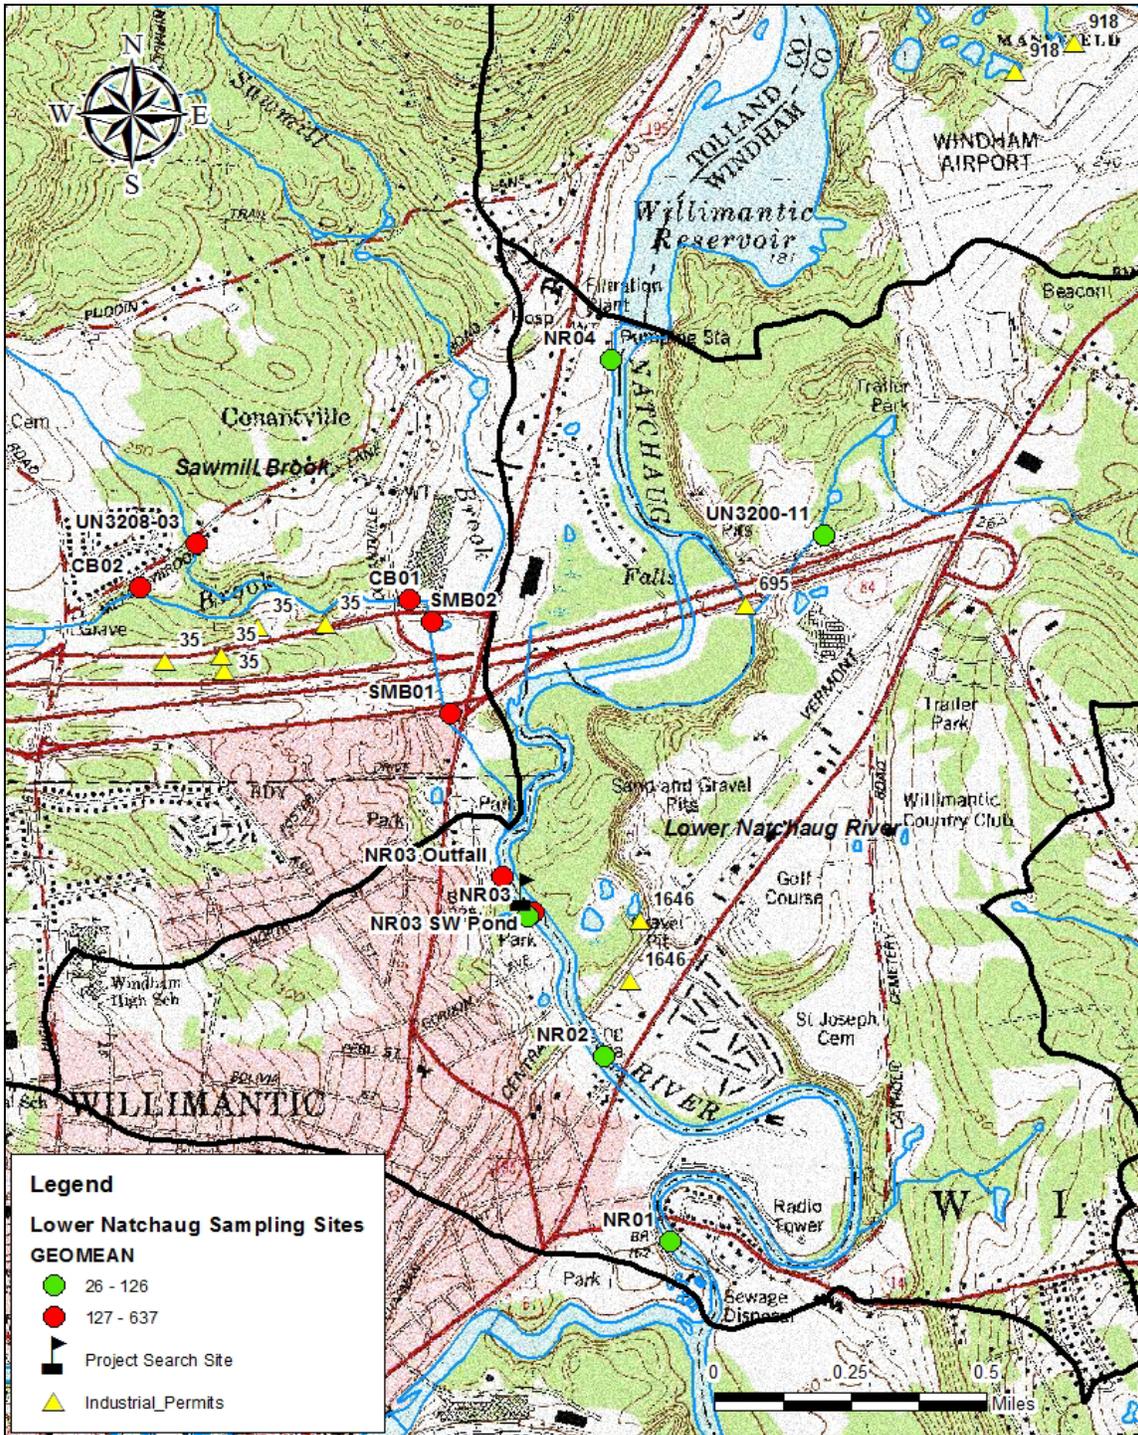
Figure 10: The lower Natchaug River Bacteria Sampling Locations. Sites indicated by a green dot met Connecticut water quality standards, while sites indicated by a red dot failed to meet established water quality standards.

In 2013, ECCD collected fecal bacteria data from ten sites on the lower Natchaug River and its tributaries over an eight week period (Table 4). Several samples were also collected from two stormwater outfalls at Lauter Park, during both wet and dry conditions. In addition, water quality data from other sources was reviewed as part of this investigation, including data collected by the North Central District Health Department (NCDHD) from the public swim beach at Lauter Park from 2008 to 2013 (Appendix A), data collected by Project SEARCH program at Lauter Park from 1998 to 2001 (Appendix A), and industrial stormwater permit data reviewed by CT DEEP as part of the development of a bacteria TMDL for the Natchaug River (Appendix D). The sampling locations are displayed on Figure 10.

Bacteria levels at five of the ten sites sampled by ECCD in 2013 failed to meet Connecticut water quality standards (Figure 10). Additionally, the two stormwater outfall sites at Lauter Park that were sampled several times over the investigative period also failed to meet water quality standards. The four sampling sites on the Natchaug River and the sampling site on a small unnamed tributary draining watershed 3200-11, located on Stonegate Drive to the south of Windham Airport, met state standards for recreational contact. The five sampling sites associated with streams in the Sawmill Brook watershed failed to meet established water quality standards (Figure 11).

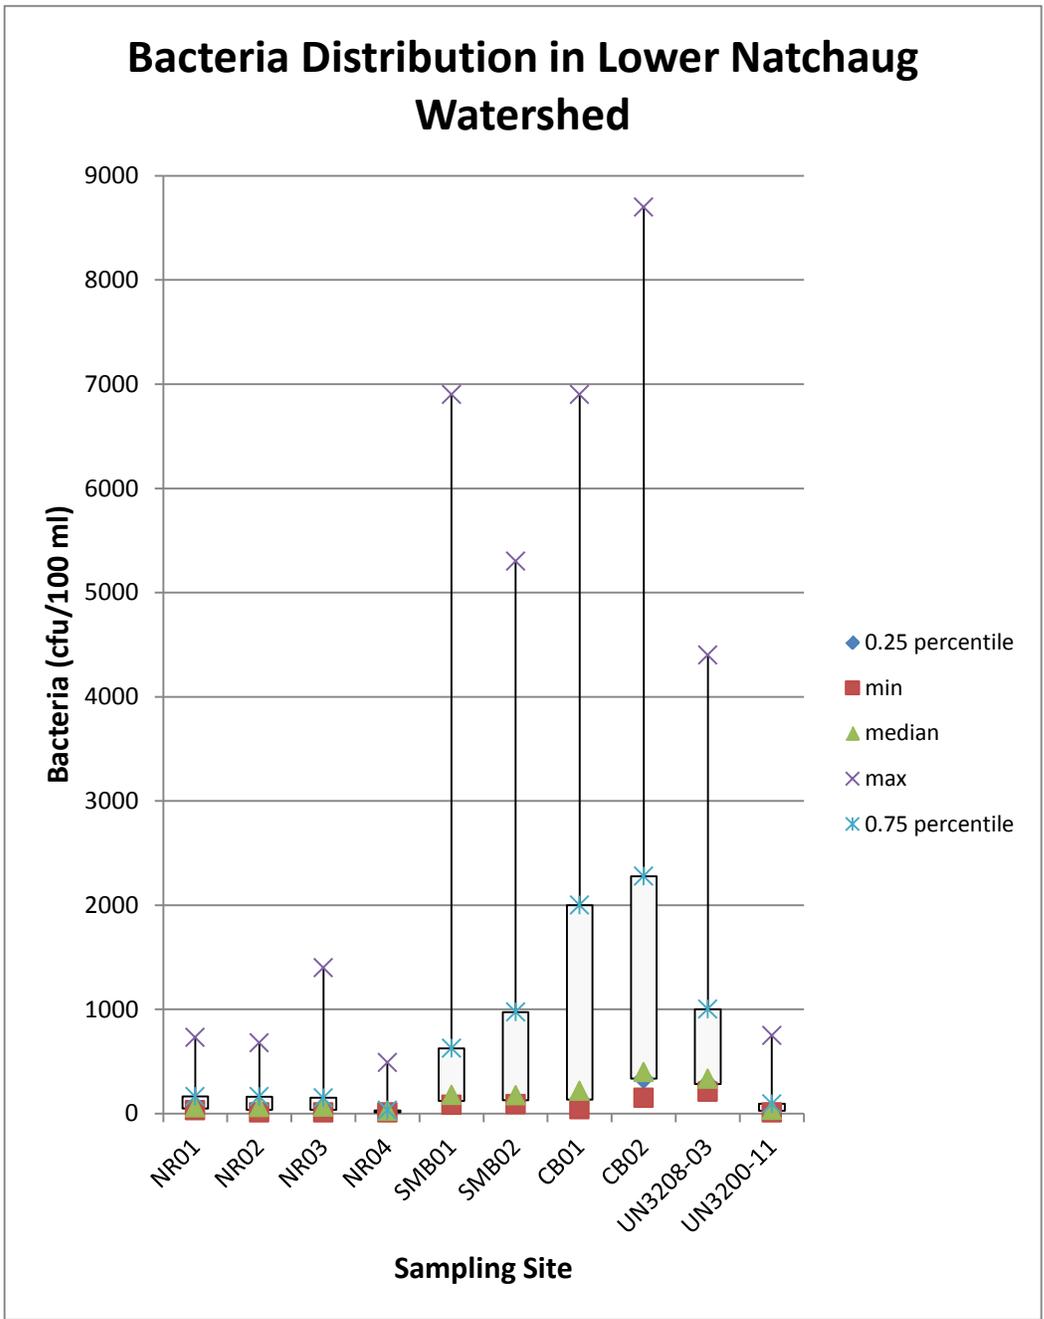
Figure 11: Distribution of bacteria sample results by sampling site.

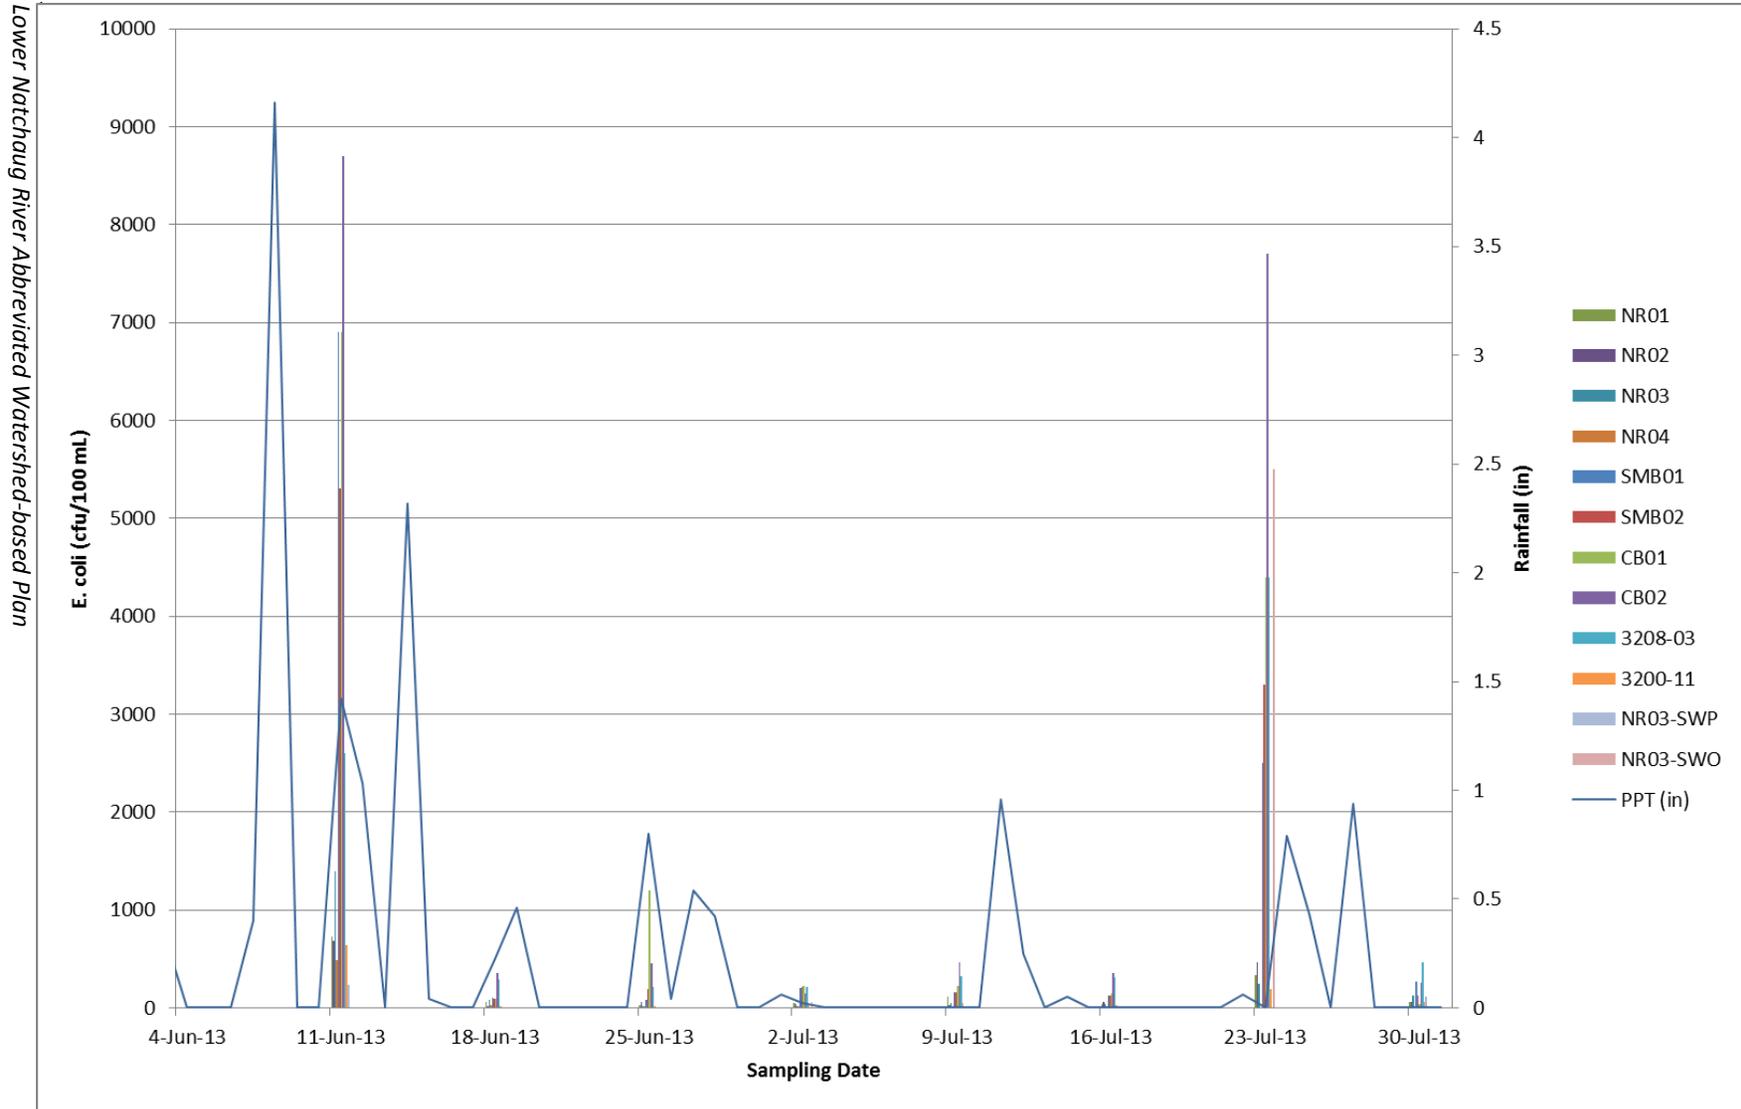
Figure 12: Stream sample bacteria levels plotted against rainfall.

During bacteria sampling, volunteers recorded the weather for the past three days on the field form. The bacteria results were plotted against rainfall for the months of July and August (Figure 12). It was noted that bacteria levels spiked during and immediately after periods of rainfall, and that during dry periods, bacteria levels were generally low, indicating that stormwater flow most likely contributes to the majority of pollutant loading to the Natchaug River and tributaries.

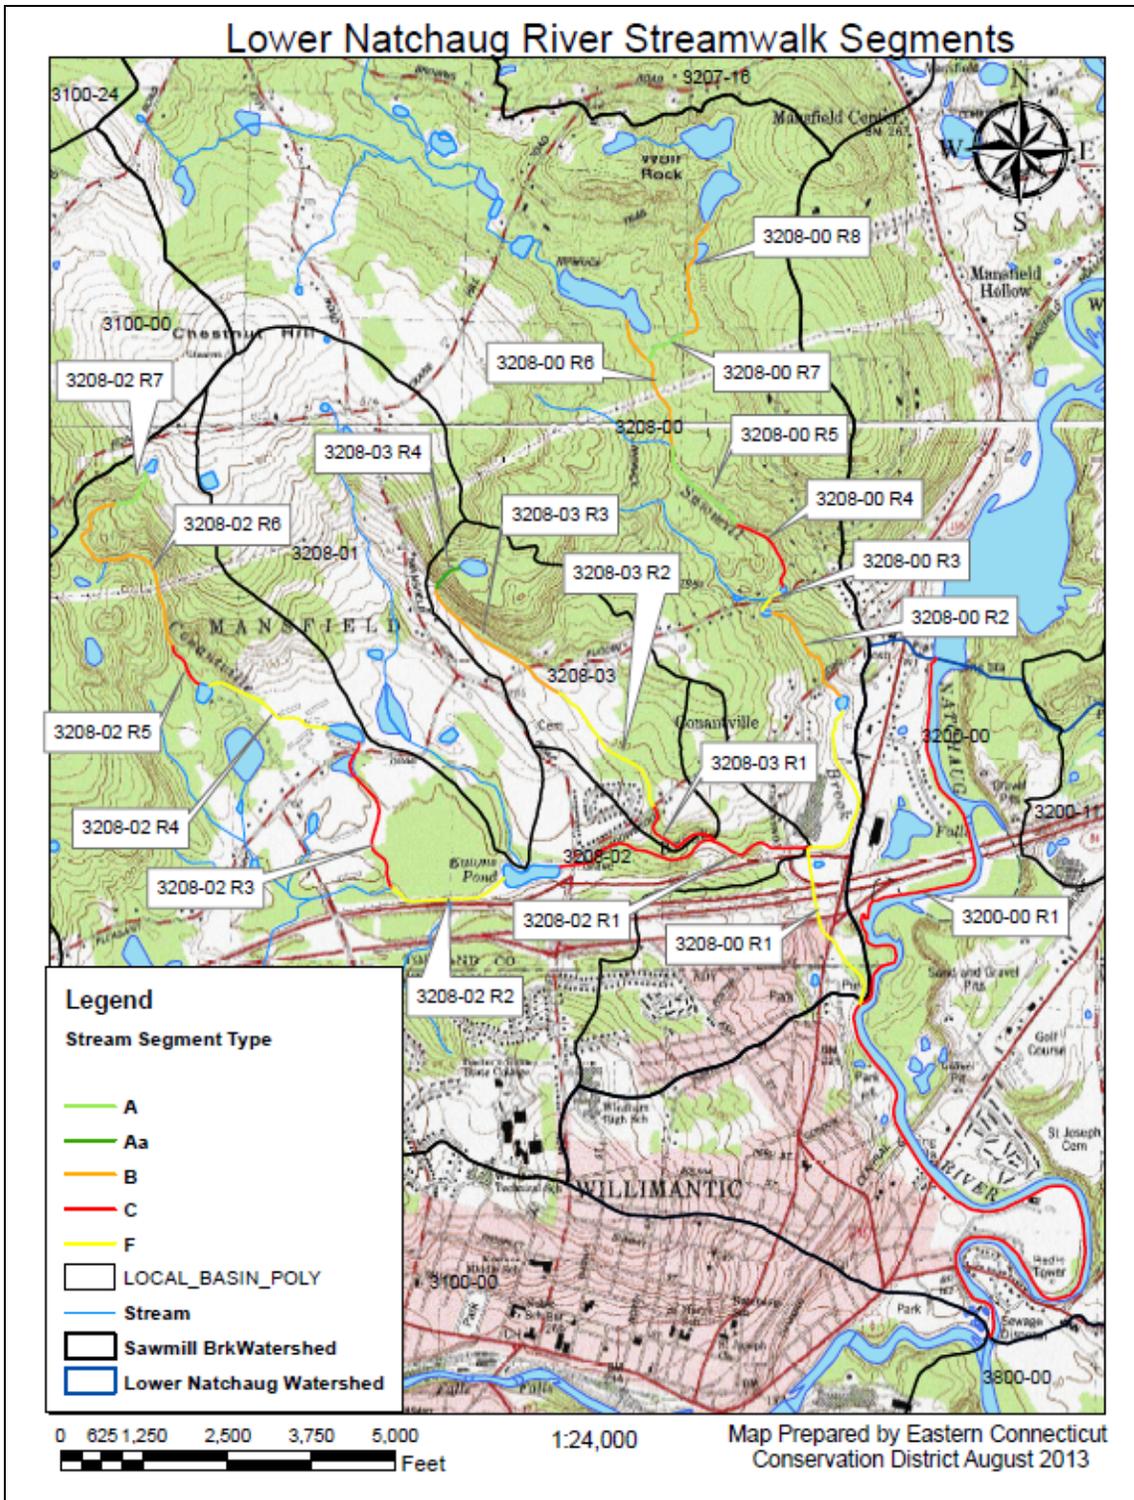
Figure 13: Streamwalk segments and stream types of lower Natchaug River and tributaries, Mansfield and Windham, CT.

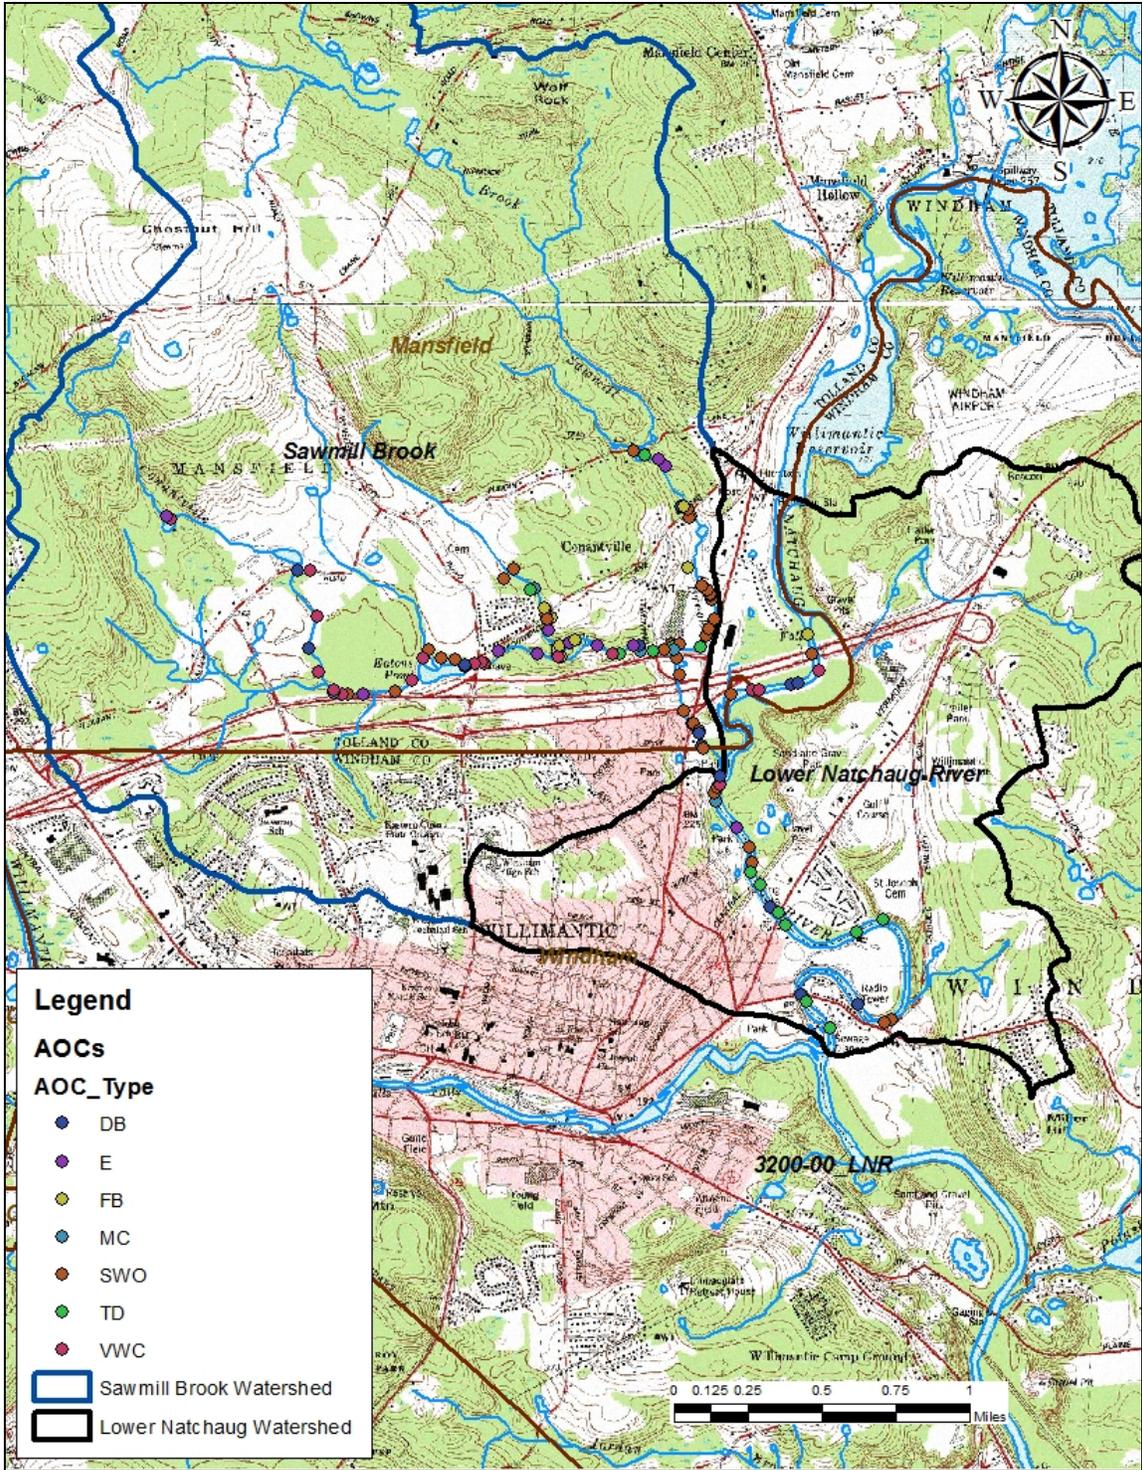
Figure 14: Locations of Areas of Concern identified during Streamwalks.

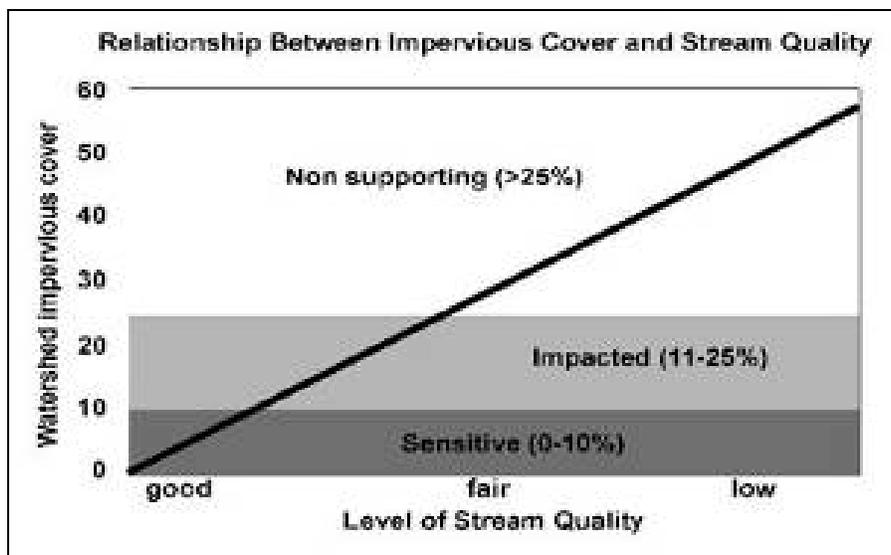
Figure 15: Relationship between impervious cover and stream Quality (Schueler, 1994).

Numerous studies, including those conducted by Schueler (1994) have established that the amount of impervious cover in a watershed directly impacts stream quality (Figure 15). In 2007, Roy Schiff and Gaboury Benoit published data from a study of the West River in New Haven, CT. Their study showed that water quality declined when total impervious area exceeded 5%. A 2008 study conducted by CT DEEP indicated that water quality declined when impervious cover exceeded 6% (Bellucci, Beauchene and Becker, 2008). Approximately 44% of the lower Natchaug River watershed is developed, exceeding the recommended impervious cover of 10% or less for good stream quality. Developed areas are located along main transportation corridors, including Routes 6 and 195, which have significant commercial and high density residential development, and extend into downtown Willimantic. Approximately 19% of Sawmill Brook watershed is developed, also exceeding recommendations for impervious cover.

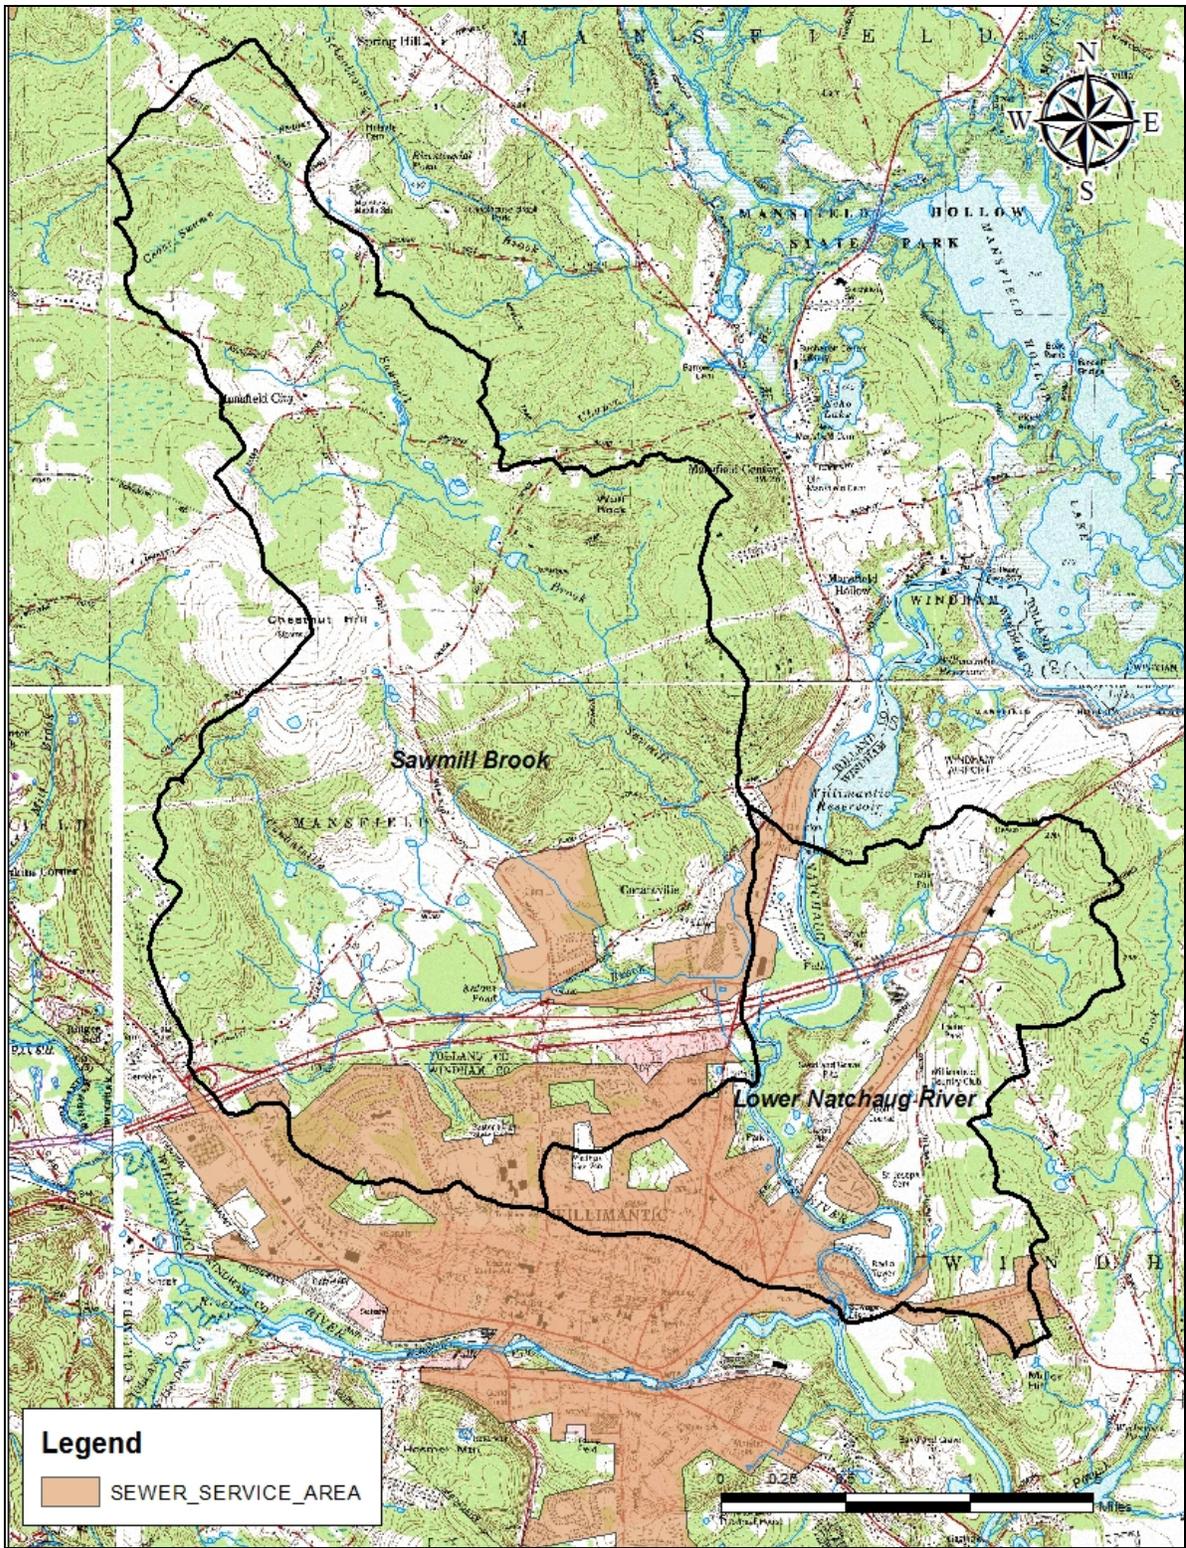
Figure 16: Sewer service area in Mansfield and Windham (CT DEEP 2013).
