Contract #2013-13096

Lower Natchaug River Abbreviated Watershed-Based Plan

Prepared by the Eastern
Connecticut Conservation
District, Inc.

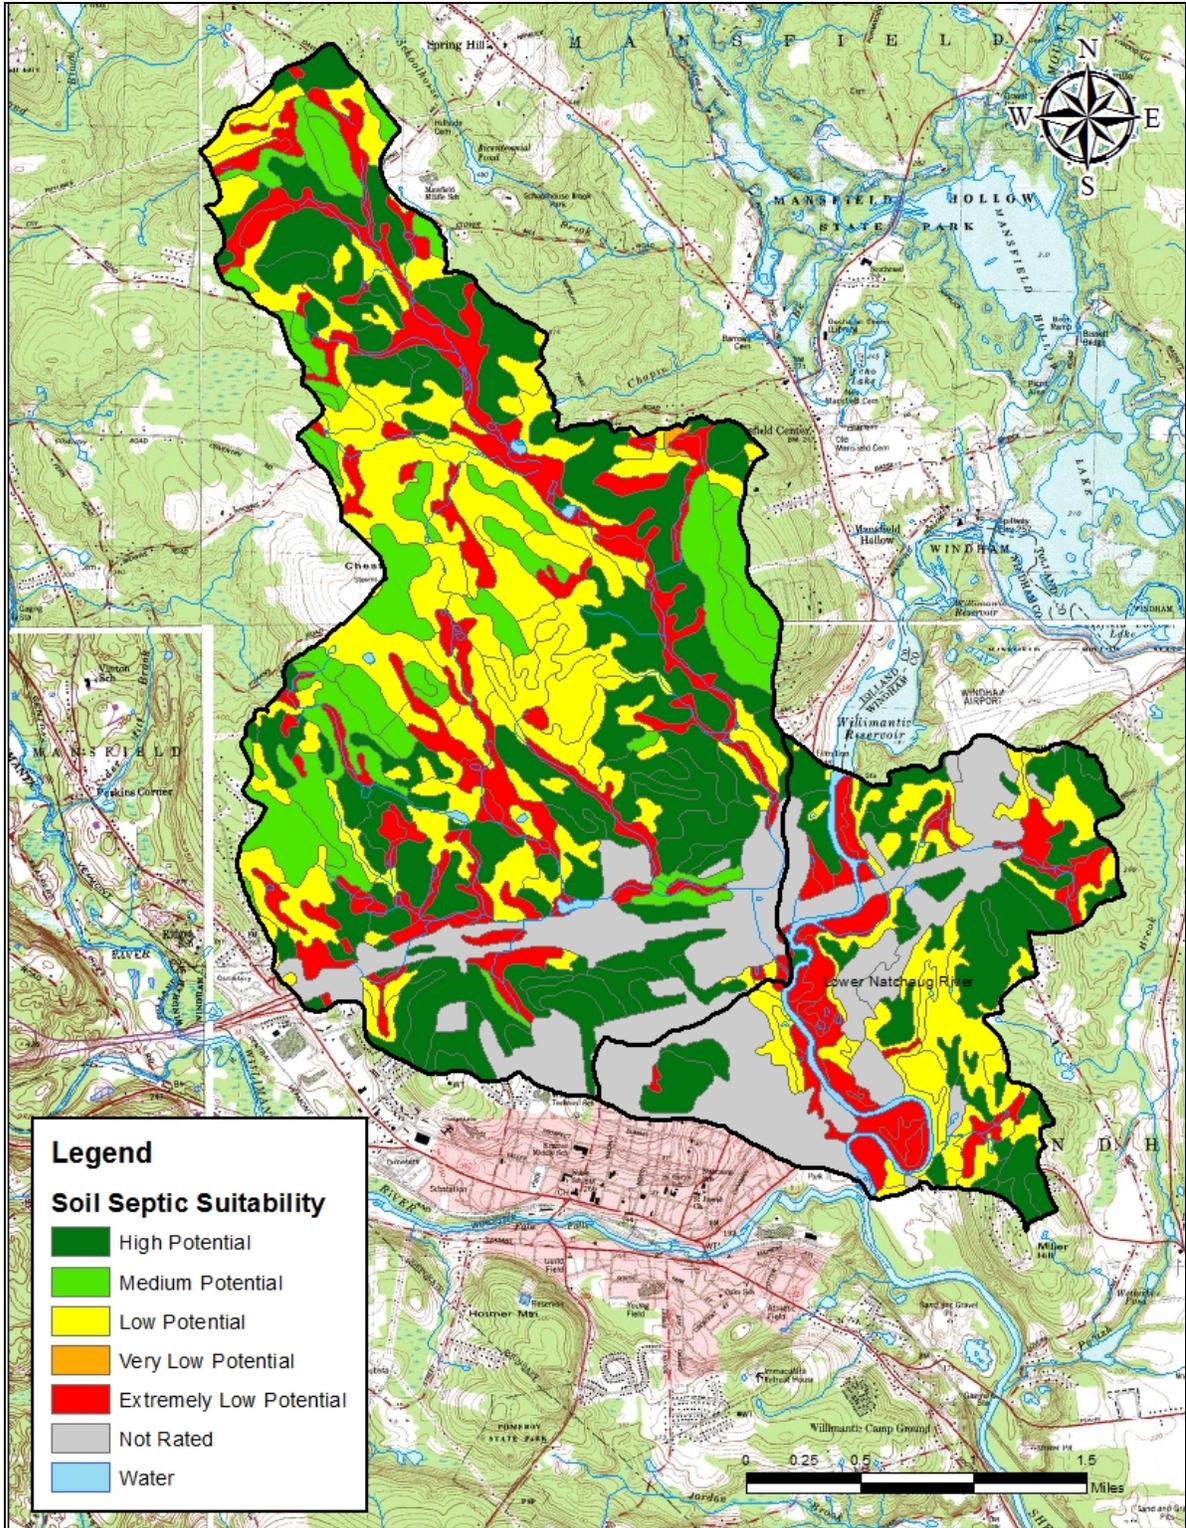
Figure 17: Septic Suitability of soils in the lower Natchaug River and Sawmill Brook watersheds (USDA-NRCS Web Soil Survey).

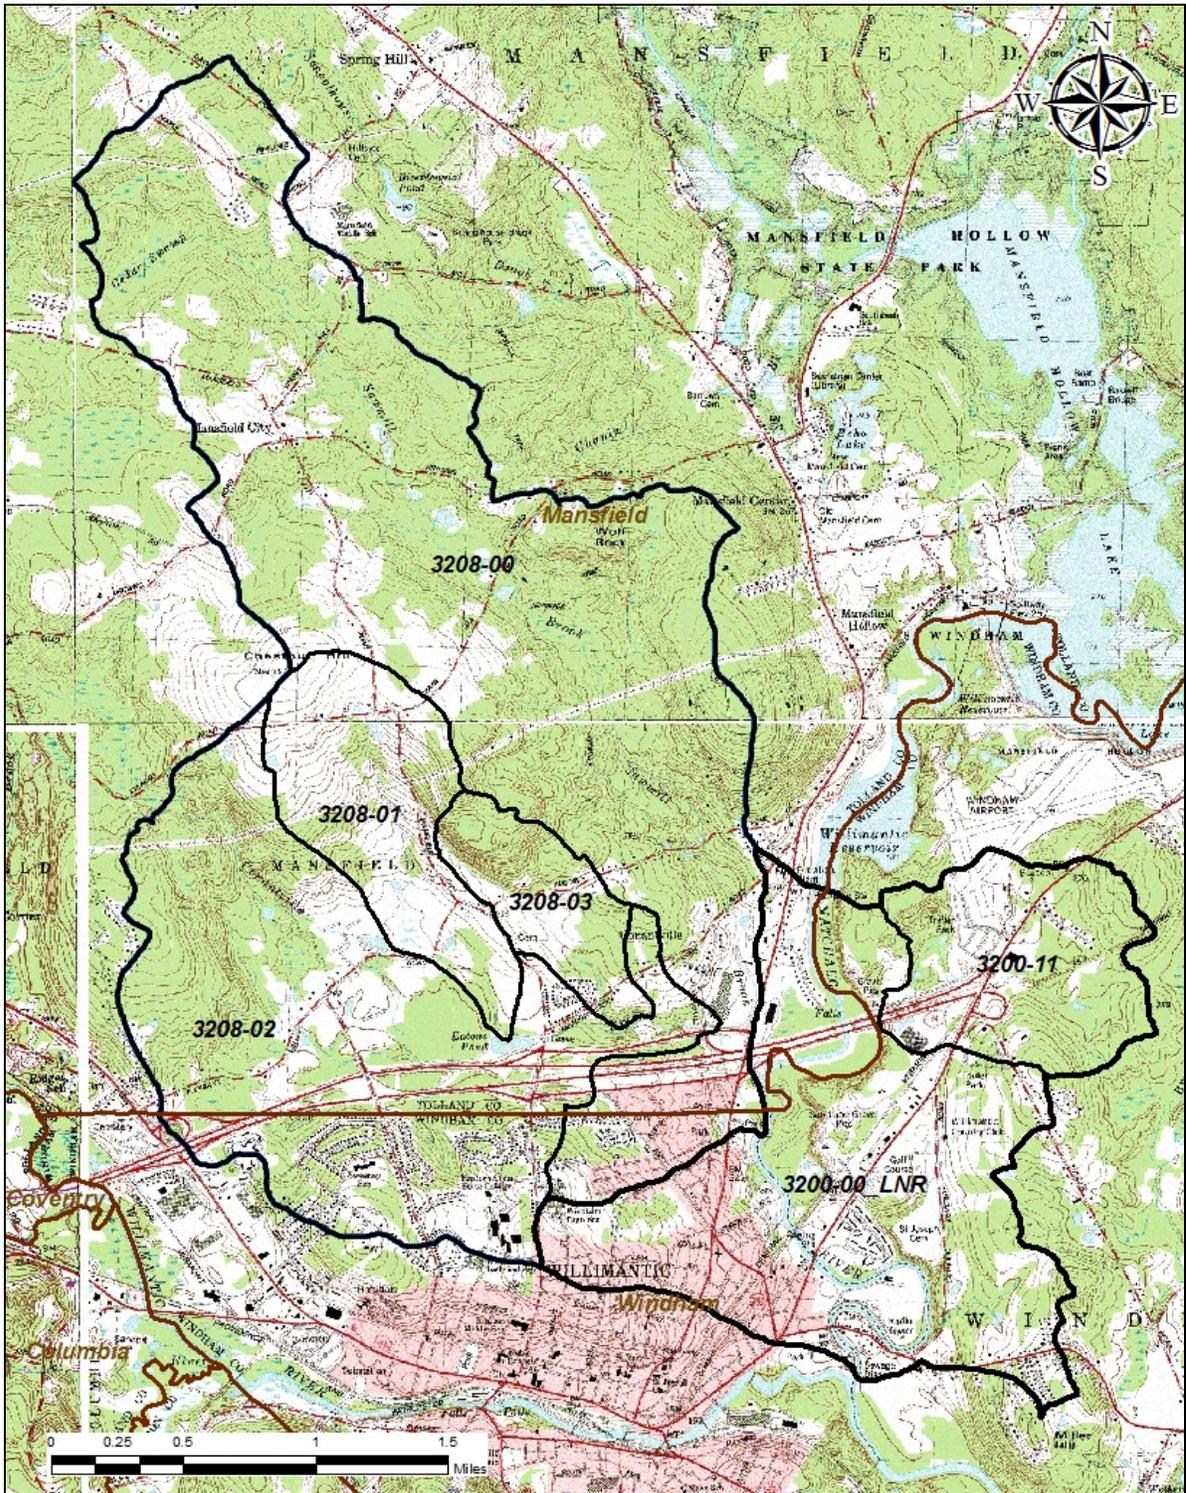
Figure 18: Local watersheds delineated for pollutant loading calculations.

In order to better isolate pollutant loading, Sawmill Brook and the lower Natchaug River watersheds were divided into sub-watersheds. The sub-watersheds are depicted in Figure 18. Pollutant load reductions for the two watersheds investigated for this project are depicted in Table 10. Pollutant loads for each sub-watershed are depicted in Table 11.

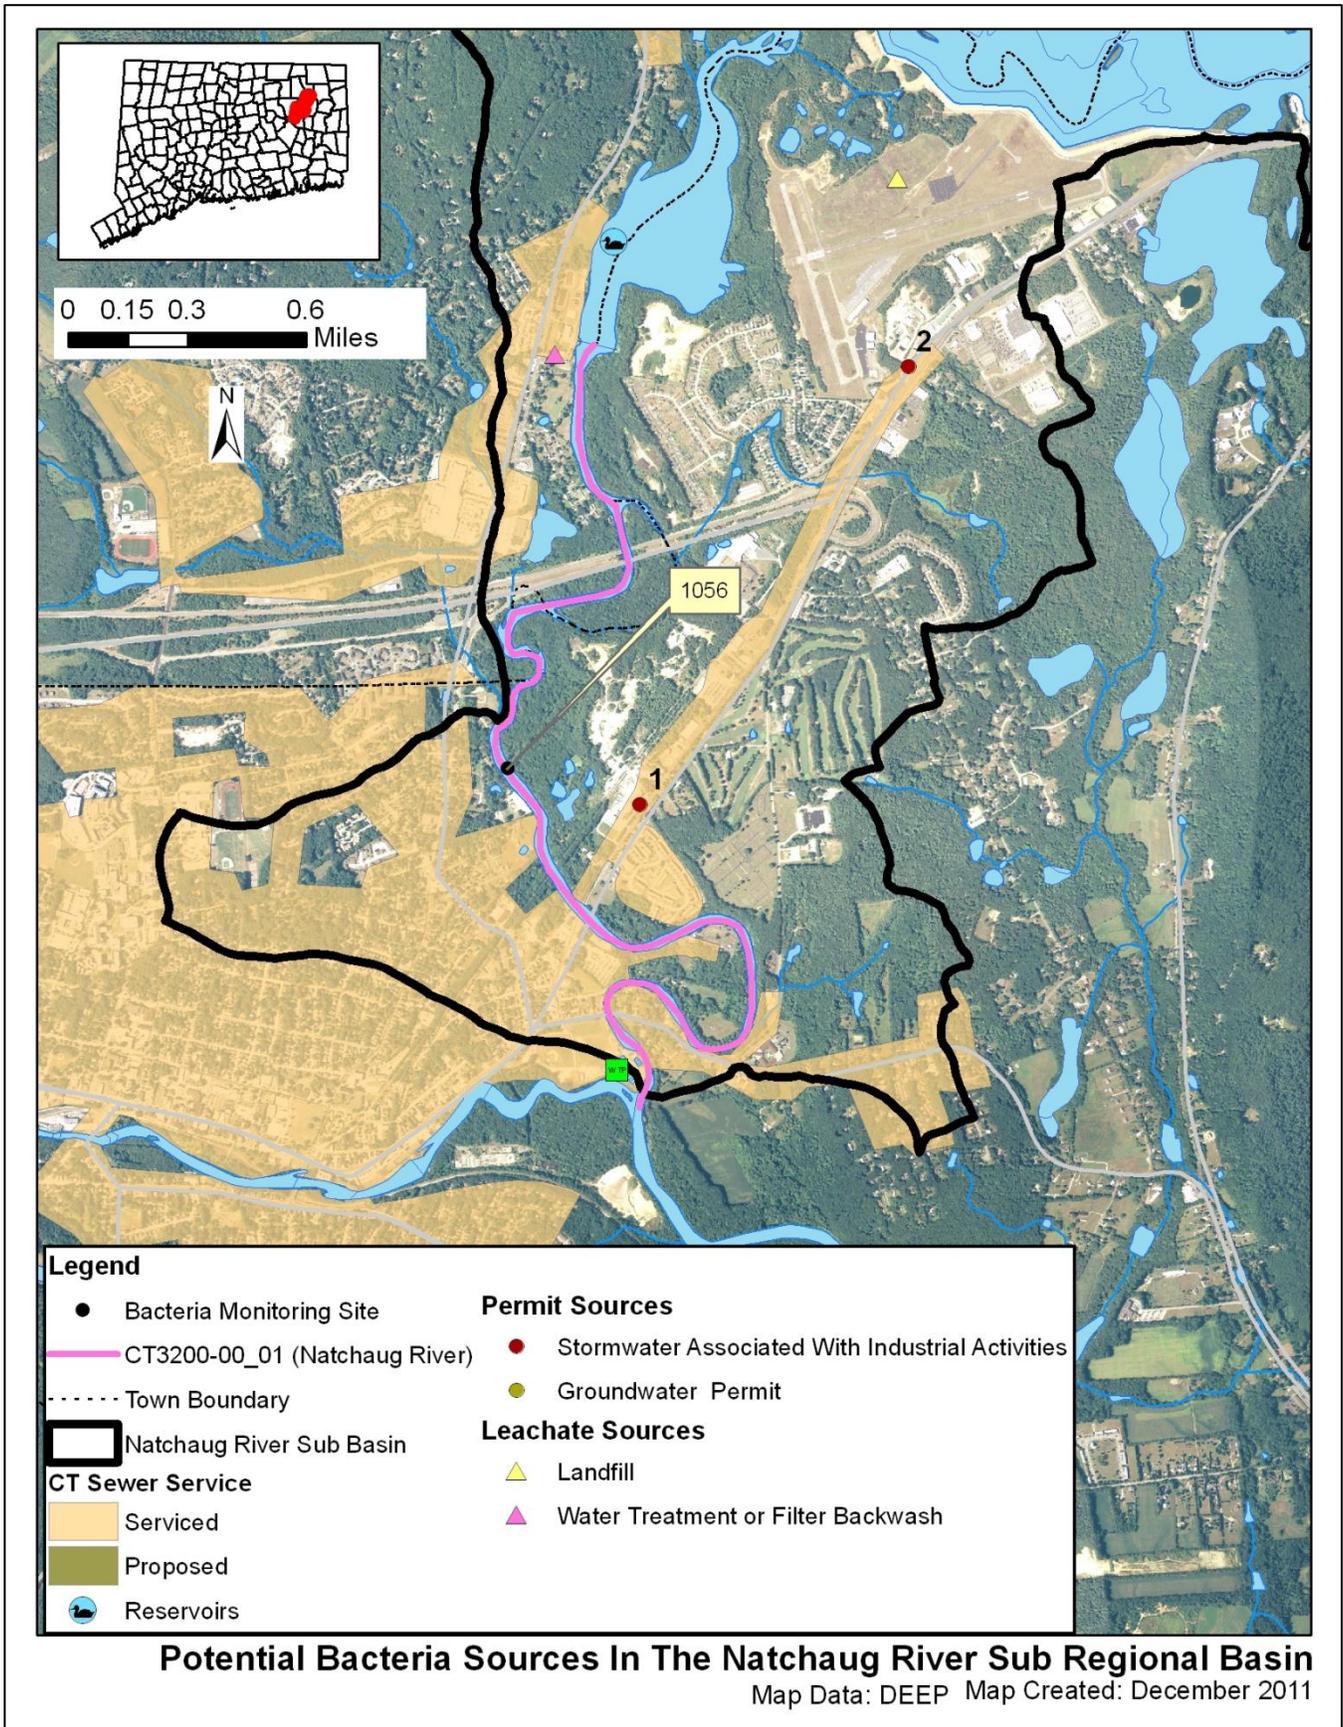
Figure 6: Potential sources in the Natchaug River watershed at the sub-regional level

The potential sources map for the impaired basin was developed after thorough analysis of available data sets. If information is not displayed in the map, then no sources were discovered during the analysis. The following is the list of potential sources that were evaluated: problems with migratory waterfowl, golf course locations, reservoirs, proposed and existing sewer service, cattle farms, poultry farms, permitted sources of bacteria loading (surface water discharge, MS4 permit, industrial stormwater, commercial stormwater, groundwater permits, and construction related stormwater), and leachate and discharge sources (agricultural waste, CSOs, failing septic systems, landfills, large septic tank leach fields, septage lagoons, sewage treatment plants, and water treatment or filter backwash).

As shown in Figure 6, there is one publicly owned treatment works (POTWs), or wastewater treatment plant (WTP) in the Natchaug River watershed. The Windham Water Treatment Control Facility (WTCF) is located on the watershed boundary where the Natchaug River flows into the Willimantic River. While a portion of the treatment facility is located in the watershed, the plant discharges to the Willimantic River. Bacteria data from this permitted facility is not currently available, nor would it have any impact on the impaired Natchaug River segment (Table 6).

There are at least two active permitted stormwater outfalls in the watershed (Figure 6), with potential for many more inactive permits (Tables 6 and 7) as well as unknown stormwater outfalls to the Natchaug River. Potential bacteria sources from these outfalls could impact the water quality of the Natchaug River. A watershed study to map stormwater outfalls that contribute to the impairment in the river should be considered to improve water quality.

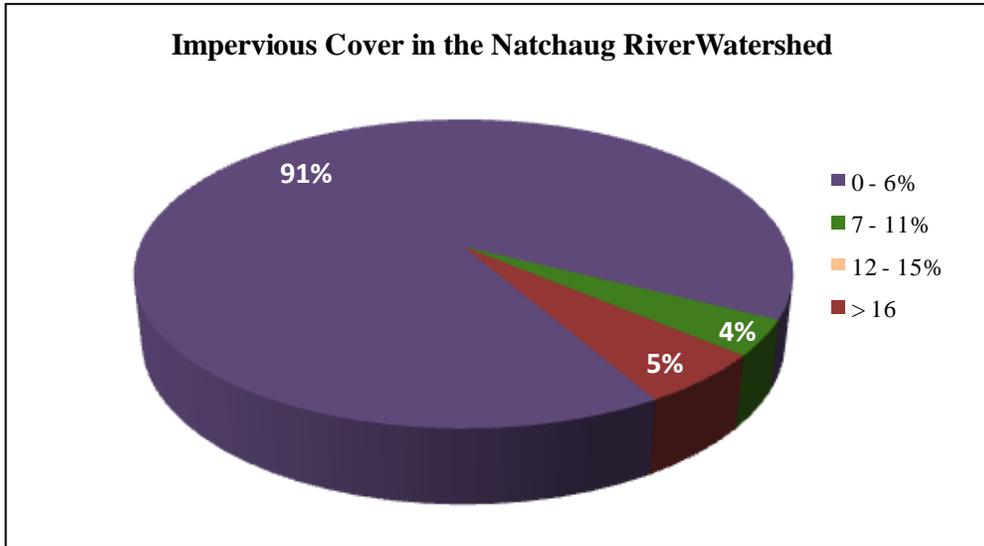
Figure 8: Range of impervious cover (%) in the Natchaug River watershed

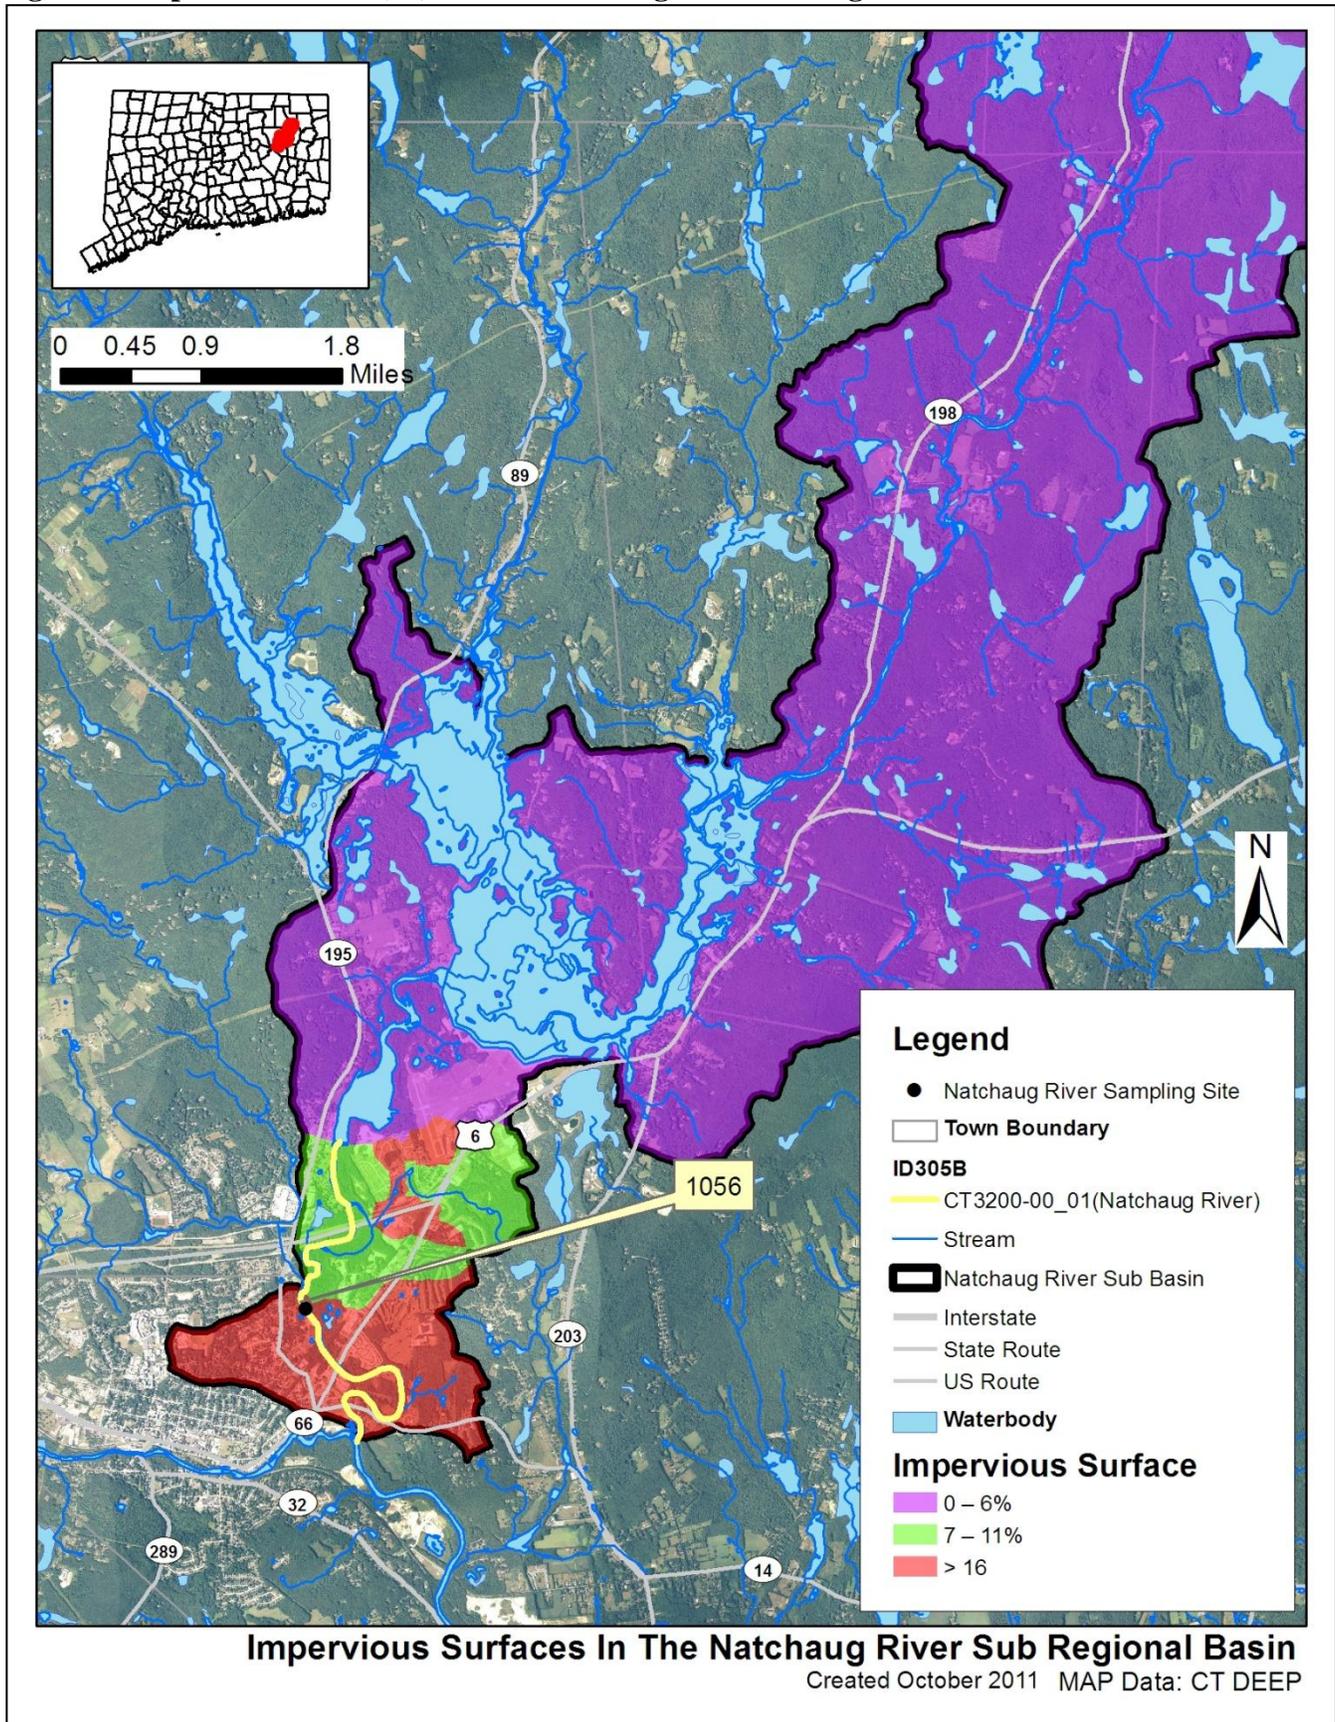
Figure 9: Impervious cover (%) for the Natchaug River sub-regional watershed

As shown in Figure 9, the portion of the Natchaug River watershed containing the impaired segment contains a high percentage of impervious cover, ranging from 7-11% in the section immediately below the dam, to greater than 16% impervious cover in the southern portion of the watershed below the sampling station, and around the Windham Airport. The remainder of the watershed above the impaired segment contains areas of impervious cover between 0-6% typical of more rural residential, agricultural, and forested watersheds. High geometric means during wet-weather may indicate that stormwater runoff is contributing to the bacterial impairment in a river segment. As shown in Table 8, the bacteria concentration in the Natchaug River exceeded the WQS at Station 1056 on the impaired segment during a wet-weather sampling event.
