Mill River Watershed Based Plan

LID/Green Infrastructure Assessment

Other Green Infrastructure Retrofit Opportunities in the Mill River Watershed

Mill River Watershed – Other Green Infrastructure Opportunities

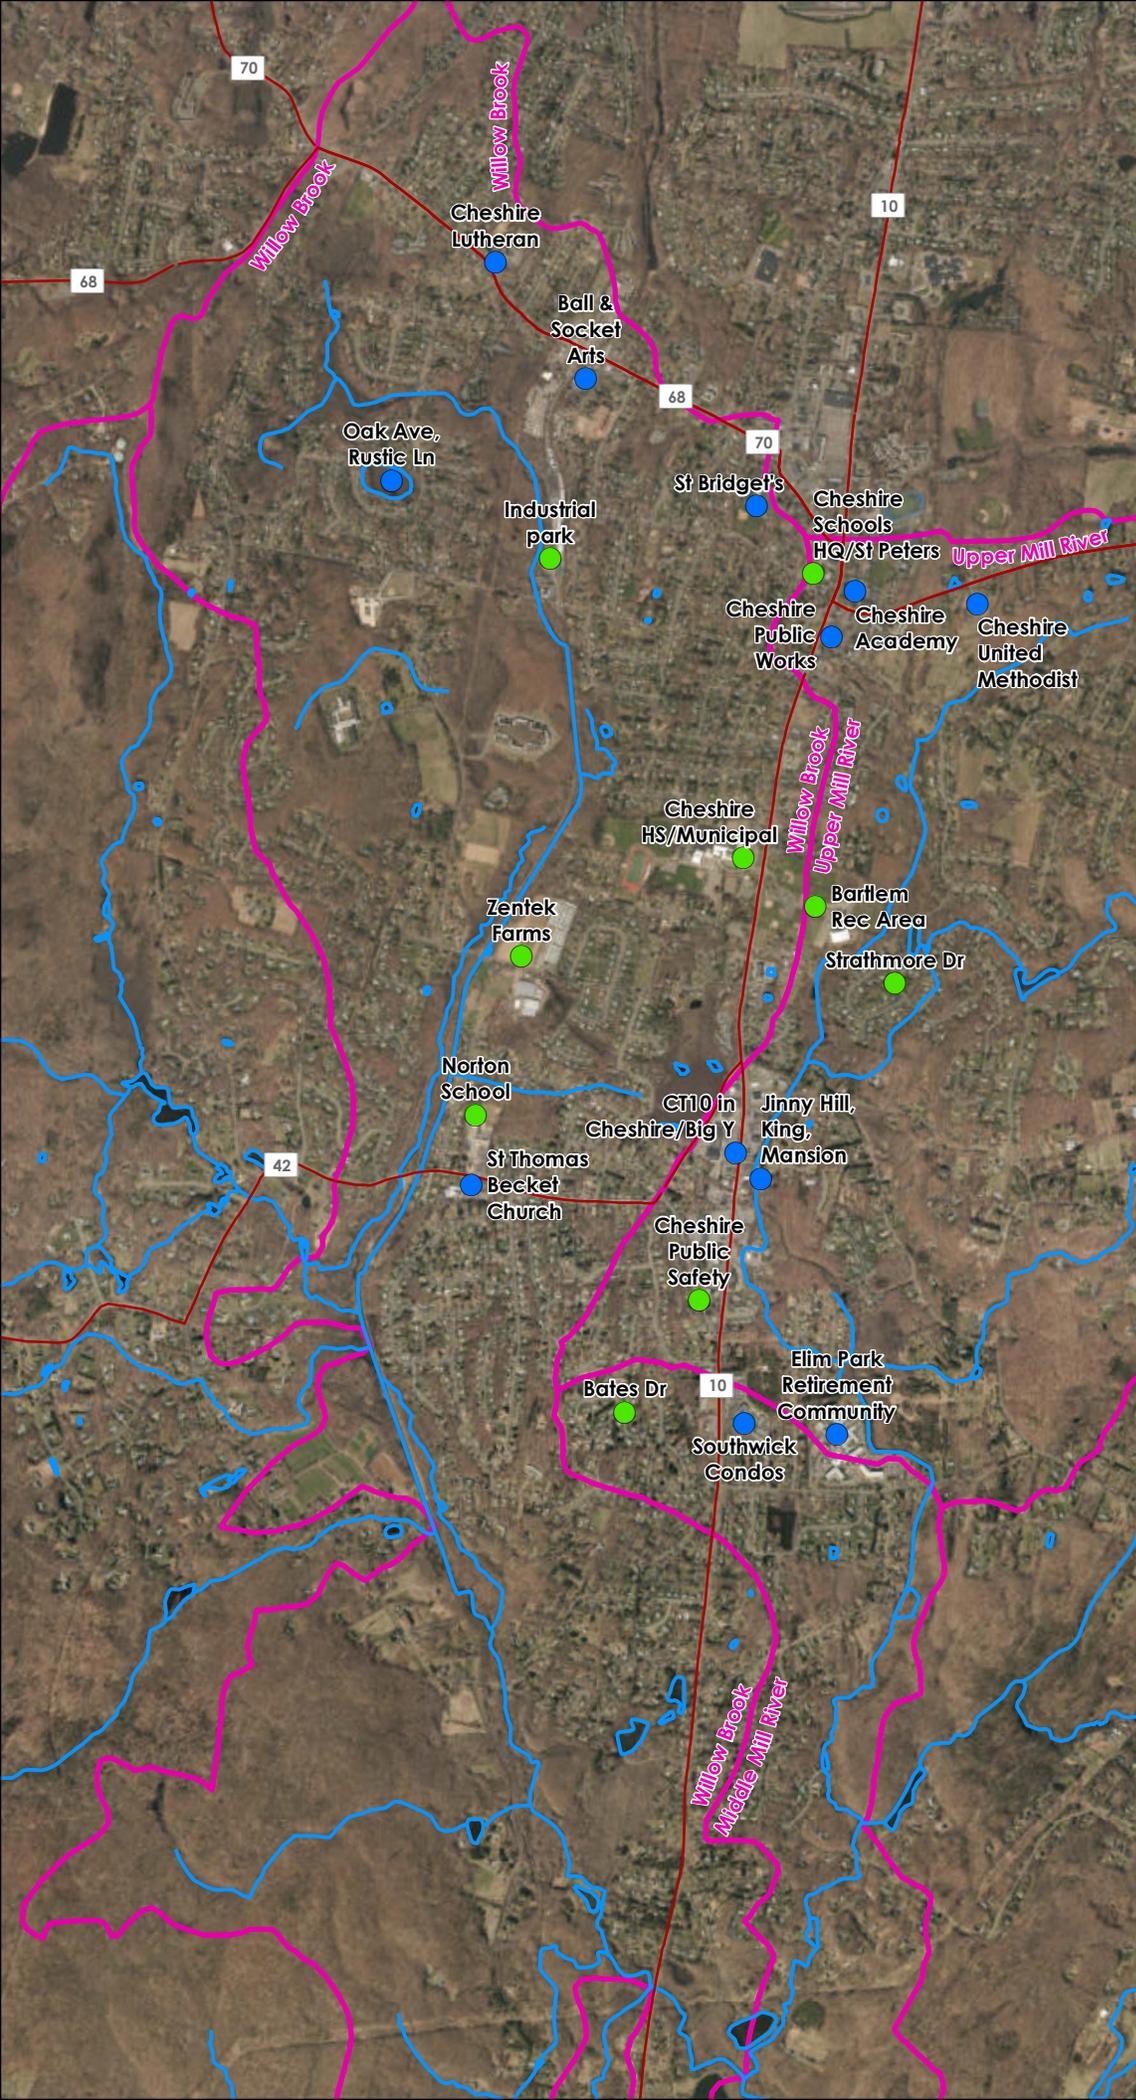
Upper Watershed

Potential Sites

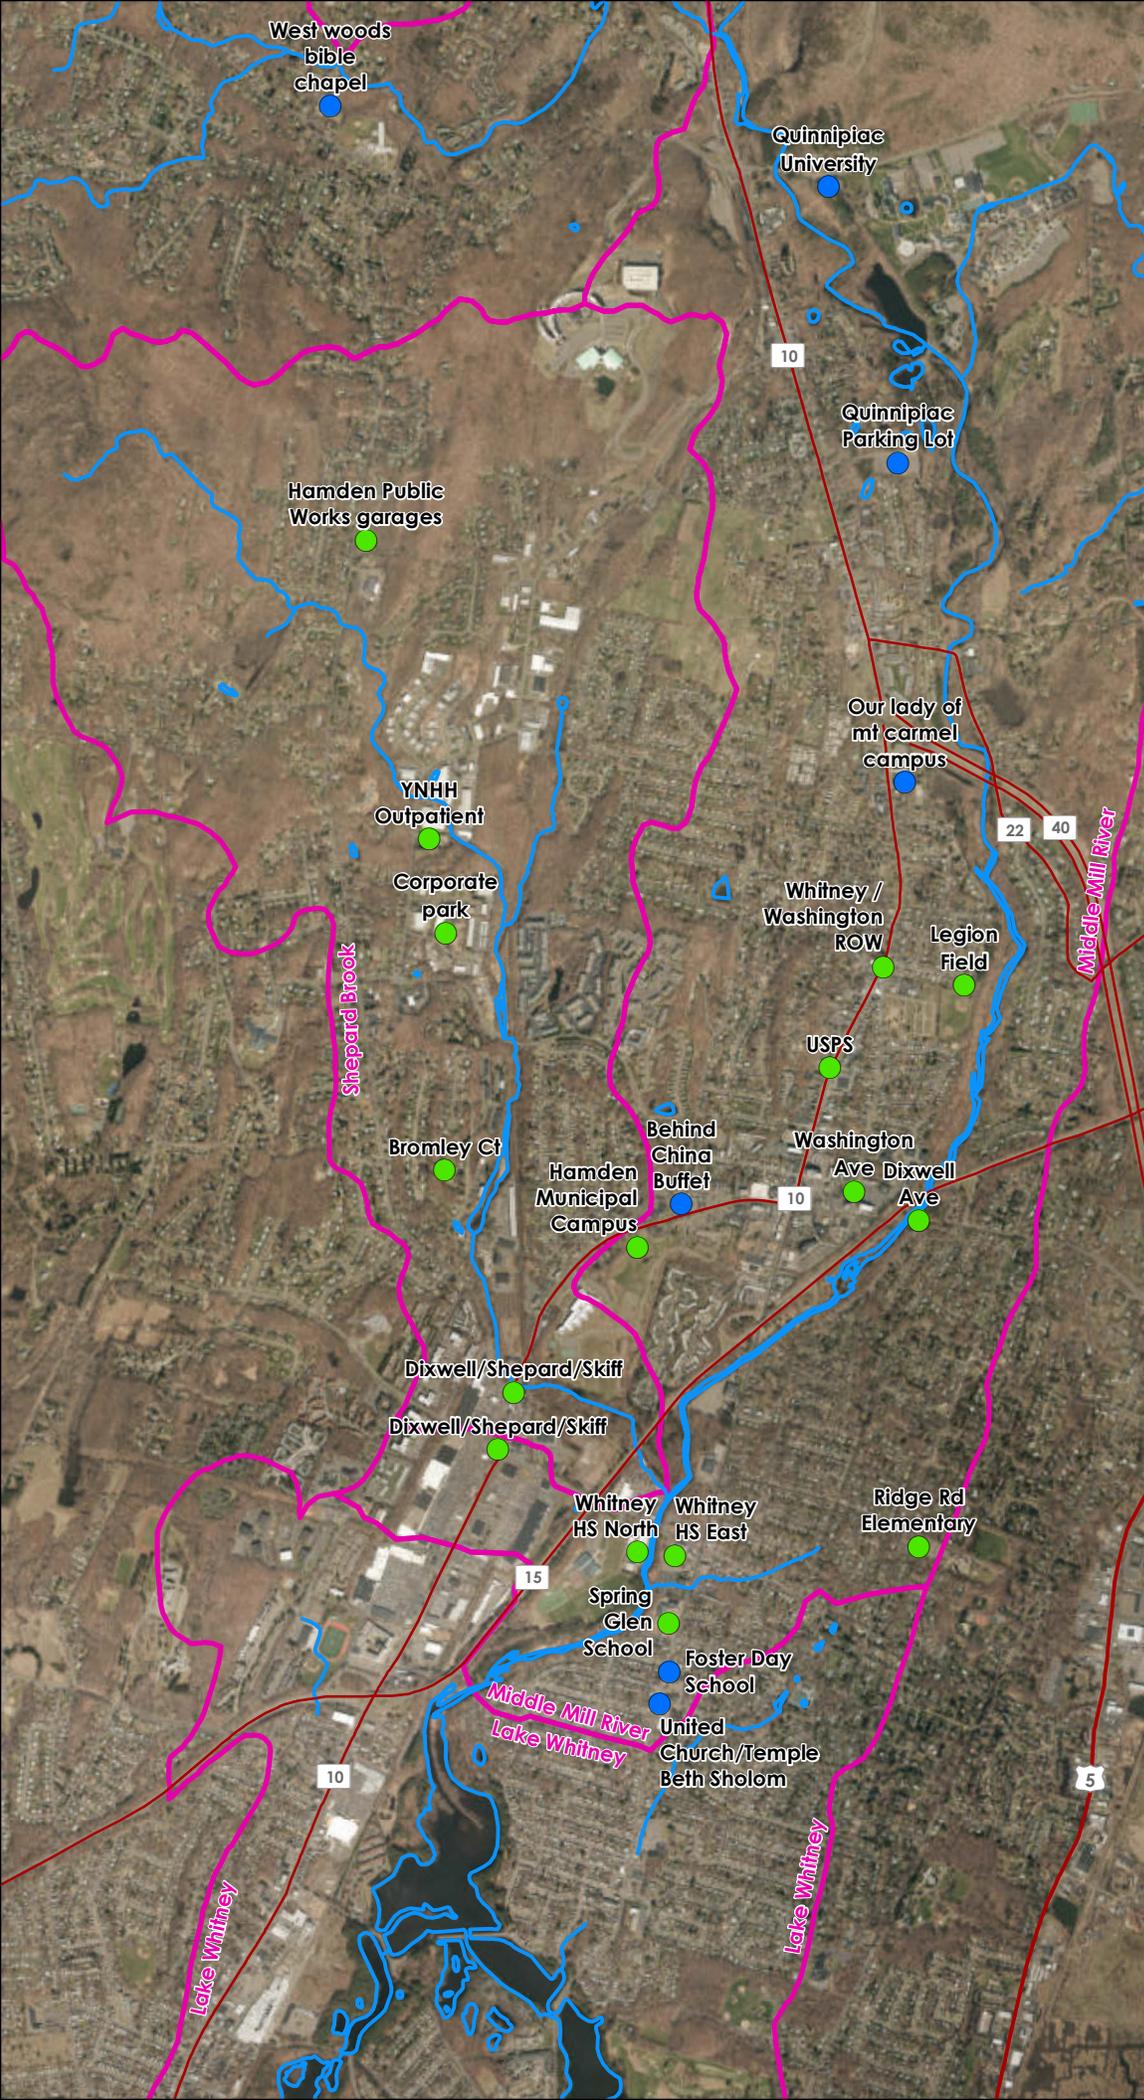
Middle Watershed

Potential Sites

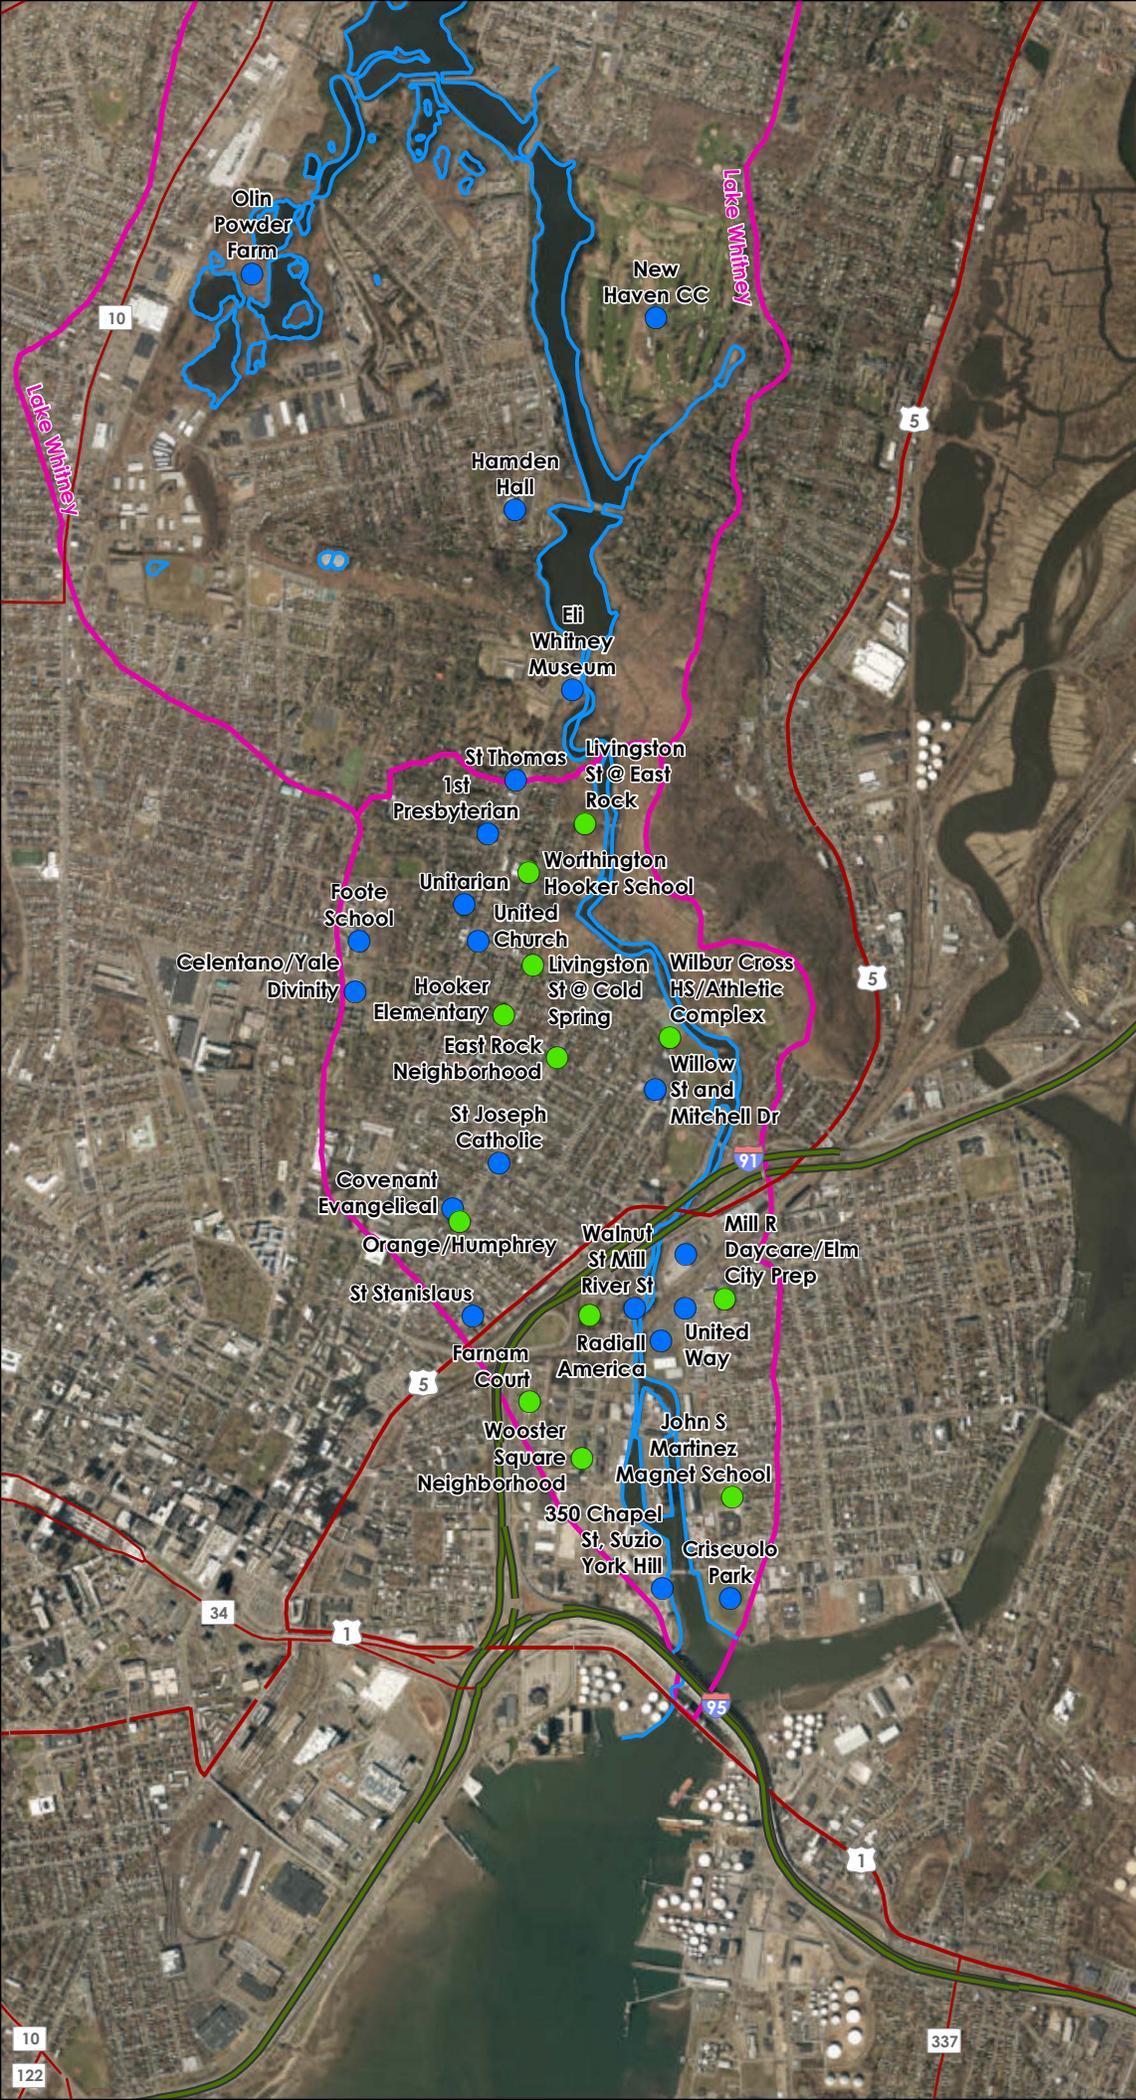
Lower Watershed

Potential Sites

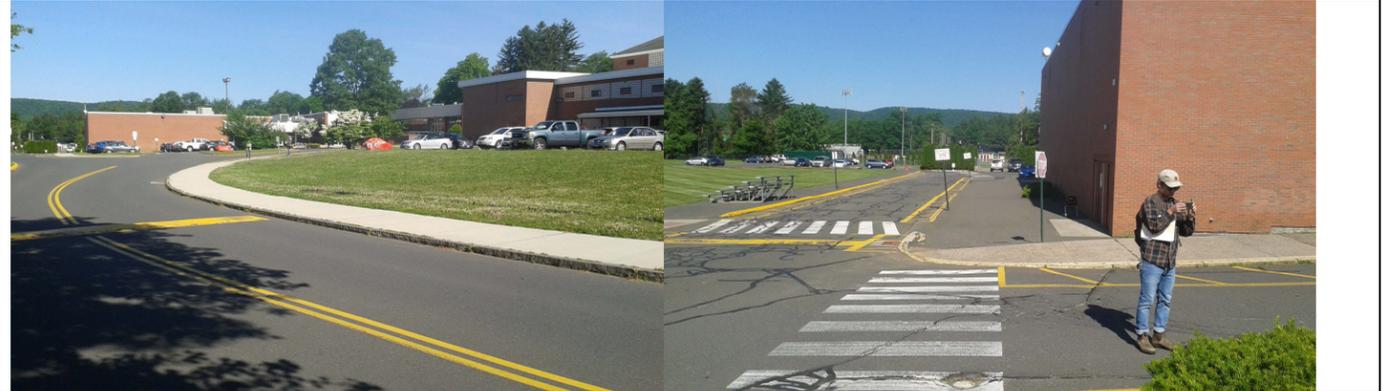
Site Location	Municipality	Existing Conditions	Recommendation	Photo
Cheshire HS	Cheshire	Large amount of impervious cover, multiple parking areas. Internal roof drainage from buildings.	Disconnect roof downspouts. Potential for infiltration or bioretention using existing landscaped areas in front lawn, just west of entrance, and/or under fire lane by gym. Replace impervious parking lots with pervious pavers. Low-lying area behind operations/maintenance building could also receive water.

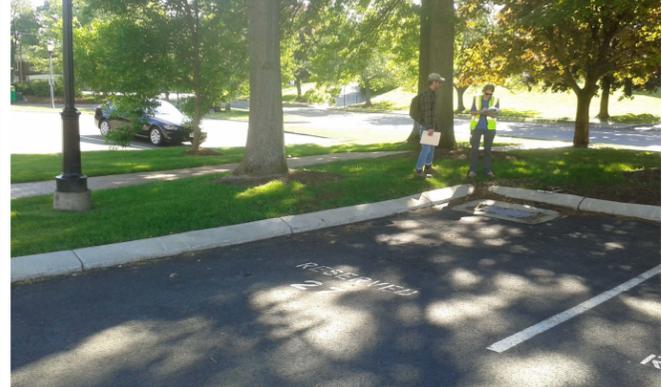
Cheshire Public Works/Town Hall	Cheshire	Large parking lot, drains via catch basins. Catch basin in NE corner of parking lot was observed to have moderate flow, despite no rain in past 24h. Dumpsters without secondary containment adjacent were located adjacent to another catch basin.	Potential for subsurface infiltration under NE corner at catch basin.

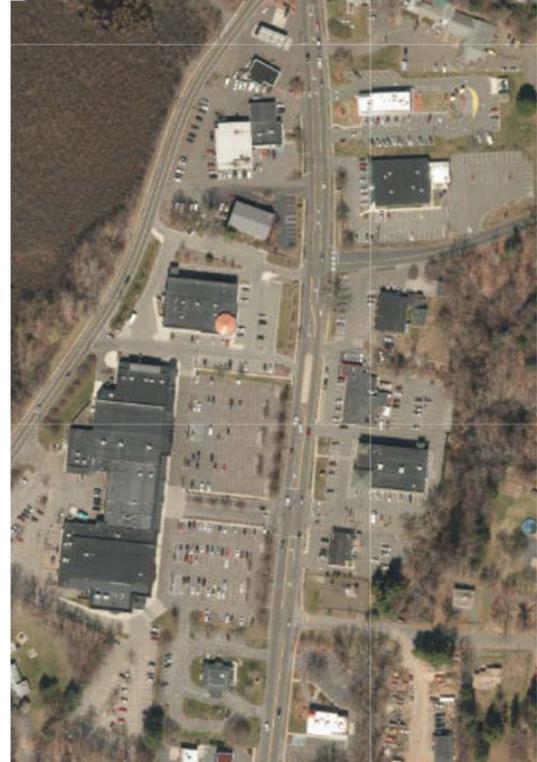
Route 10 Corridor	Cheshire	Large amount of impervious cover, multiple parking areas many of which back up to the Mill River with little or no Riparian Buffer	Decrease impervious cover throughout Route 10 Corridor.

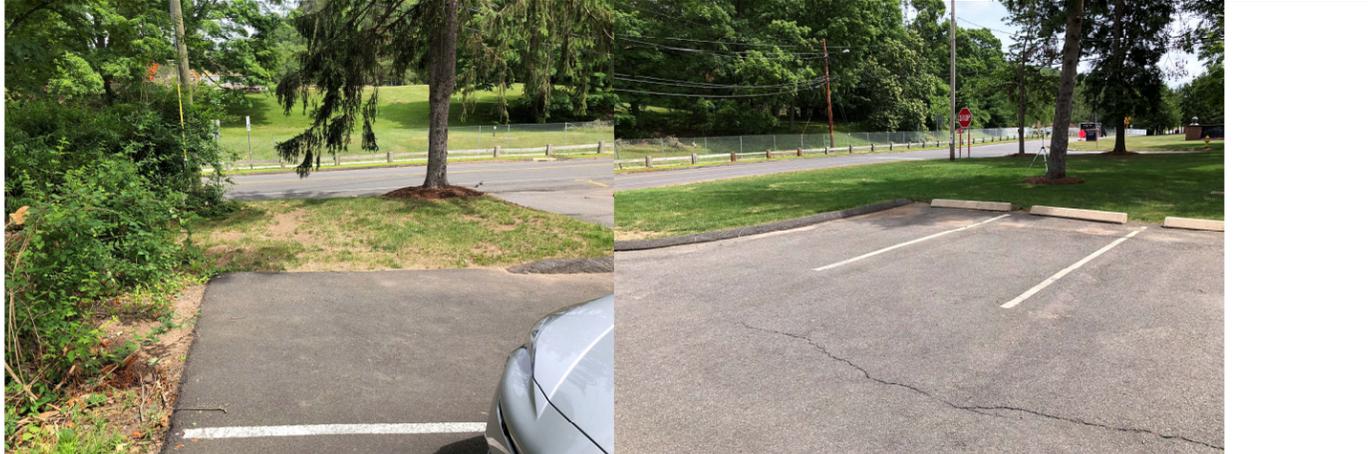
Site Location	Municipality	Existing Conditions	Recommendation	Photo
Quinnipiac University - Albert Schweitzer Institute	Hamden	Paved parking lots with no storm drains next to Mill River	Install educational rain garden to capture runoff from the front parking area.

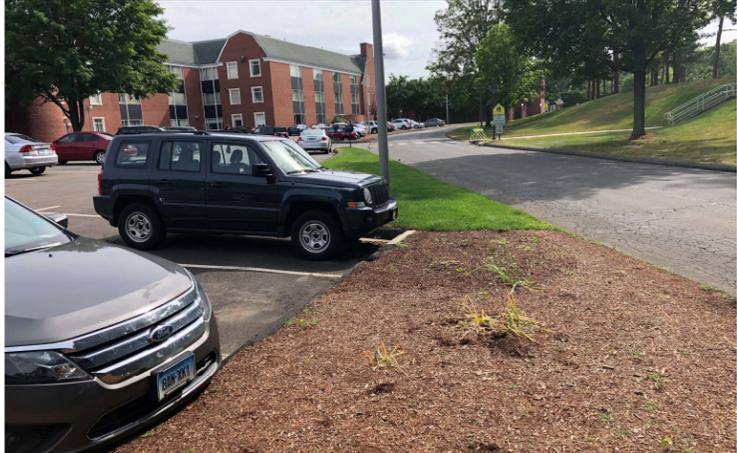
Quinnipiac University – Bobcat way parking areas	Hamden	Extensive parking areas with curbed planted islands	Potential for bioretention in existing landscaped area with catch basin adjacent to each island

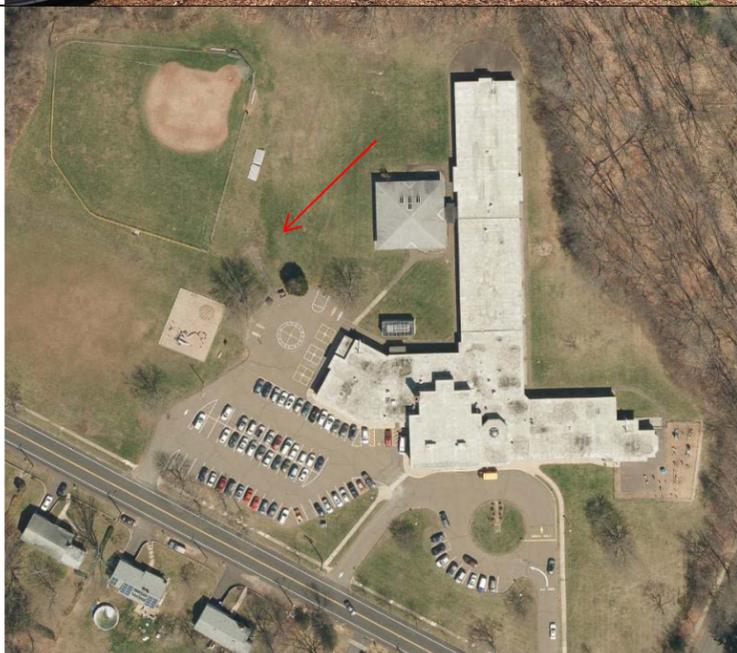
Alice Peck School	Hamden	Roof leaders and parking lot drain to paved open channel. Renovations to the school are expected during 2019.	Potential for bioretention and swale between parking lot and baseball field.

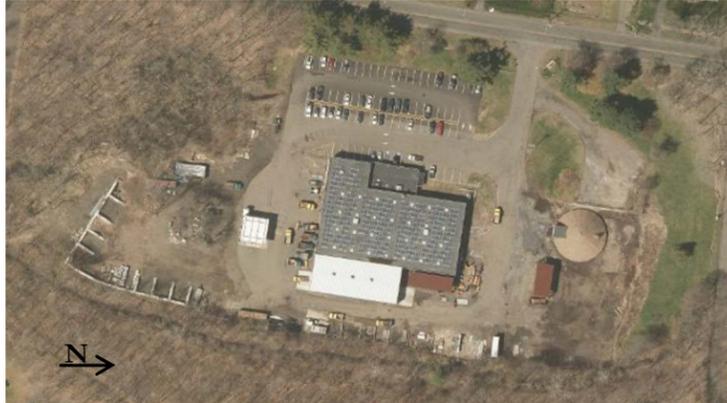
Site Location	Municipality	Existing Conditions	Recommendation	Photo
Hamden Public Works	Hamden	Large parking lot drains to low point on south side of lot. Discharges to eroded channel into wet, wooded area south of site. No curbing or catch basins.	Bioretention or created wetland at south side of parking lot. Replace parking lot with pervious pavers.

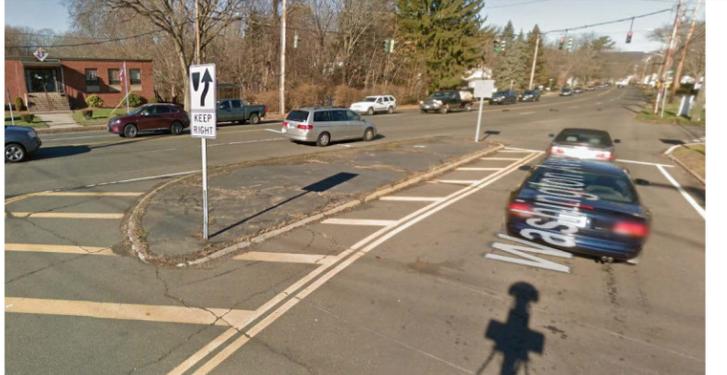
Whitney Washington ROW	Hamden	Bituminous island at intersection.	Potential to install bioretention cell or infiltration practice and/or remove impervious cover.

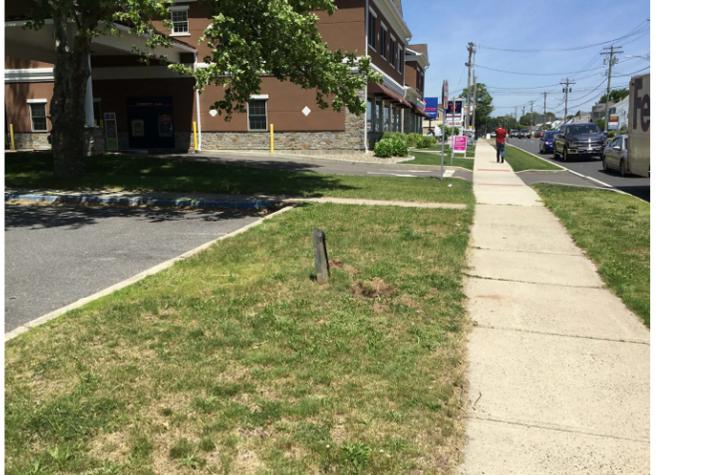
USPS Whitney Ave	Hamden	Existing catch basins full of sediment. Roof leaders buried, discharge to catch basin on property.	Disconnect roof downspout. Potential for subsurface infiltration in parking lanes, under pervious pavement. Bioswale or linear bioretention between parking lot and road.

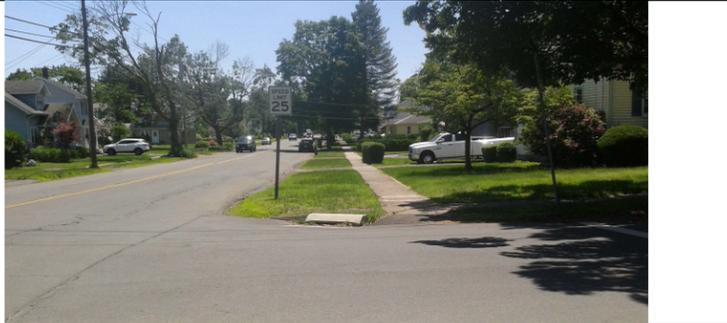
Washington Ave between Lincoln and Harding	Hamden	Wide ROW, no curb, sediment collecting at grass edge. Onstreet parking.	Linear bioretention or bioswales along west side of street. Bioswales where practicable elsewhere on Washington Ave. Replace parking lanes on either side of street with pervious pavement.

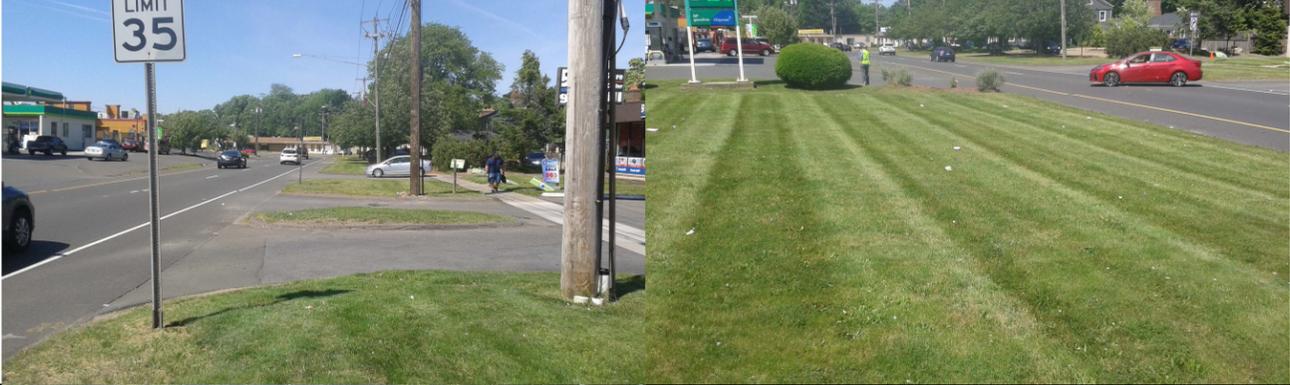
Site Location	Municipality	Existing Conditions	Recommendation	Photo
Hamden Municipal Campus	Hamden	Large parking lots at Hamden Senior Center, Library, Middle School, and Town Hall.	Develop a Municipal Campus Stormwater Masterplan.	
Dixwell Ave./ Shepard Ave./ Skiff Street	Hamden	Busy intersection near many large parking lots and commercial center.	Potential for bioretention or infiltration in ROW island and linear practices in ROW. Paved ROW could, at minimum, be replaced with pervious cover.

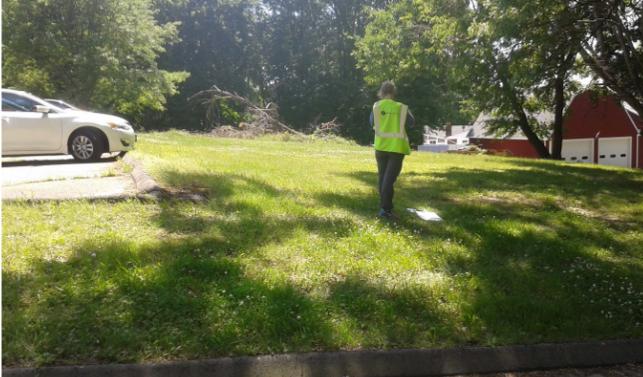
Ridge Road Elementary	Hamden	Cracked pavement in parking lot, may be due for repaving.	Regrade parking lot, remove western curb and install bioretention or infiltration practice. Potential to replace parking lot with pervious pavers.

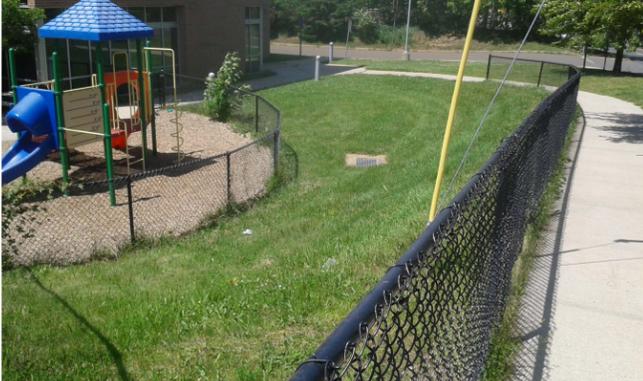
Spring Glen School	Hamden	Medium sized parking lot, recent pavement, trees in median.	Potential for bioretention in existing landscaped area with catchbasin adjacent to lower play area. Rain garden at SW corner of site.

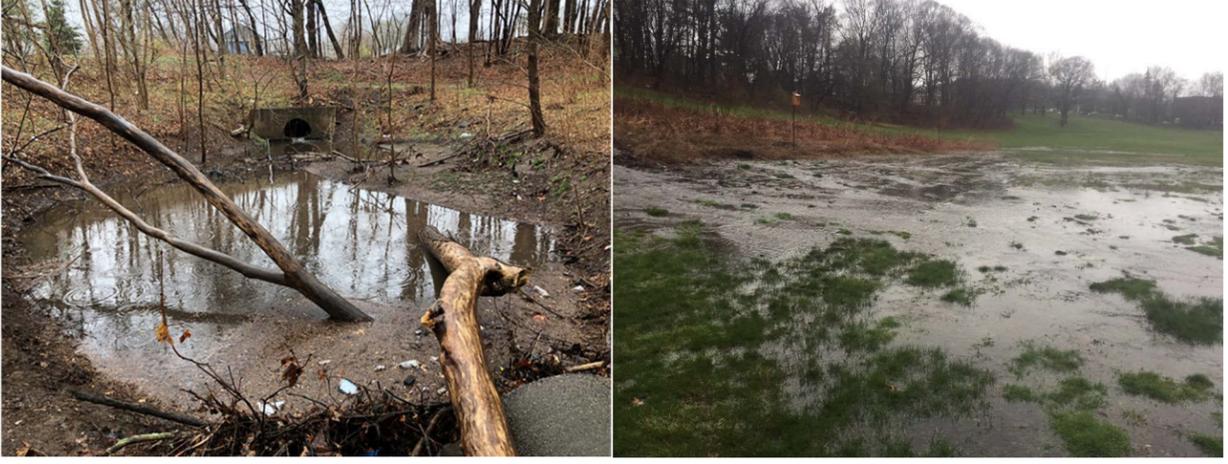
Site Location	Municipality	Existing Conditions	Recommendation	Photo
Town Center Park	Hamden	Town Park that receives runoff from 88 acres or surrounding urban land use (commercial and residential). Impervious cover is estimated to be 21%.	<p>Installation of best management practices (BMPs) that slow, treat, capture, and filter the stormwater before it reaches the Pardee Brook diversion channel and Shepard Brook. The designs consist of reinforcing the existing plunge pool with a boulder overflow weir; installing a sediment filter riverbed, a stormwater treatment pond, constructed wetland and rain garden; and restoring the meadow area to create an emergent marsh. This series of engineered but natural stormwater management practices will reduce pollutant loading and erosion entering Pardee Brook</p> <p>**High Priority Project</p>

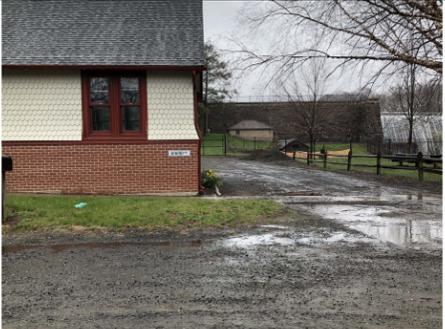
RWA Water Center	Hamden	Hard packed access road with downspout discharging to access road	Install Rain barrel to capture roof runoff. Potential for demonstration bioretention.

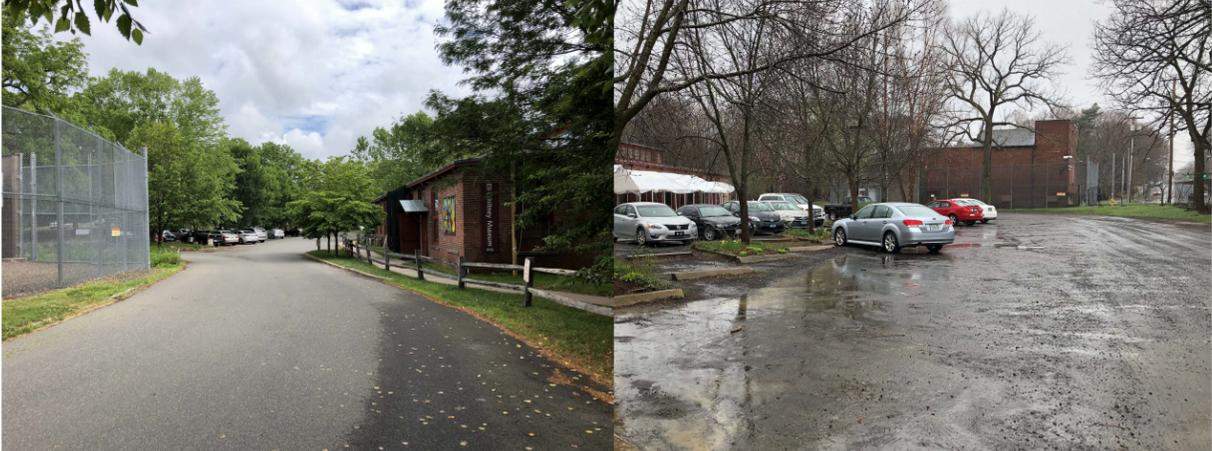
Eli Whitney Museum	Hamden	Hard pack and paved parking area with catch basins discharging directly to river; curbed island and planters in the center of parking lot	Potential to retrofit curbing and islands in the center of the parking lot to be used for bioretention. Potential to install bioswales in grass areas along the paved driveway. Potential to install rain barrels to capture water from existing building and reuse onsite.

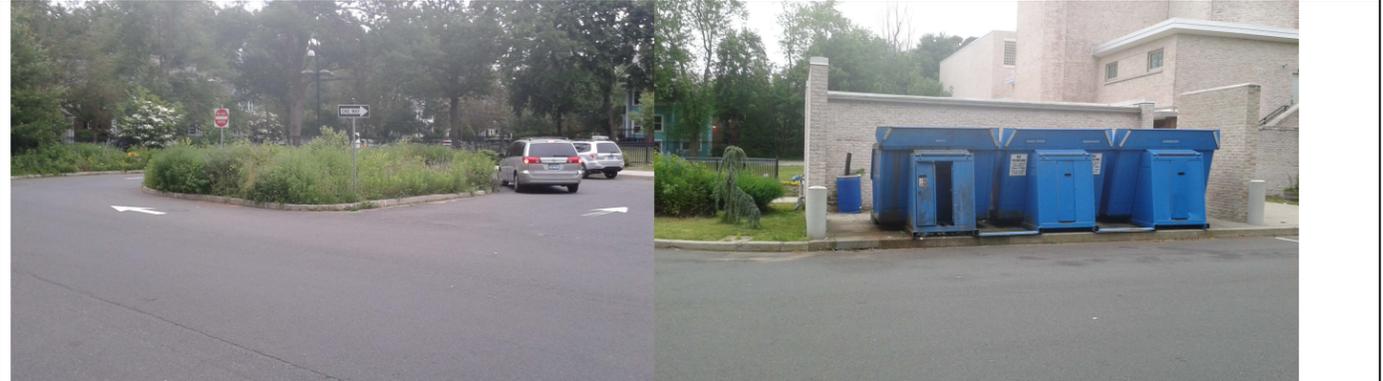
Site Location	Municipality	Existing Conditions	Recommendation	Photo
Hooker Middle School	New Haven	Church converted to school in 2009. Island in turnaround. Catch basins in parking lot, including beneath dumpsters. Former PTA constructed native habitat, but now is not maintained (invasives present). School has signage about native habitat and outdoor classroom.	Potential for green roof above main entrance, bioretention in island and at lower elevation on property in existing, unmaintained habitat garden. Recommend native plantings in bioretention. Rain garden by eastern gate. Secondary containment around dumpsters.

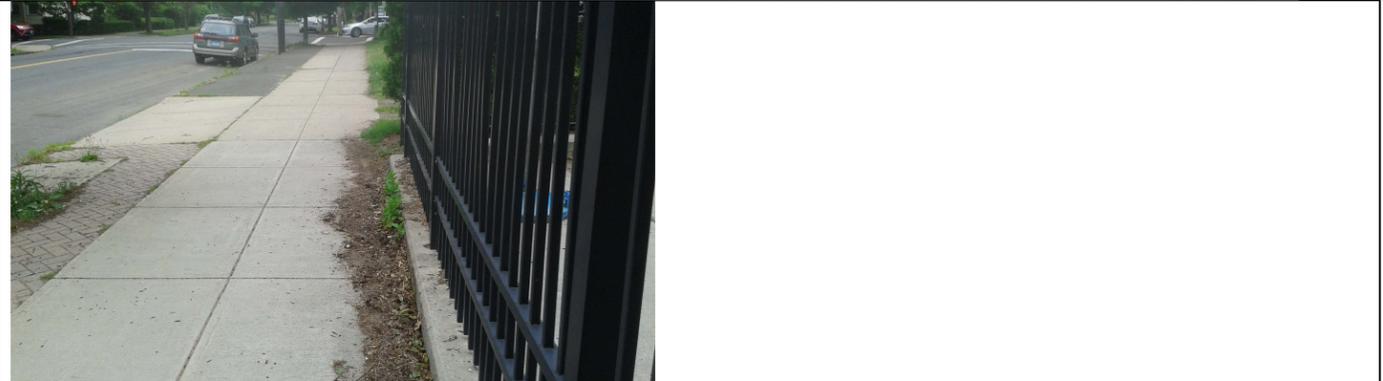
Hooker Elementary School	New Haven	Moderately old street/sidewalk, possibly separated sewer/past CSO. Buried roof leaders to catchbasins.	Linear bioretention to subsurface infiltration along Canner, east of Livingston. Replace paved ROW area on Livingston, south of the school, with bioretention; connect to low points of playground via trench drain or replace with pervious pavers.

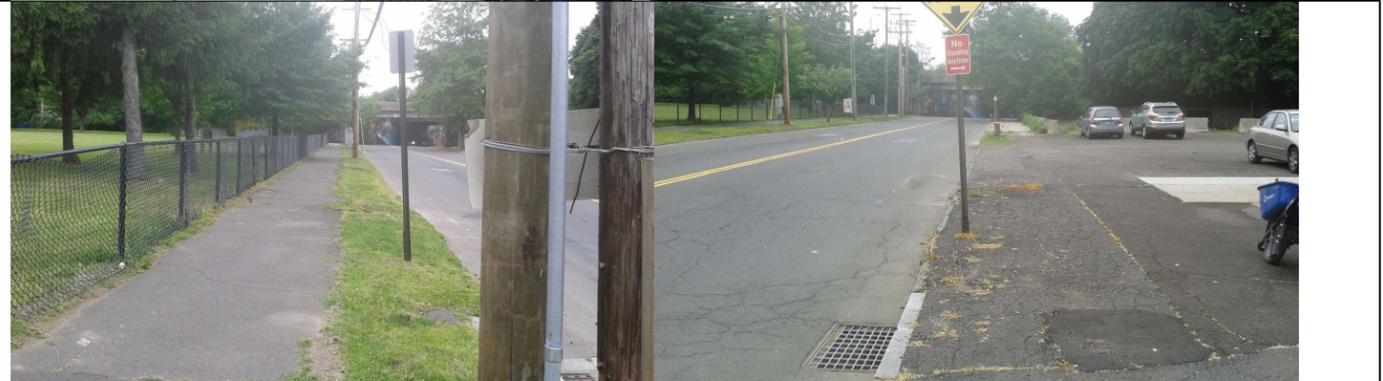
Jocelyn Square Park	New Haven	Broken 6' wide sidewalk on north side of park. Drainage existing along Humphrey. Leaching catch basin in private parking lot across Humphrey, at 175 Humphrey St.	Bioswale in ROW between utility poles. Potential for subsurface storage/infiltration under paved park entrance.

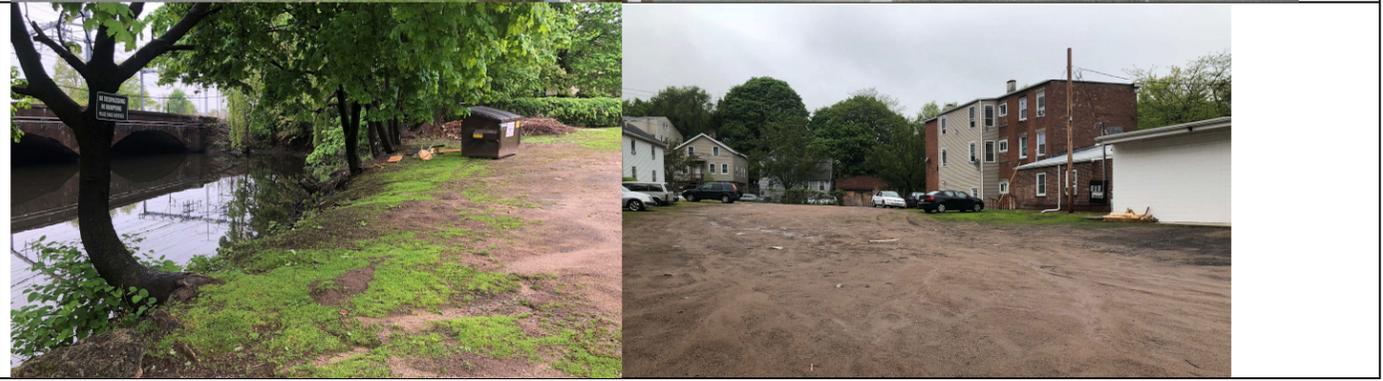
Humphrey Street and Mill River Street	New Haven	Large parking area comprised of sand, gravel and pavement, which slopes towards the Mill River. The stream bank is eroded with no riparian area.	Potential for living shoreline

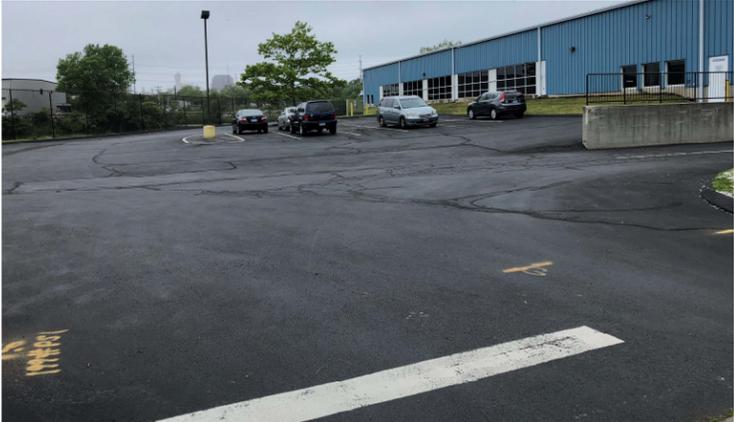
Site Location	Municipality	Existing Conditions	Recommendation	Photo
Radiall America	New Haven	Large parking lot, buried roof leaders	Disconnect roof leaders, bioretention in existing landscaped areas.

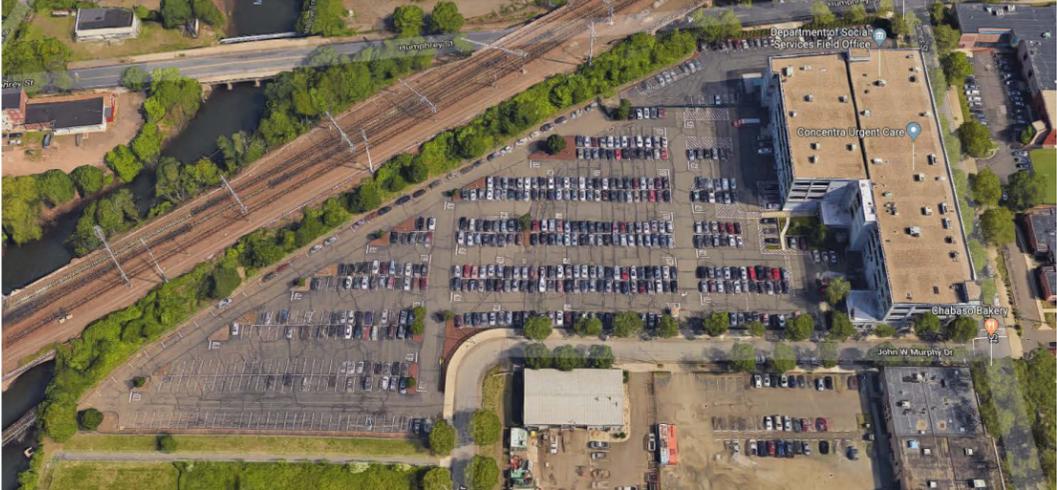
United Way	New Haven	Large parking area, landscaped islands.	Bioretention in islands.

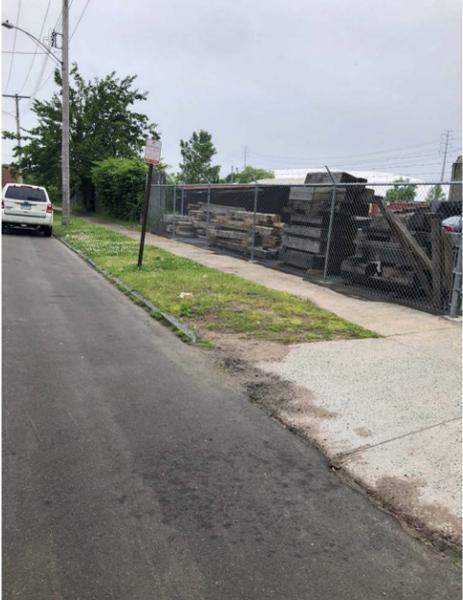
Haven Street	New Haven	Existing drainage along Haven Street captures private driveway.	Potential for bioretention to capture road runoff and stormwater from residential properties and to serve as connection to the Mill River Trail.

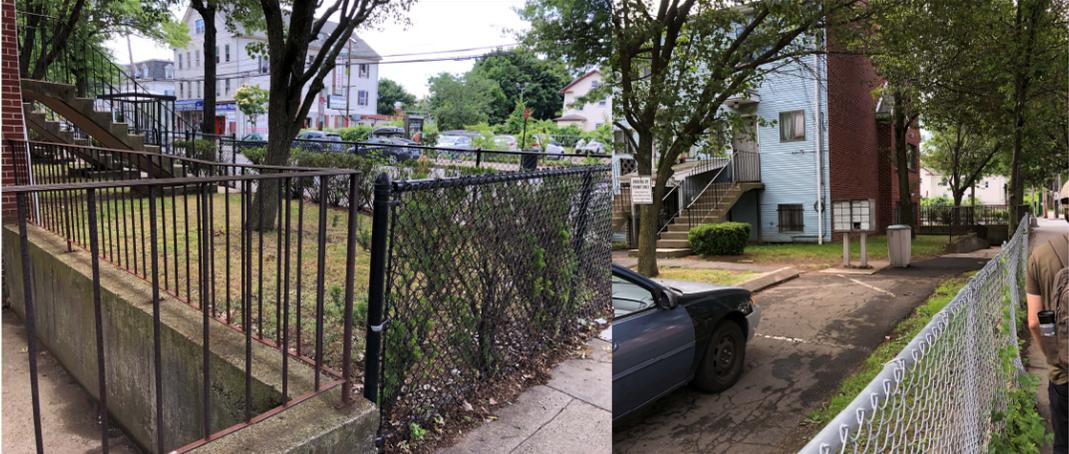
Site Location	Municipality	Existing Conditions	Recommendation	Photo
Fair P.A.C Housing	New Haven	Large parking lot and connected roof leaders	Potential for retention in the vegetated areas in the front and rear of the building

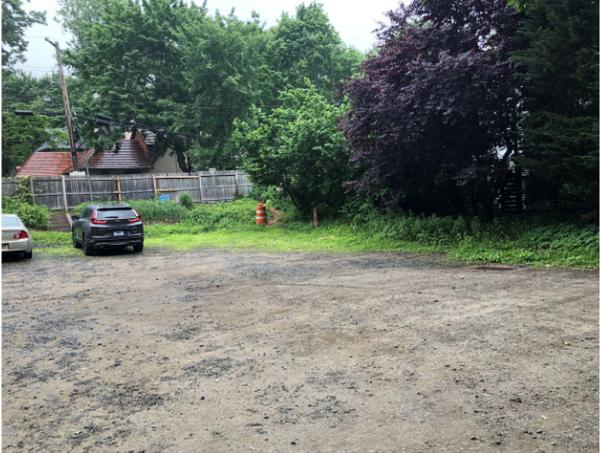
St James Unity	New Haven	Buried roof leaders, underutilized parking area.	Disconnect roof leaders, potential for pervious pavement.	
Yale Divinity	New Haven	Buried roof leaders, potential evidence of gray water from building in catch basins along driveway between Divinity School buildings and adjacent conference center. Drainage system appears to drain east towards large landscaped area and potentially out to Whitney Ave. Possible existing infiltration basins at conference center.	Potential for curb cuts to bioretention, potential for subsurface infiltration, disconnect roof leaders.	
First Unitarian Church	New Haven	Buried roof leaders, compacted gravel. Paved play area sheet flow to parking lot.	Potential for subsurface infiltration.

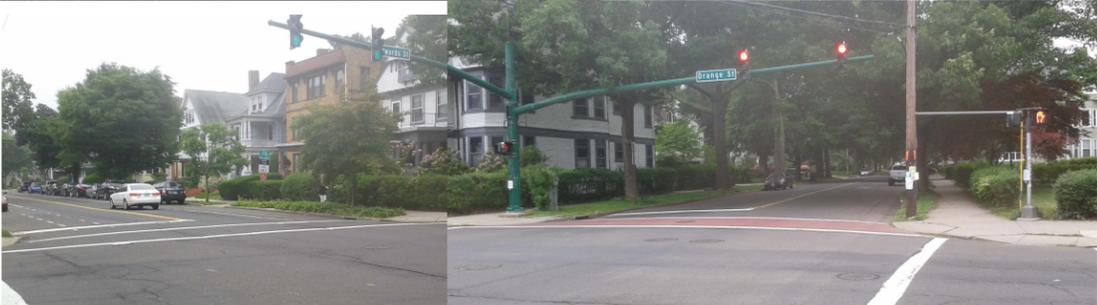
Orange/Edward Canner/Foster	New Haven	Cracking pavement. Possibly separated sewer/past CSO area. No Standing Anytime signs on all corners.	ROW bump-out bioretention or bioswale at intersection without removing on-street parking or infringing on bike lane. Potential for pervious pavers in parking/cycling lane.

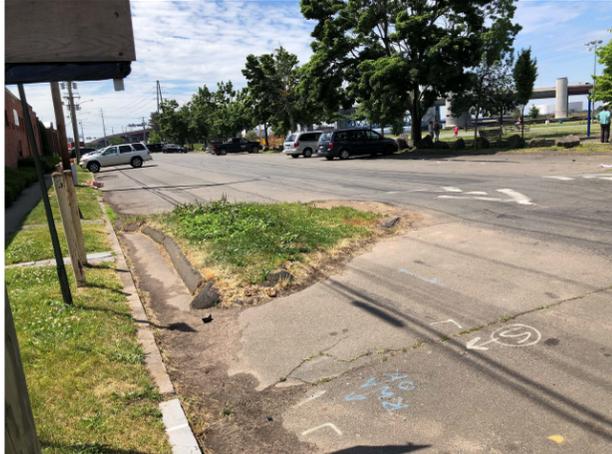
Site Location	Municipality	Existing Conditions	Recommendation	Photo
James and River Street	New Haven	Curbed bump out with gutter	Potential to retrofit bump out for use as bioswale. Location next to Criscuolo park also offers potential for education and outreach.

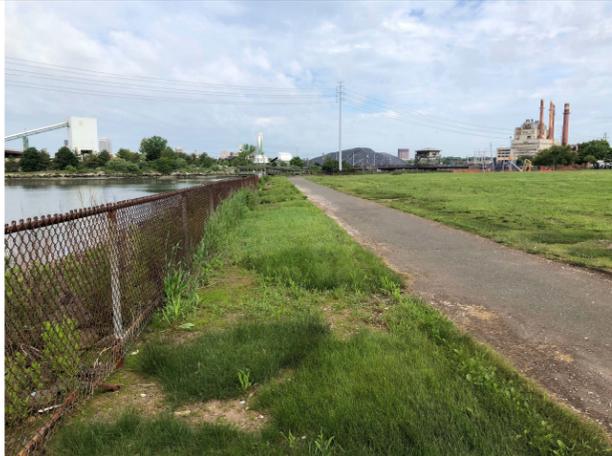
Criscuolo park	New Haven	Heavily used urban park and playing fields	Potential for riparian plantings and demonstration rain garden.
