Appendix D:
DEP Sediment Data

DATE: 09/02/03
TO: TRACI IOTT
CC: ERNIE PIZUTTO,GUY HOFFMAN, LEE DUNBAR
FROM: CHRIS BELLUCCI
RE: HEMINWAY POND SEDIMENT SAMPLING

Appendix E:
Ground Penetrating Radar Report

Subject: ENG -- Ground-Penetrating Radar (GPR) Assistance

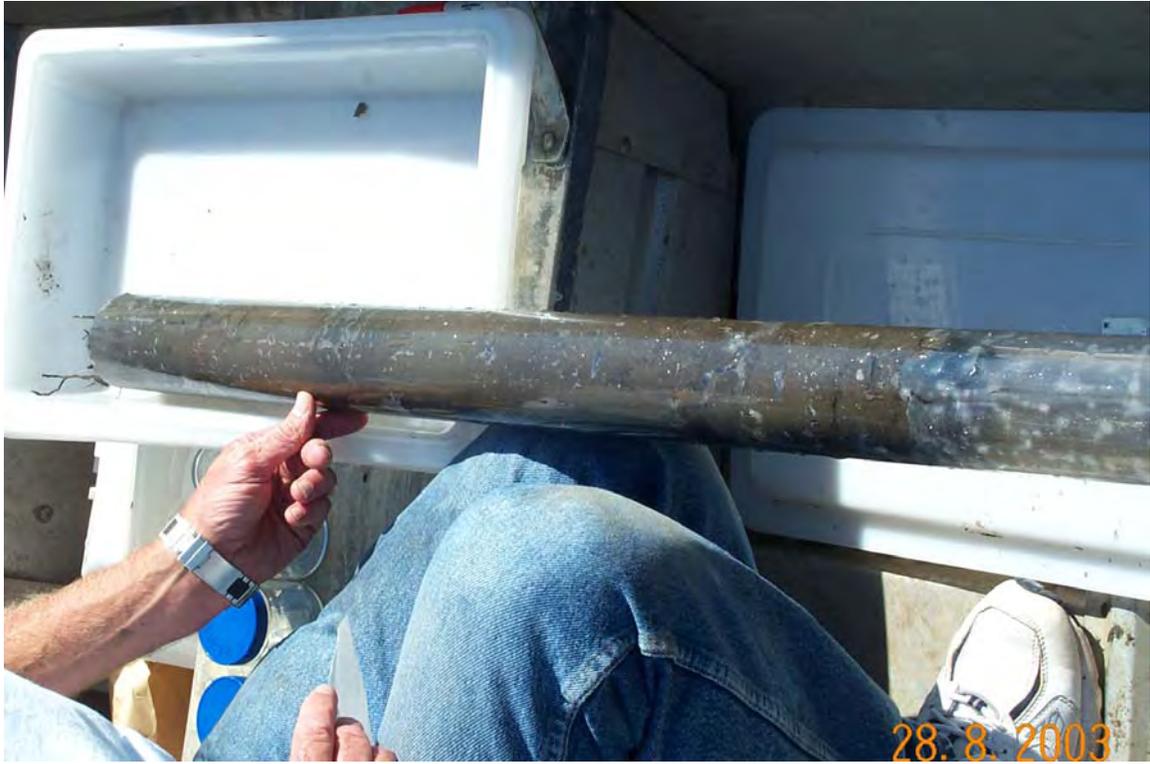
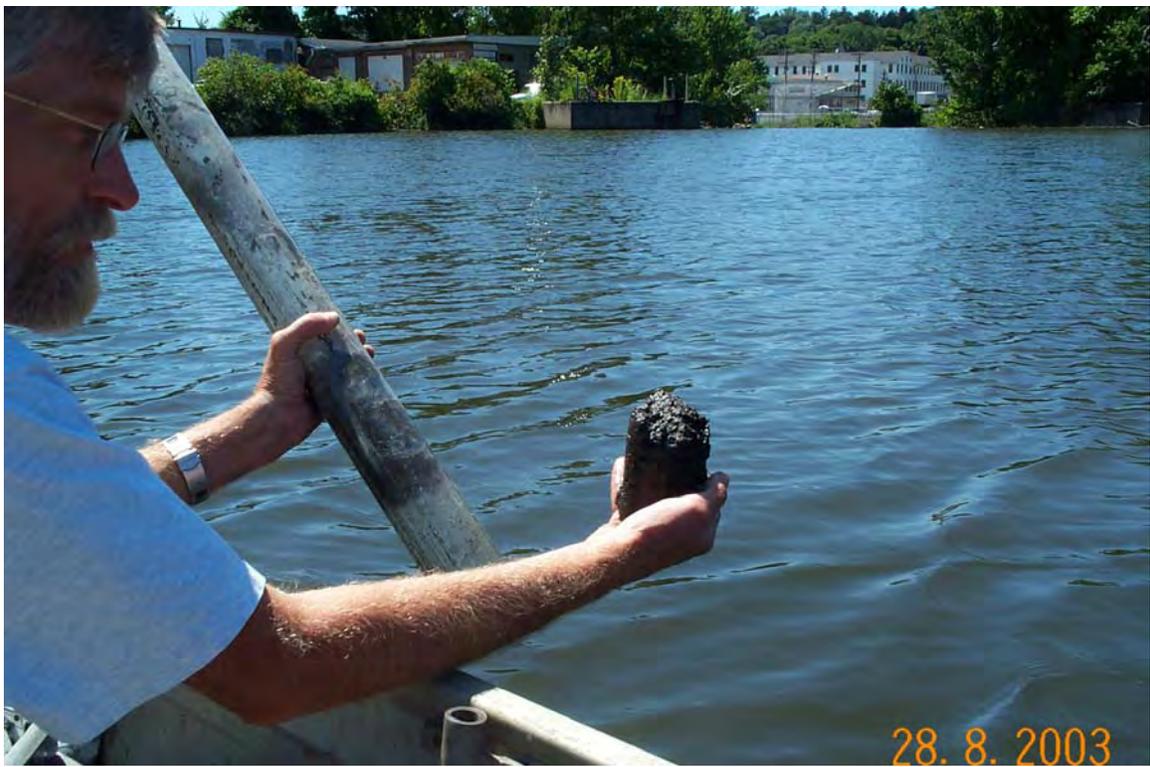
Figure 2. Sediment cores from Heminway Pond from HP 3.

Sediments were consistently fine-grained and grey black at HP1, HP2, HP3 (see Figure 2). Sediments at HP 4 were shallow and only a surface layer sample could be collected. Samples from in front of Heminway Pond dam (HP5,HP6,HP7) had noticeably more leaf and plant material and a petroleum odor with noticeable oil sheen when washed in water.
