Water Quality Investigation Summary

Contract 12-05f French River Watershed-Based Plan and Implementation Action

**Eastern Connecticut Conservation District
August 25, 2015**

Task 1d – Conduct Water Sampling

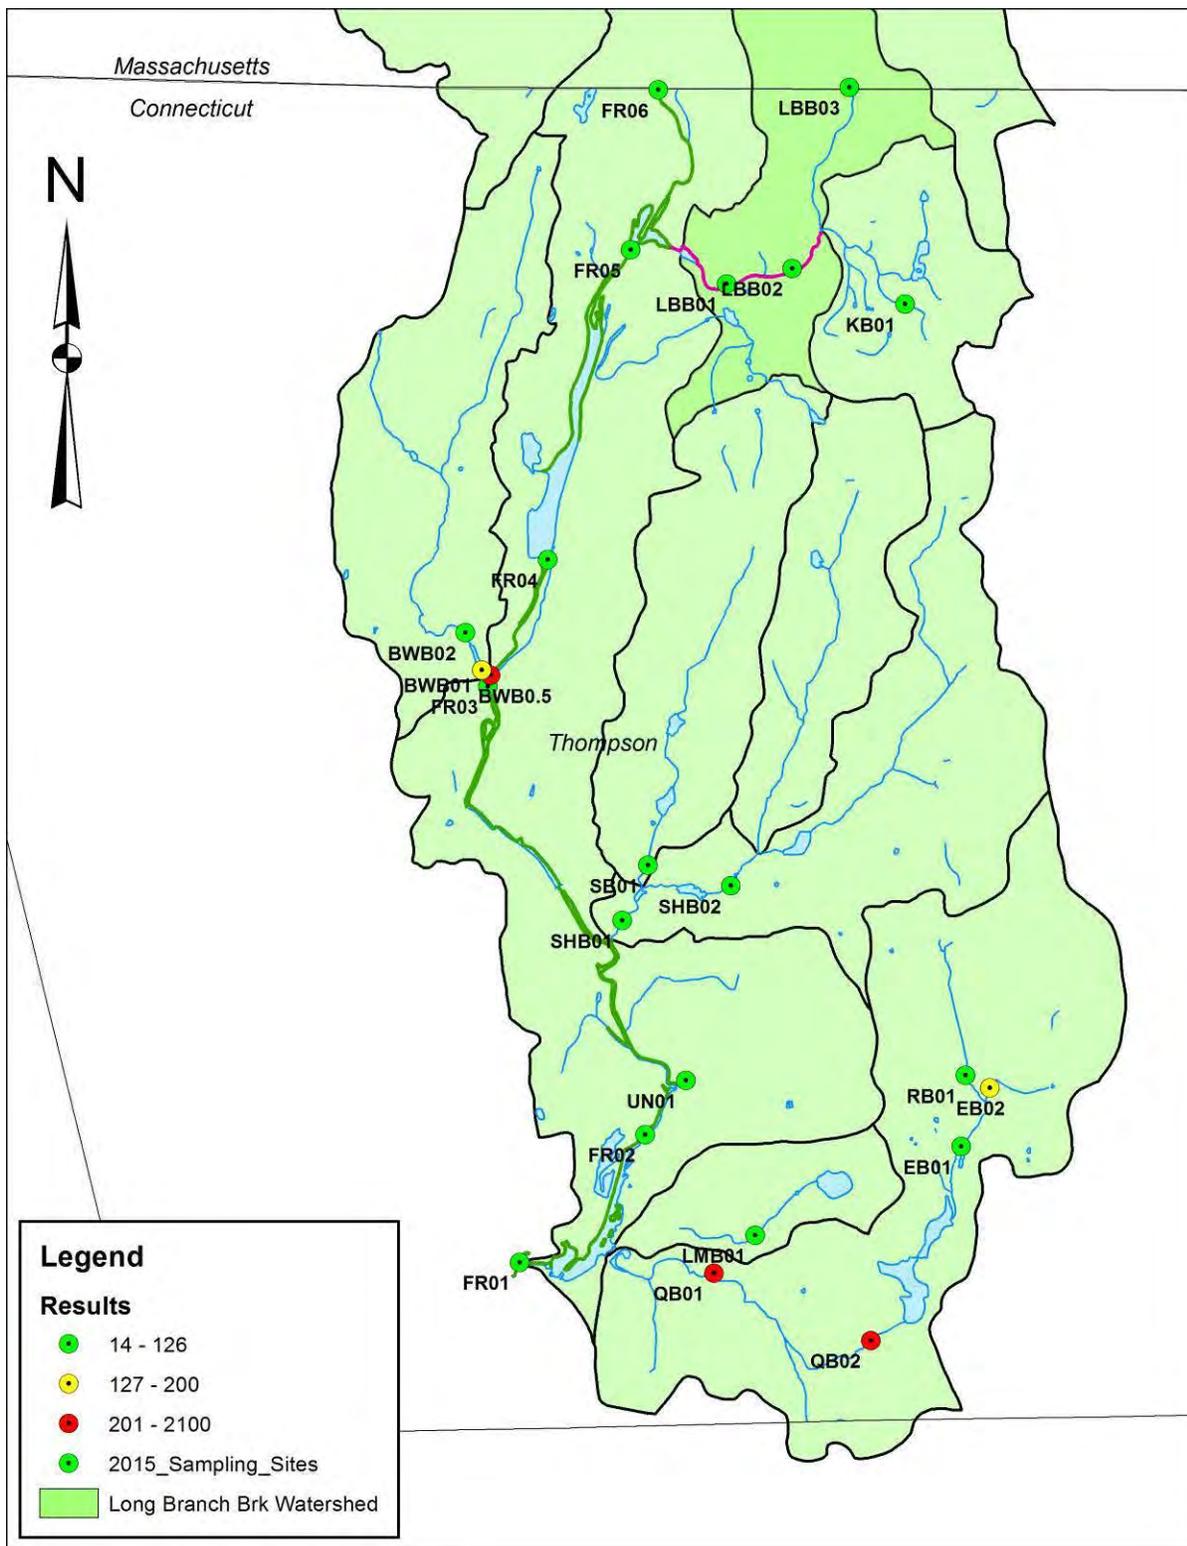
Figure 4. French River watershed bacteria sampling results. A green dot indicates the site may have had a single sample exceedance, but met established water quality criteria for the geometric mean; a yellow dot indicates that the site had no single sample exceedances but failed to meet the geometric mean criteria; and a red dot indicates the site exceeded both single sample and geometric mean criteria.

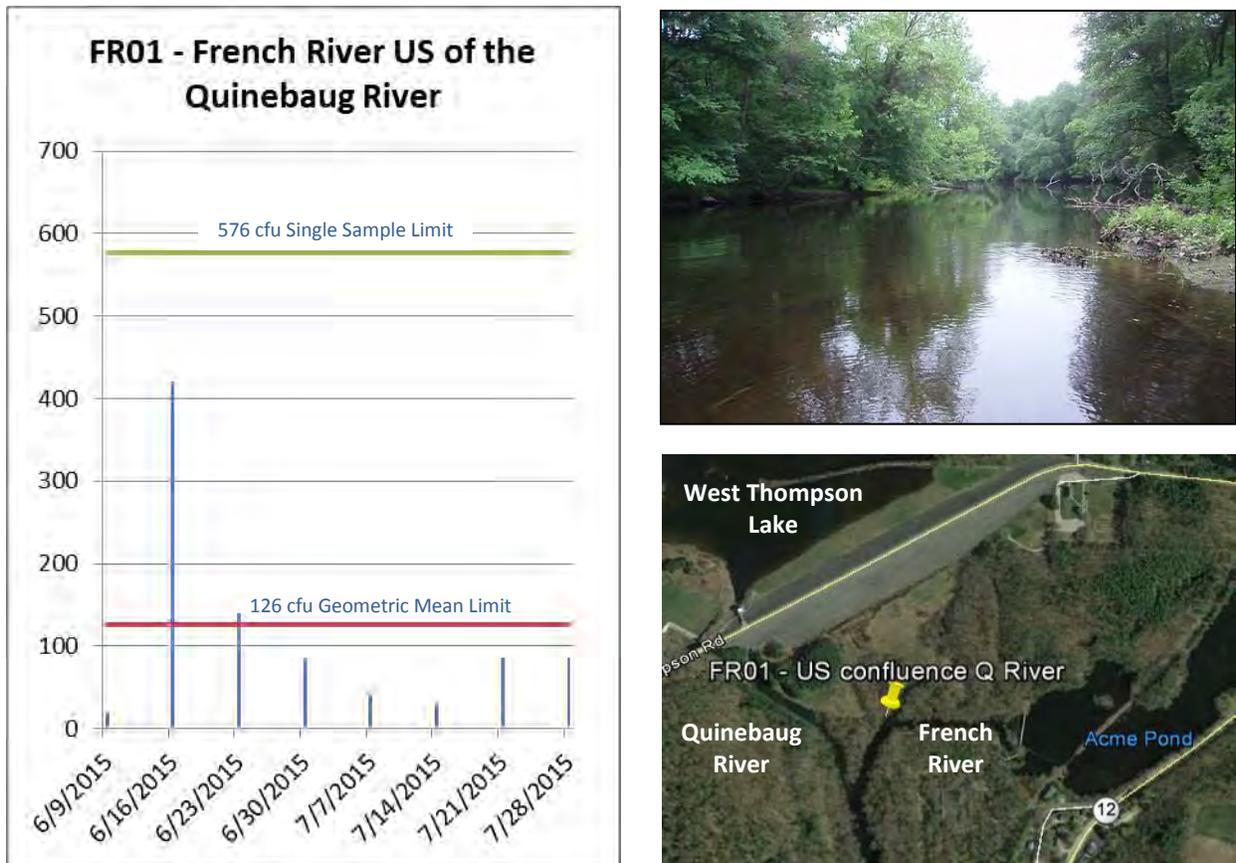
FR01 – French River upstream of the confluence with the Quinebaug River:

Figure 7. Graph of bacteria sampling results at FR01; downstream view of the French River at the sampling location; and an aerial (Google Earth) image of the sampling site location and vicinity.

Eight water samples were collected at this site. All of the samples met the single sample Connecticut water quality standard of 576 cfu/100ml. The geometric mean for this site is 74, which is within the allowable geometric mean of 126 cfu/100 ml. No bacteria reduction is required at this site.

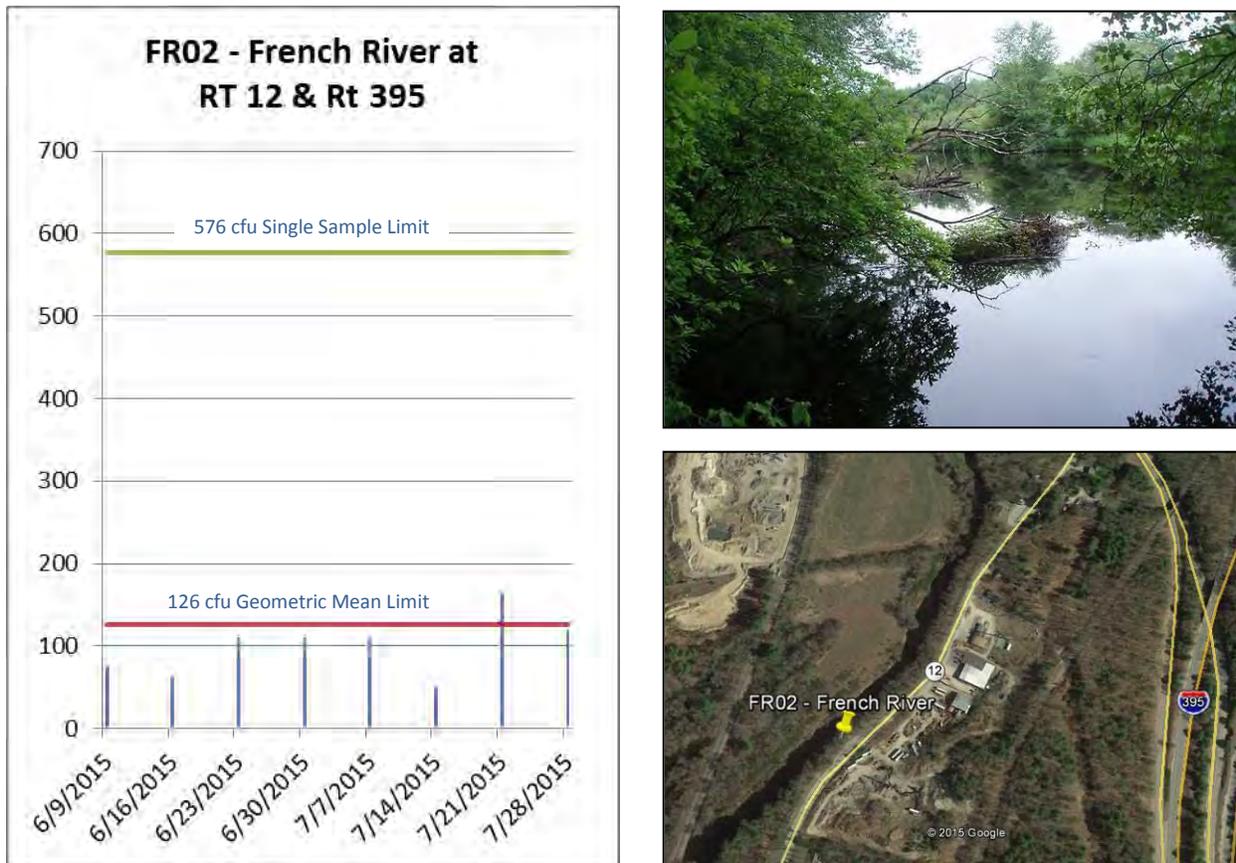
FR02 – French River at Route 12:

Figure 8. Graph of bacteria sampling results at FR02; downstream view of the French River at the sampling location; and an aerial image of the sampling site location and vicinity.

Nine water samples were collected at this site, including one duplicate sample. All of the samples (100%) met the single sample Connecticut water quality standard of 576 cfu/100ml. The geometric mean for this site is 101, which did not exceed the allowable geometric mean of 126 cfu/100 ml. No bacteria reduction is required at this site.

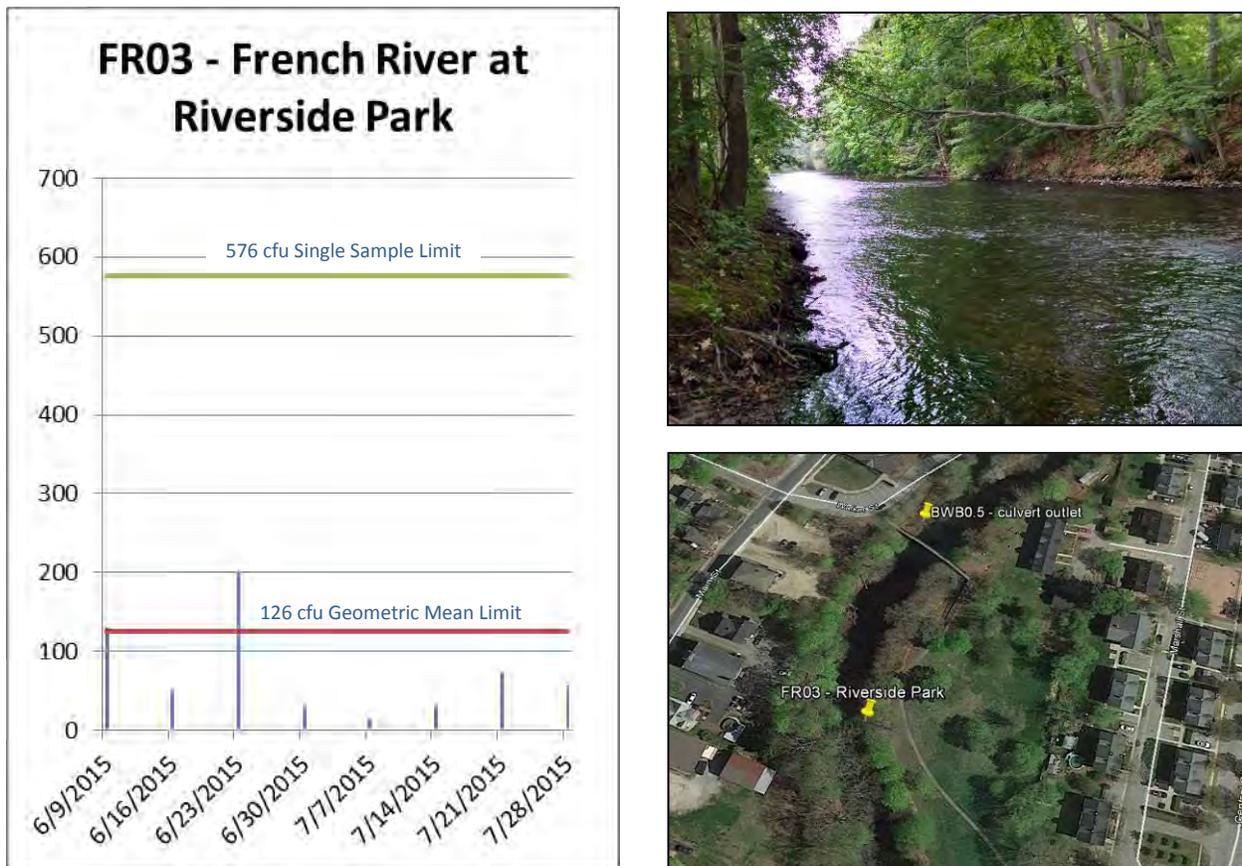
FR03 – French River at Riverside Park in North Grosvenordale:

Figure 9. Graph of bacteria sampling results at FR03; downstream view of the French River at the sampling location; and an aerial image of the sampling site location and vicinity.

Ten water samples were collected at this site, including two duplicate samples. All of the samples (100%) met the single sample Connecticut water quality standard of 576 cfu/100ml. The geometric mean for this site is 47, which is within the allowable geometric mean of 126 cfu/100 ml. No bacteria reduction is required at this site.

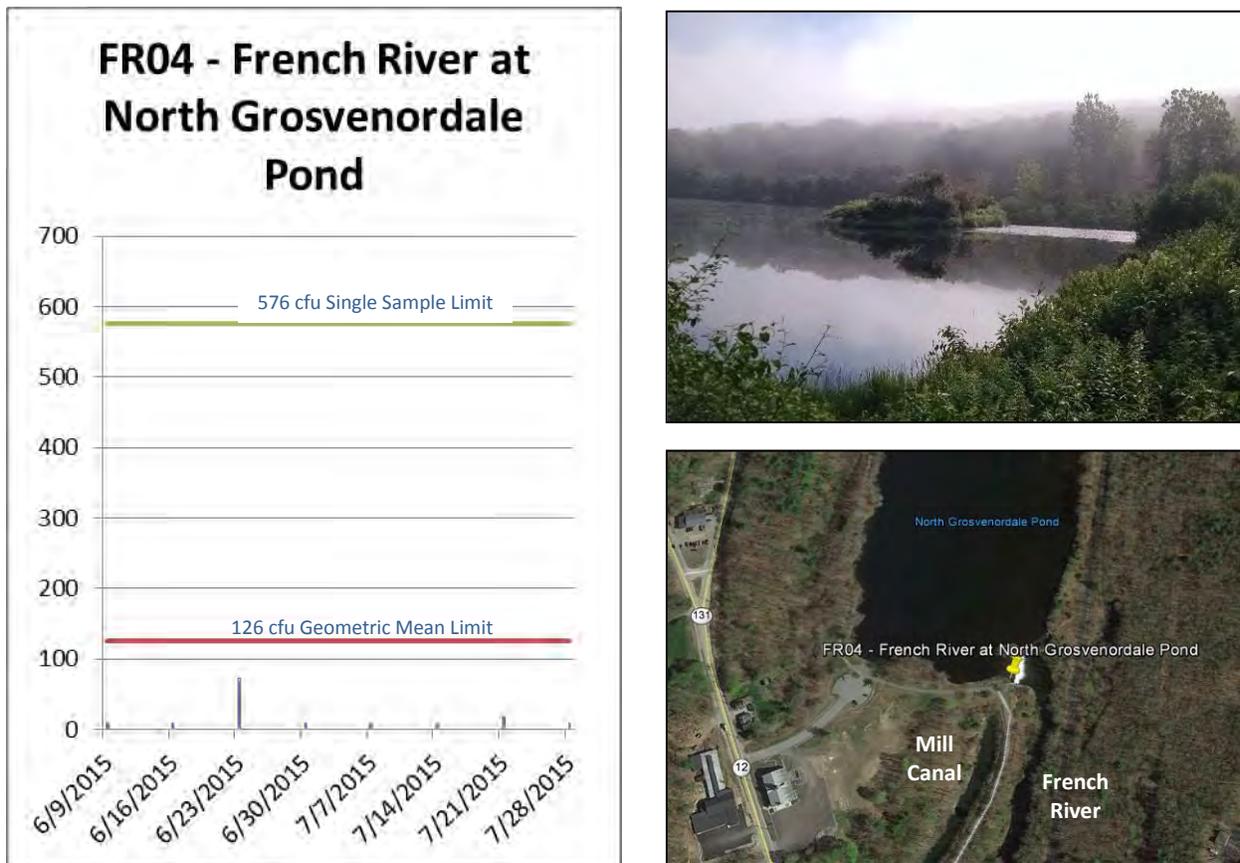
FR04 – French River at North Grosvenordale Pond:

Figure 10. Graph of bacteria sampling results at FR04; view of the sampling site at the North Grosvenordale Pond spillway; and an aerial imagery of the sampling site location and vicinity.

Eight water samples were collected at this site. All of the samples (100%) met the single sample Connecticut water quality standard of 576 cfu/100ml. The geometric mean for this site is 14, which is within the allowable geometric mean of 126 cfu/100 ml. No bacteria reduction is required at this site.

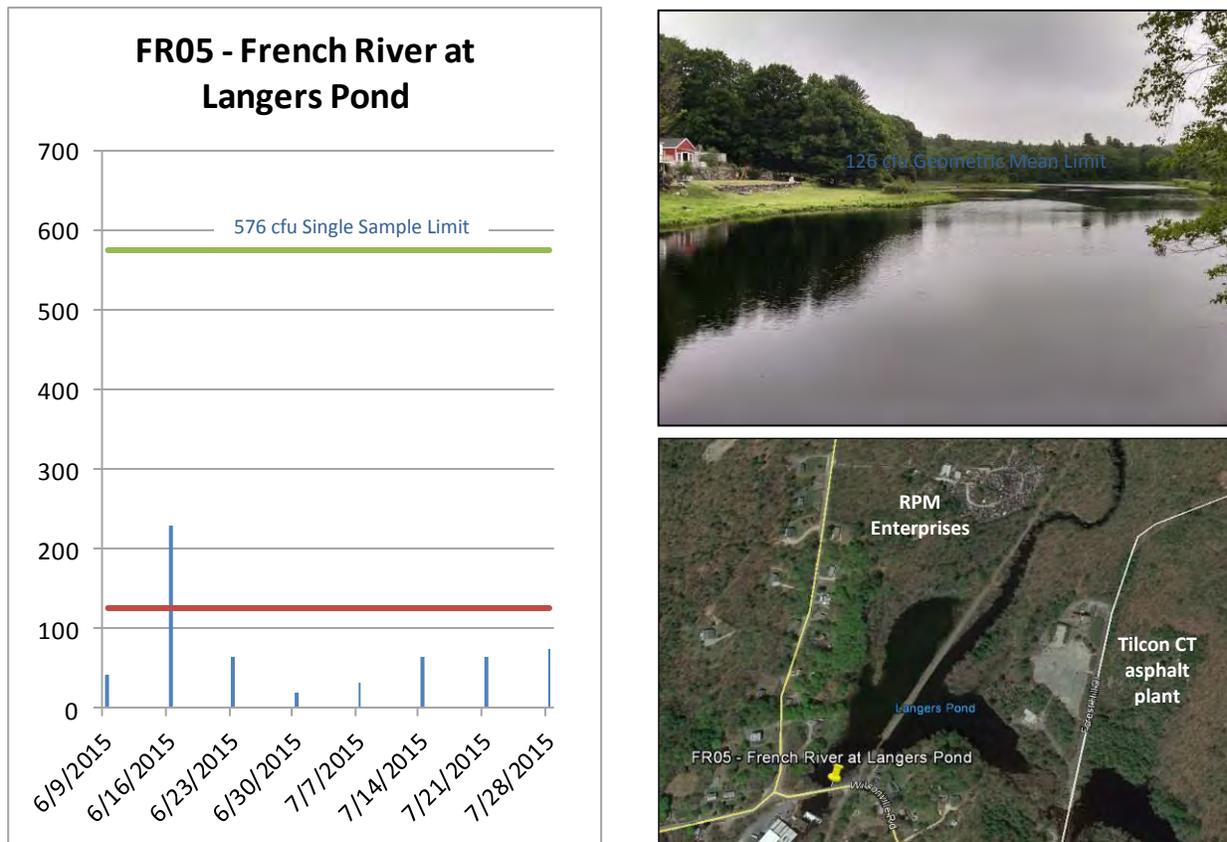
FR05 – French River at Langers Pond/Wilsonville Road:

Figure 11. Graph of bacteria sampling results at FR05; upstream view of the French River at the sampling location; and an aerial image of the sampling site location and vicinity.

Eight water samples were collected at this site. All of the samples (100%) met the single sample Connecticut water quality standard of 576 cfu/100ml. The geometric mean for this site is 57, which is within the allowable geometric mean of 126 cfu/100 ml. No bacteria reduction is required at this site.

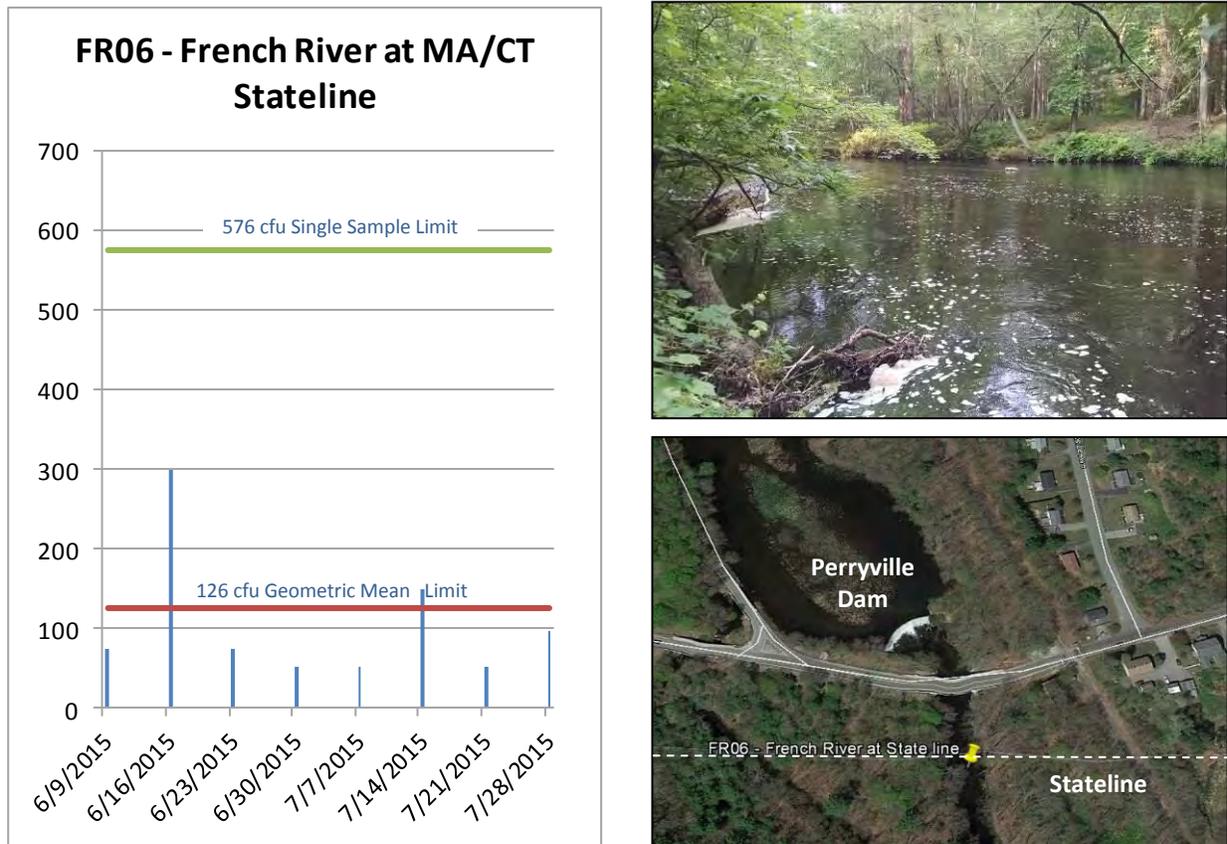
FR06 – French River near the Massachusetts State Line:

Figure 12. Graph of bacteria sampling results at FR06; downstream view of the French River at the sampling location; and an aerial image of the sampling site location and vicinity.

Eight water samples were collected at this site. All of the samples (100%) met the single sample Connecticut water quality standard of 576 cfu/100ml. The geometric mean for this site is 87, which is within the allowable geometric mean of 126 cfu/100 ml. No bacteria reduction is required at this site.

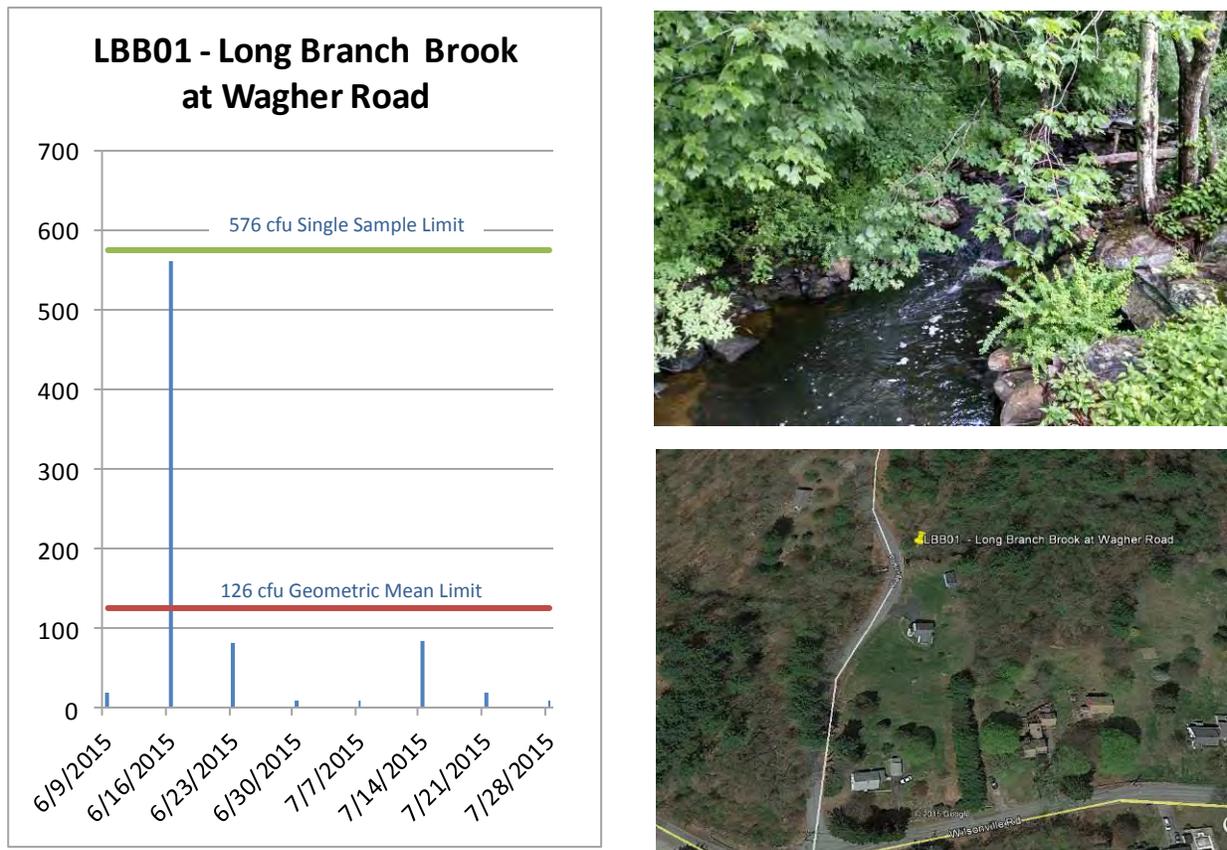
LBB01 – Long Branch Brook at Wagher Road:

Figure 13. Graph of bacteria sampling results at LBB01; upstream view of Long Branch Brook at the sampling location; and an aerial image of the sampling site location and vicinity.

Nine water samples were collected at this site, including one duplicate sample. All of the samples (100%) met the Connecticut water quality standard of 576 cfu/100ml for single samples. The geometric mean for this site is 36, which is within the allowable geometric mean of 126 cfu/100 ml. No bacteria reduction is required at this site.

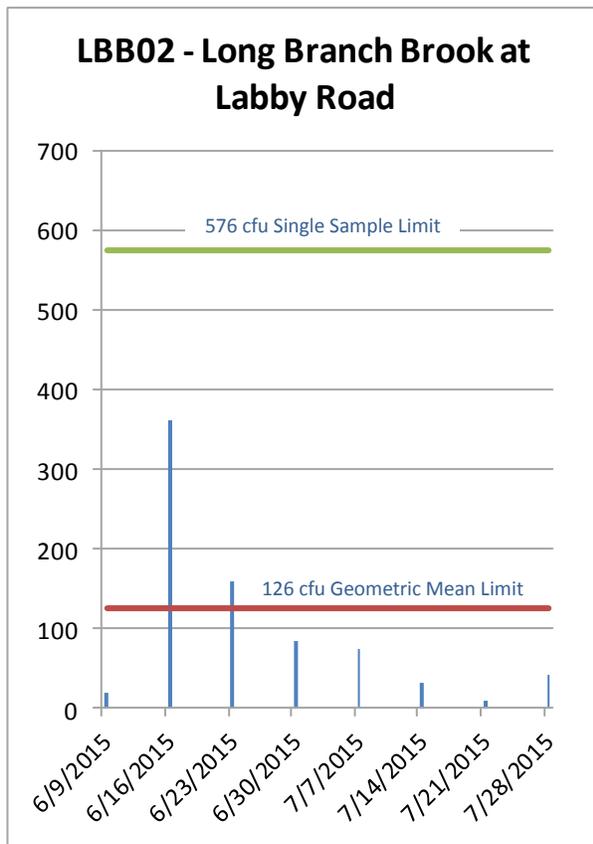
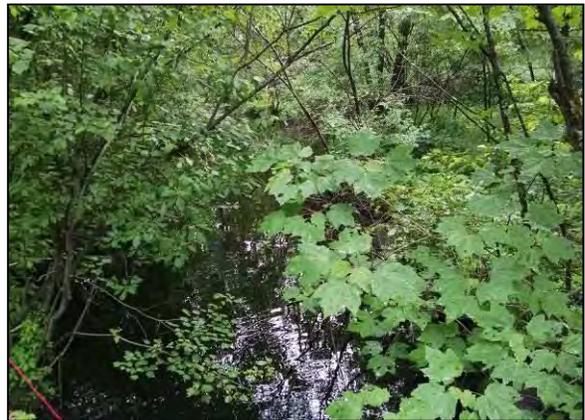
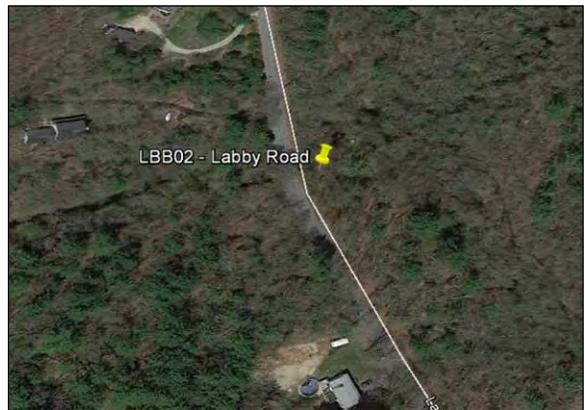
LBB02– Long Branch Brook at Labby Road:

Figure 14. Graph of bacteria sampling results at LBB02; upstream view of Long Branch Brook at the sampling location; and an aerial image of the sampling site location and vicinity.

Eight water samples were collected at this site. All the samples (100%) met the single sample Connecticut water quality standard of 576 cfu/100ml. The geometric mean for this site is 56, which is within the allowable geometric mean of 126 cfu/100 ml. No bacteria reduction is required at this site.

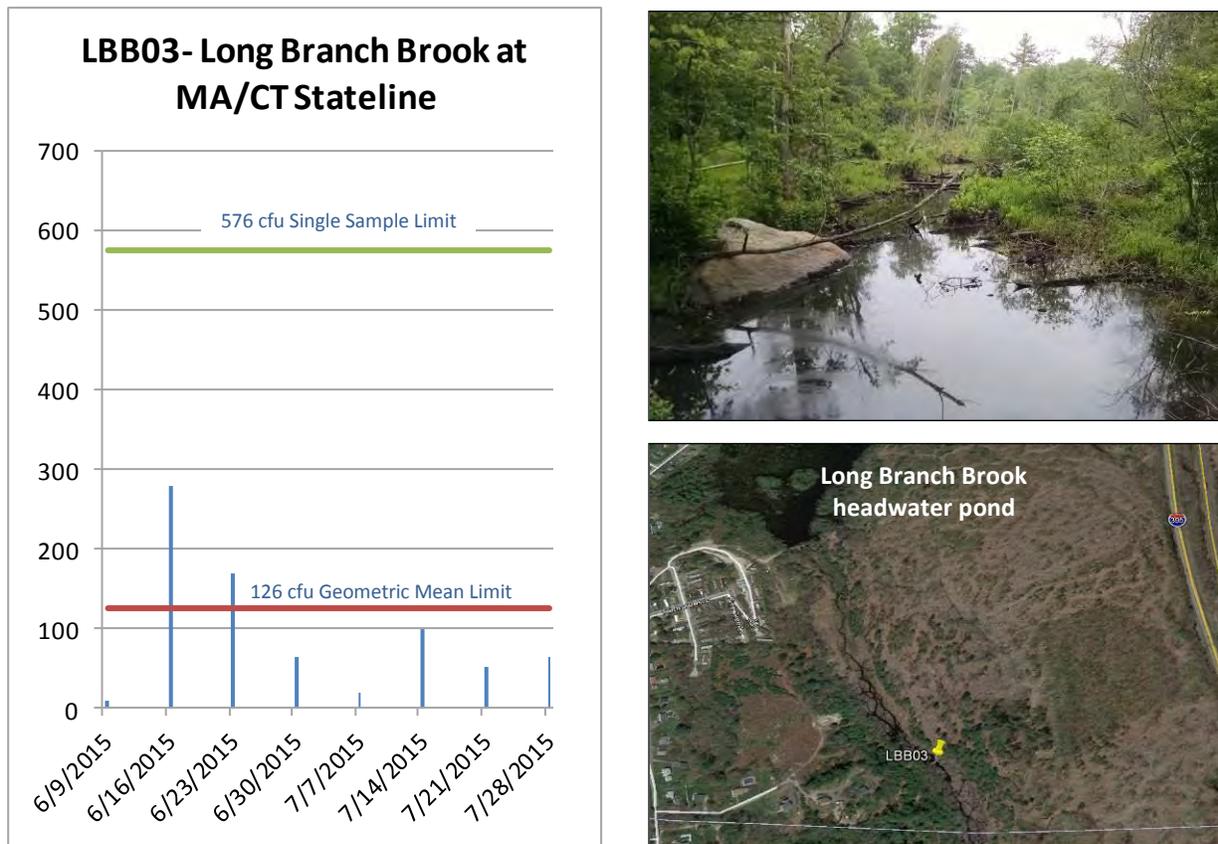
LBB03 – Long Branch Brook at the Massachusetts State Line:

Figure 15. Graph of bacteria sampling results at LBB03; downstream view of Long Branch Brook at the sampling location; and an aerial image of the sampling site location and vicinity.

Eight water samples were collected at this site. All the samples (100%) met the Connecticut water quality standard of 576 cfu/100ml for single samples. The geometric mean for this site is 61, which is within the allowable geometric mean of 126 cfu/100 ml. No bacteria reduction is required at this site.

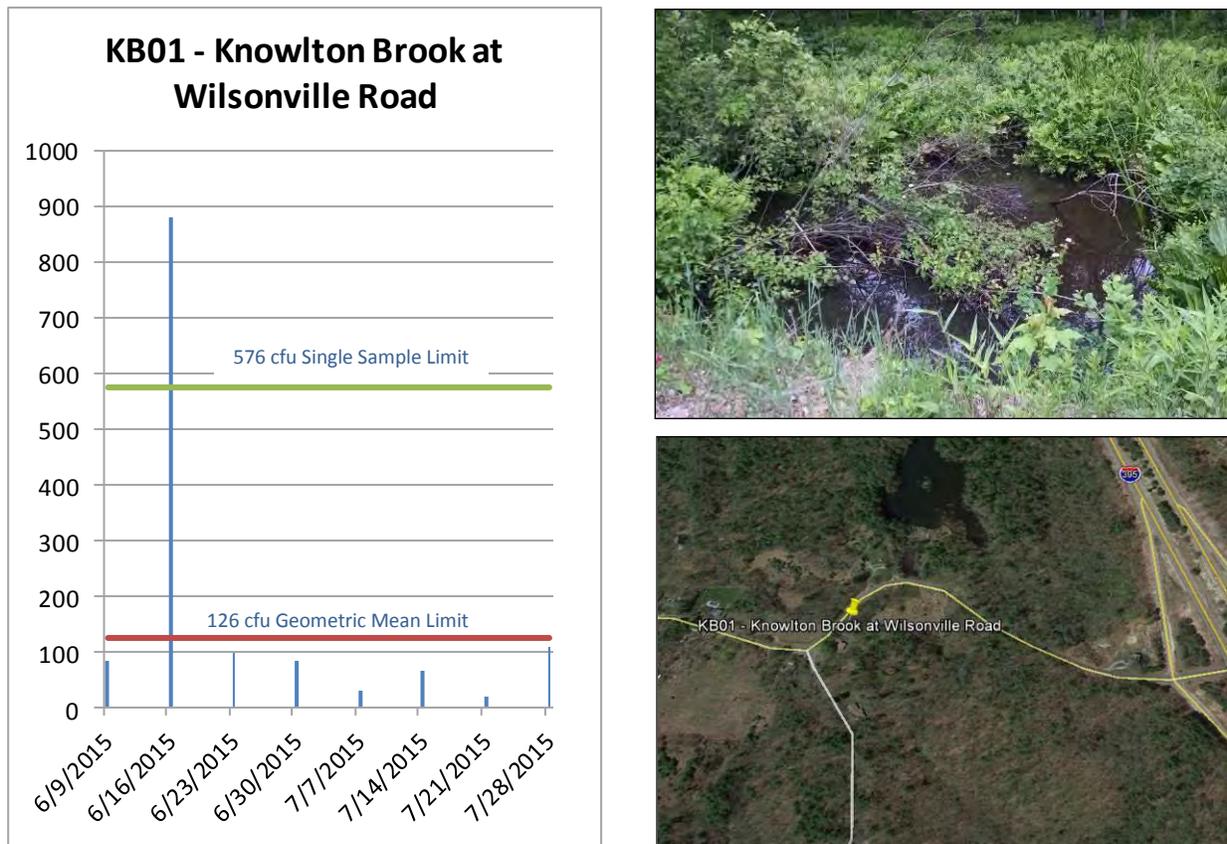
KB01 – Knowlton Brook at Wilsonville Road:

Figure 16. Graph of bacteria sampling results at KB01; downstream view of Knowlton Brook at the sampling location; and an aerial image of the sampling site location and vicinity.

Nine water samples were collected at this site, including one duplicate sample. Eight samples (89%) met the Connecticut water quality standard of 576 cfu/100 ml for single samples. The geometric mean for this site is 83, which is within the allowable geometric mean of 126 cfu/100 ml. No bacteria reduction is required at this site.

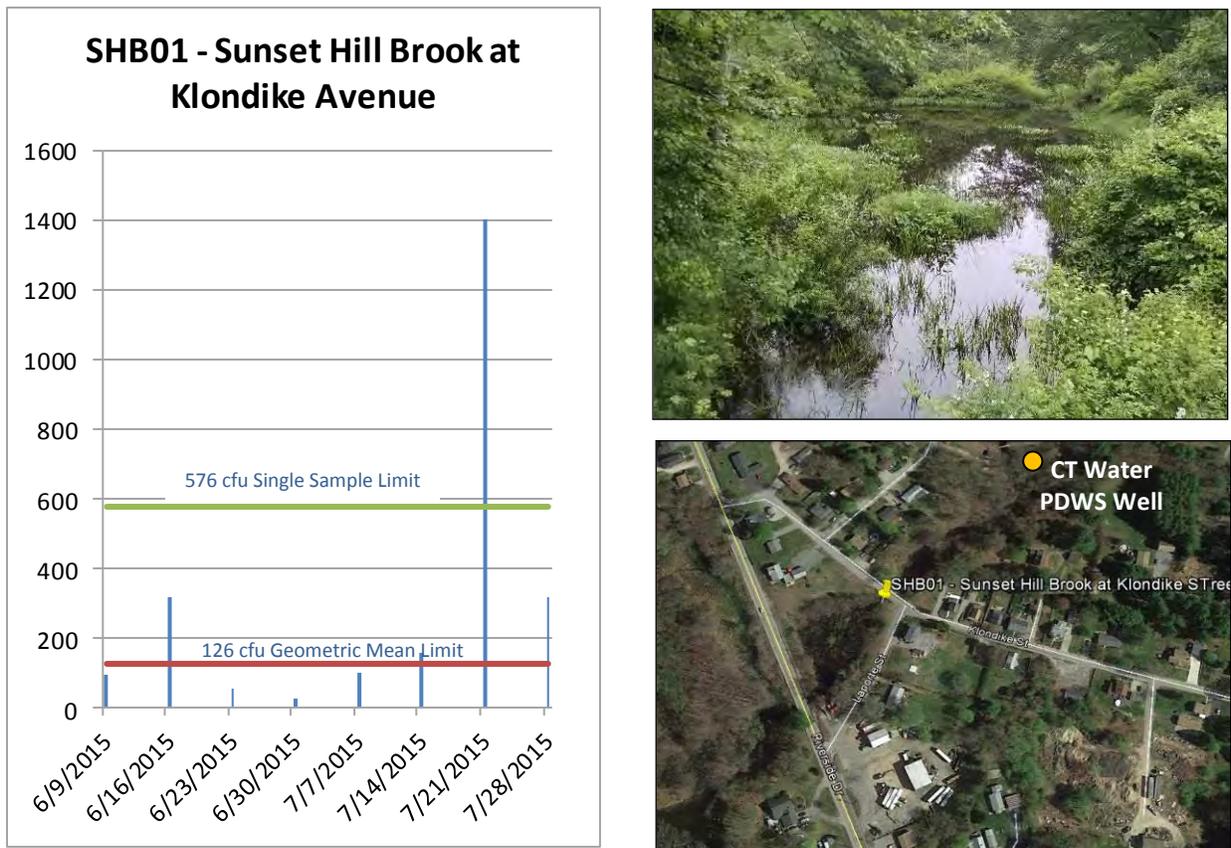
SHB01– Sunset Hill Brook at Klondike Avenue:

Figure 17. Graph of bacteria sampling results at SHB01; view of Sunset Hill Brook upstream of the sampling site; and an aerial image of the sampling site location and vicinity.

Nine water samples were collected at this site, including one duplicate sample. Eight of the samples (89%) met Connecticut water quality standard of 576 cfu/100 ml for single samples. The geometric mean for this site is 124, which is within the allowable geometric mean of 126 cfu/100 ml. No bacteria reduction is required at this site.

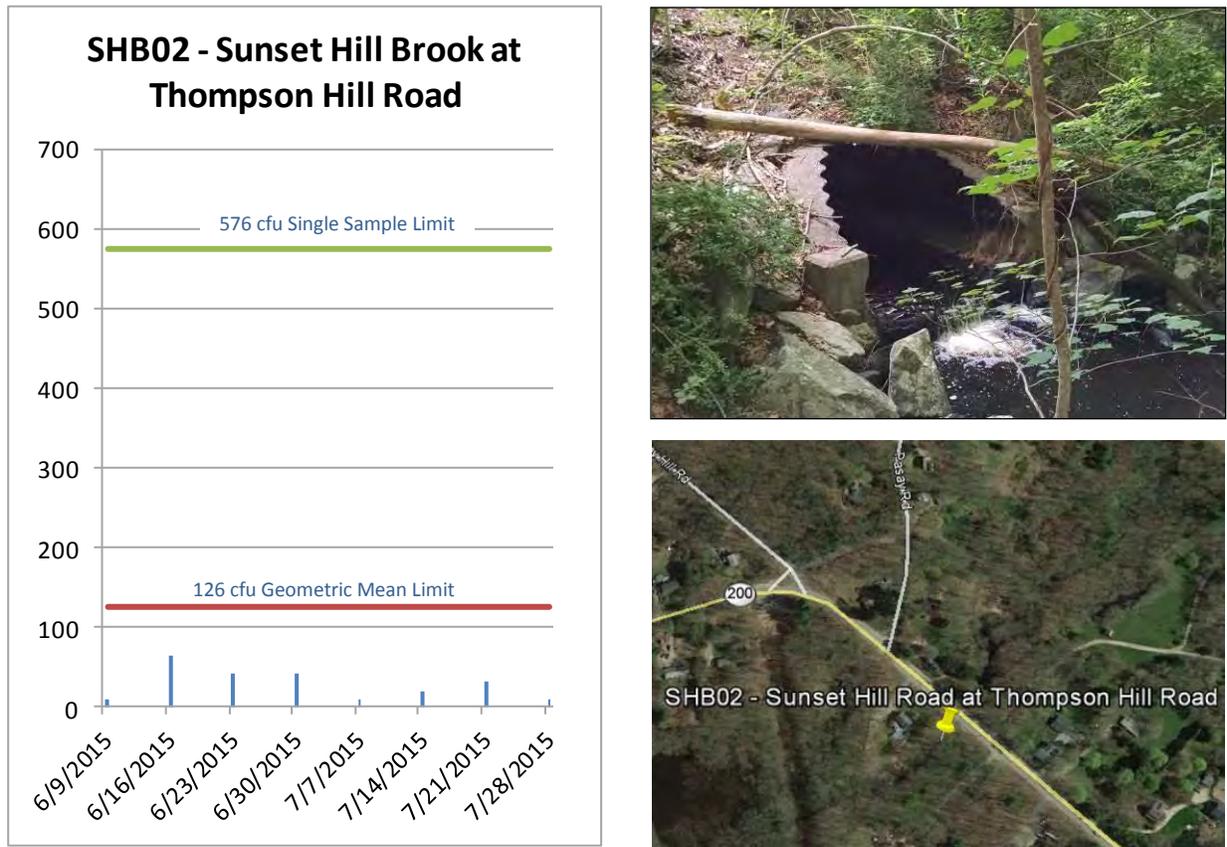
SHB02 – Sunset Hill Brook at Thompson Hill Road (State Route 200):

Figure 18. Graph of bacteria sampling results at SHB02; view of the culvert at the sampling location that conveys Sunset Hill Brook under Thompson Hill Road; and an aerial image of the sampling site location and vicinity.

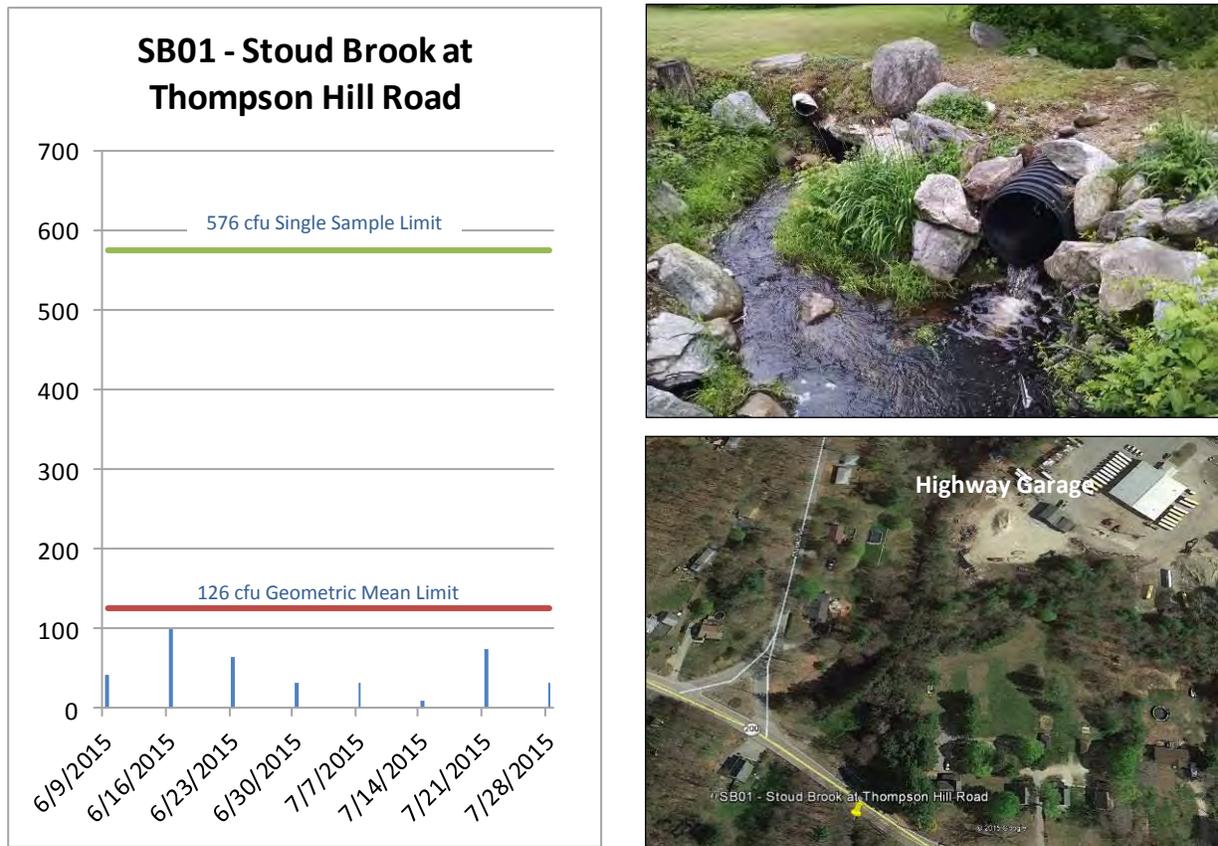
SB01 – Stoud Brook at Thompson Hill Road (State Route 200):

Figure 19. Graph of bacteria sampling results at SB01; view of Stoud Brook upstream of the sampling location; and an aerial image of the sampling site location and vicinity.

SB01 is located at the crossing of Stoud Brook at Thompson Hill Road (State Route 200), in a rural residential neighborhood. It is approximately 500 feet downstream of the Thompson Highway garage. There is a small impoundment approximately 100 feet upstream of the sampling site and a larger impoundment approximately 1250 feet upstream of the sampling site. This site was selected to isolate bacteria levels in Stoud Brook from composite water bacteria levels at SHB01, 1500 feet downstream.

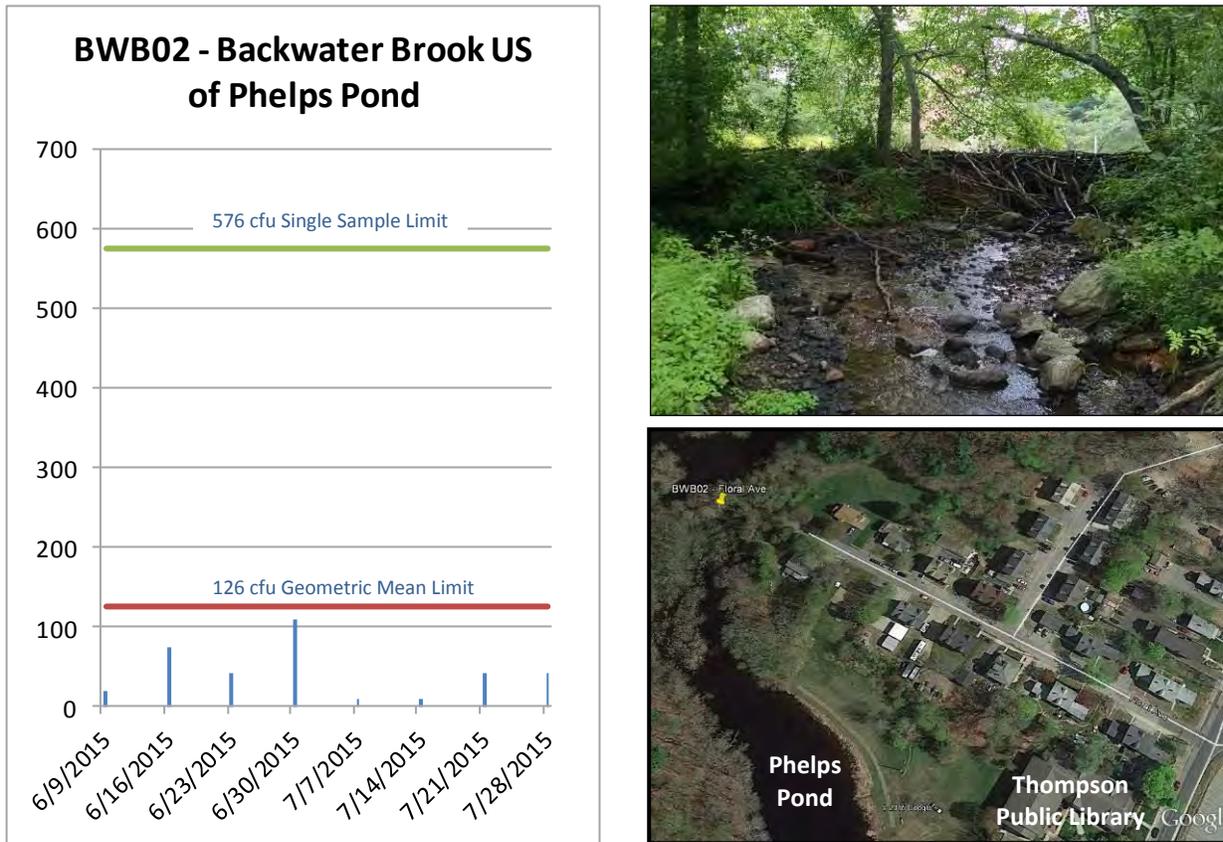
BWB02 – Backwater Brook upstream of Phelps Pond:

Figure 22. Graph of bacteria sampling results at BWB02; view of a beaver dam on Backwater Brook upstream of the sampling location; and an aerial image of the sampling site location and vicinity.

BWB02 is located on Backwater Brook approximately 300 feet upstream of Phelps Pond, off the end of Floral Avenue. This site is located upstream of dense residential development and was selected to bracket water quality observations at BWB01. The watershed upstream of BWB01 is primarily forested with scattered rural residential development.

Eight water samples were collected at this site. All the samples (100%) met Connecticut water quality standard of 576 cfu/100 ml for single samples. The geometric mean for this site is 32, which is within the allowable geometric mean of 126 cfu/100 ml. No bacteria reduction is required at this site.

A second sampling location on Backwater Brook, BWB02, upstream of Phelps Pond, was selected to bracket potential impacts of waterfowl known to utilize the pond for foraging and nesting, and to establish water quality upstream of the municipal sewer service area. Bacteria levels at this site were very low (geomean = 32), indicating that upstream bacteria contributions were insignificant.

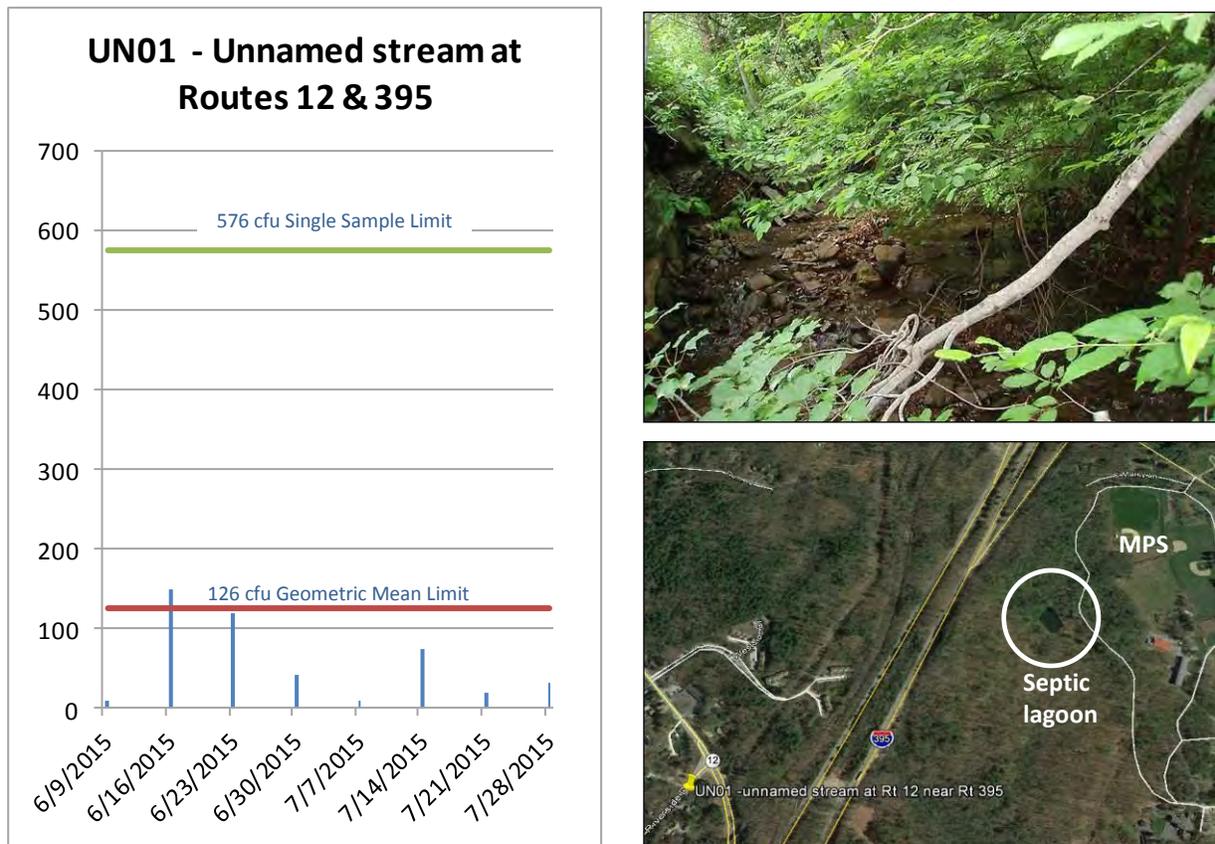
UN01 – Unnamed stream at State Route 12 and Interstate Route 395:

Figure 23. Graph of bacteria sampling results at UN01; view of the unnamed stream upstream of the sampling location; and an aerial image of the sampling site location and vicinity.

UN01 is located on an unnamed stream that originates at the Marianapolis Preparatory School (MPS) property on Thompson Hill, approximately 2700 feet upstream. This stream is suspected of periodically receiving effluent from a septic lagoon. Connection of MPS to the municipal sewer system was underway at the time of this water quality investigation. This stream also receives stormwater runoff from an off-ramp of Interstate Route 395.

Eight water samples were collected at this site. All the samples (100%) met Connecticut water quality standard of 576 cfu/100 ml for single samples. The geometric mean for this site is 37, which is within the allowable geometric mean of 126 cfu/100 ml. No bacteria reduction is required at this site.

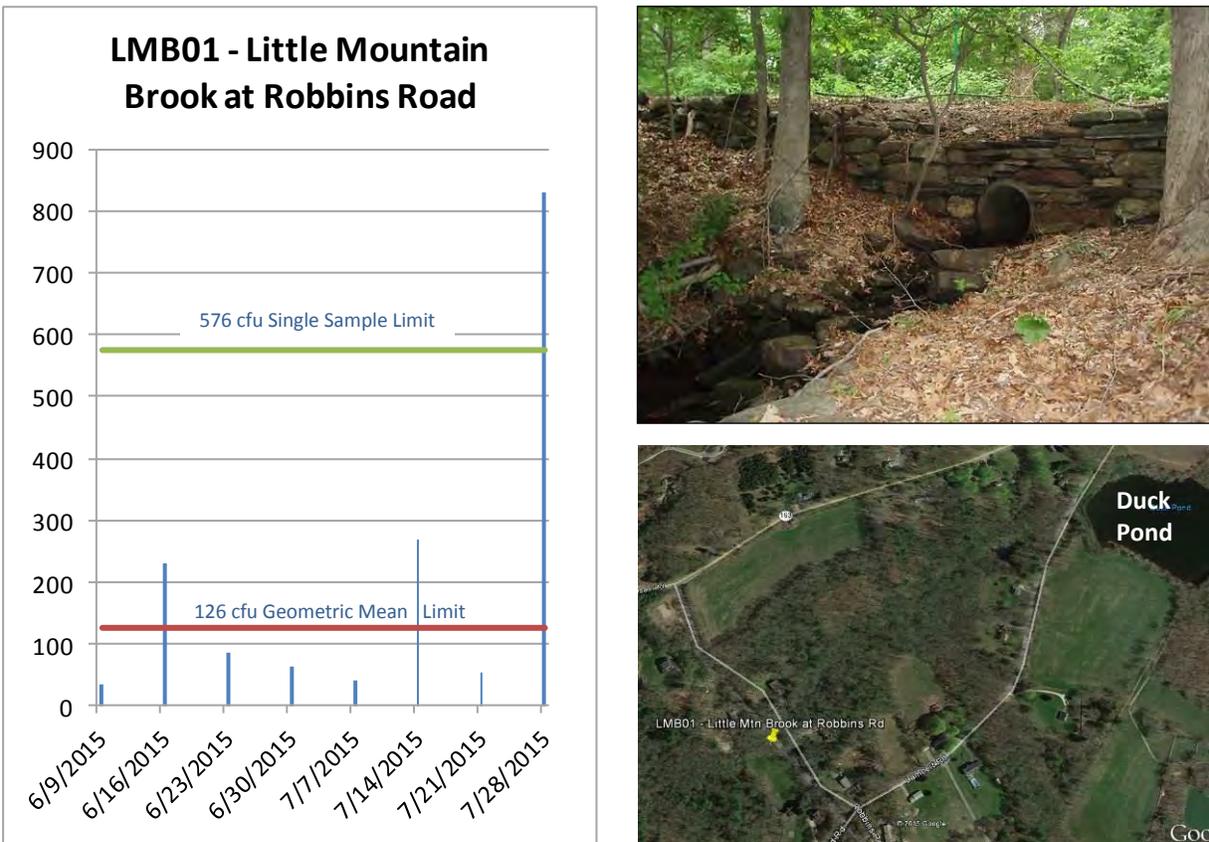
LMB01 – Little Mountain Brook at Robbins Road:

Figure 24. Graph of bacteria sampling results at LMB01; view of Little Mountain Brook at the sampling location; and an aerial image of the sampling site location and vicinity.

LMB01 is located on Little Mountain Brook downstream of the Robbins Road crossing. Little Mountain Brook originates in a small pond known locally as Duck Pond. Land use in the vicinity of Duck Pond and Little Mountain Brook is a mix of hayfields and rural residential development. This site was selected to quantify bacteria levels in Little Mountain Brook prior to its discharge to the French River.

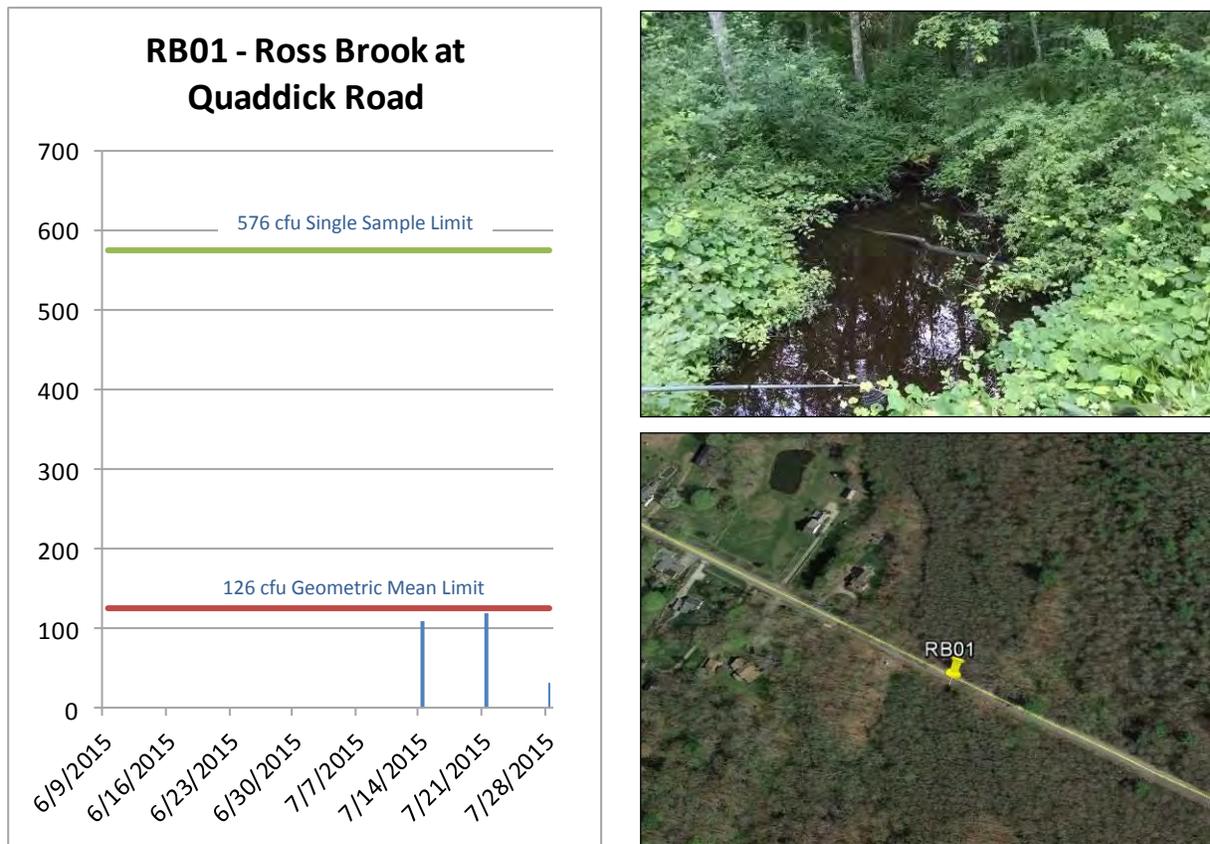
RB01 – Ross Brook at Quaddick Road:

Figure 27. Graph of bacteria sampling results at RB01; downstream view of Ross Brook at the sampling location; and an aerial image of the sampling site location and vicinity.

RB01 is located on Ross Brook at the crossing of Quaddick Road, at the southern end of an extensive red maple wetland known locally as Thompson Meadows. This site was added in week six of sampling to bracket bacteria levels that were documented at QB01, and to isolate potential bacteria sources from nearby Elliott Brook (Ross Brook and Elliott Brook merge a short distance downstream of this site and flow into Reams Pond). There is scattered rural development upstream of this site.

Three water samples were collected at this site. All the samples (100%) met Connecticut water quality standard of 576 cfu/100 ml for single samples. The geometric mean for this site is 74, which is within the allowable geometric mean of 126 cfu/100 ml. No bacteria reduction is required at this site. It should be noted that only three samples were collected from this site during the sampling period, which does not constitute a reliable sample set.
