Water Quality Investigation Summary

Contract 12-05f French River Watershed-Based Plan and Implementation Action

**Eastern Connecticut Conservation District
August 25, 2015**

Task 1d – Conduct Water Sampling

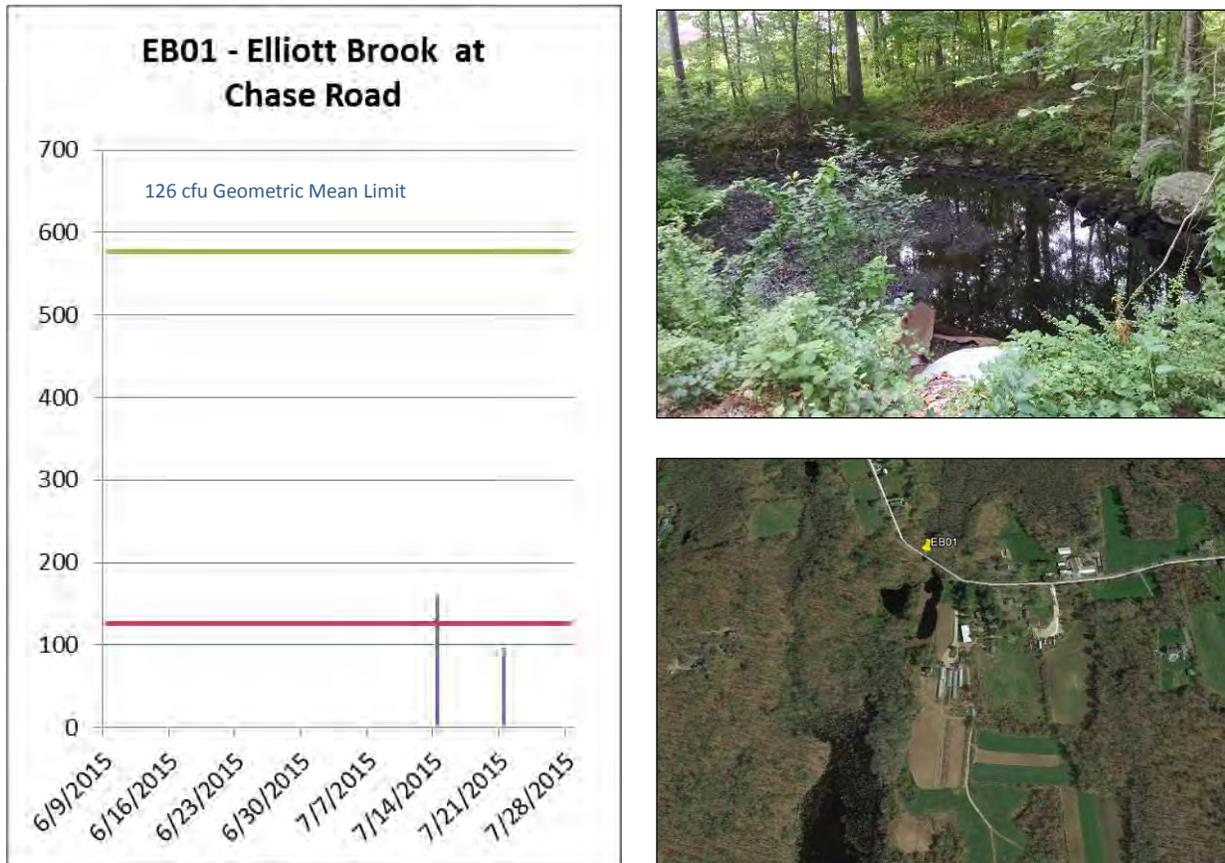
EB01 – Elliott Brook at Chase Road:

Figure 28. Graph of bacteria sampling results at EB01; view of Elliott Brook at the sampling location; and an aerial image of the sampling site location and vicinity.

EB01 is located at the crossing of Chase Road. This site was added in week six of sampling to bracket bacteria levels that were documented at QB01. This site is located downstream of the confluence of Elliott Brook and Ross Brook.

Two samples were collected at this site. Both samples (100%) met Connecticut water quality standard of 576 cfu/100 ml for single samples. The geometric mean for this site is 125, which is within the allowable geometric mean of 126 cfu/100 ml. No bacteria reduction is required at this site. It should be noted that only two samples were collected from this site during the sampling period, and do not constitute a reliable sample set.

Sampling site EB01, located on Elliott Brook at Chase Road, is upstream of the golf course and the agricultural land, and was selected to bracket potential bacteria contributions from those two land uses. The area upstream of EB01 is a forested wetland, with rural residential development along the road frontage. The geometric mean at EB01 was 125 cfu/100 ml, which was within the allowable geometric mean of 126 cfu/100 ml. It should be noted that only two samples were collected at this site, and that the stream was dry on the final day of sampling.

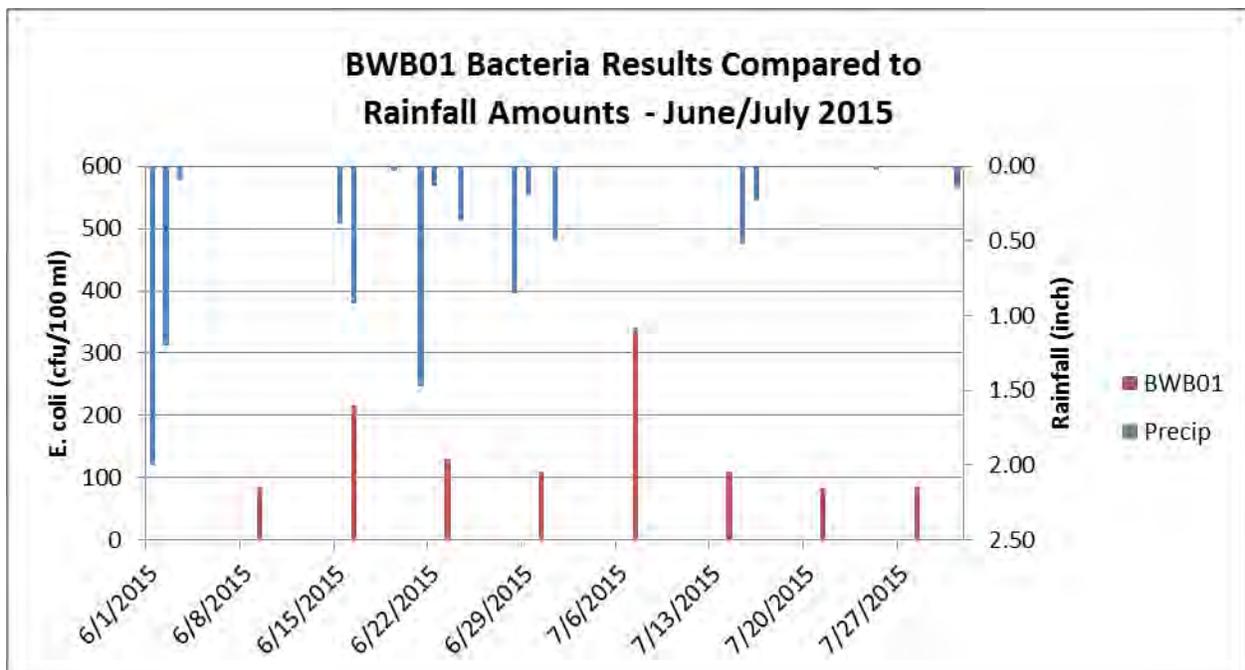
Bacteria levels at BWB01 were generally low (84 – 230 cfu/100 ml, with one higher measurement of 340 cfu/100 ml on 7/7/15). None of the samples exceeded the single sample limit of 576 cfu/100 ml. A comparison of bacteria levels at BWB01 to precipitation data collected by the Army Corps of Engineers at nearby West Thompson Lake (Fig. 30) indicates that bacteria levels spike immediately after precipitation. For example, a bacteria level of 215 (the average of 200 and 230 cfu/100 ml, the second value being a sample duplicate) was documented on 6/16/15, one day after a rainfall of 1.4 inches. In the absence of rainfall within 24 or so hours of sampling, bacteria levels in the stream water were generally low, indicating that stormwater runoff may be the primary vector for bacteria transport to Backwater Brook. The exception to this observation is a somewhat aberrant bacteria level of 340 cfu/100 ml collected on 7/7/15, during a period of dry weather. This value may be reflective of a bacteria plug from Phelps Pond due to waterfowl activity or other disturbance, or may be the result of sampling error. It should be noted that several domestic ducks were observed being kept at a property immediately upstream of the sampling site.

Figure 30. Comparison of bacteria levels at BWB01 (Backwater Brook downstream of Phelps Pond) to occurrence of rainfall.

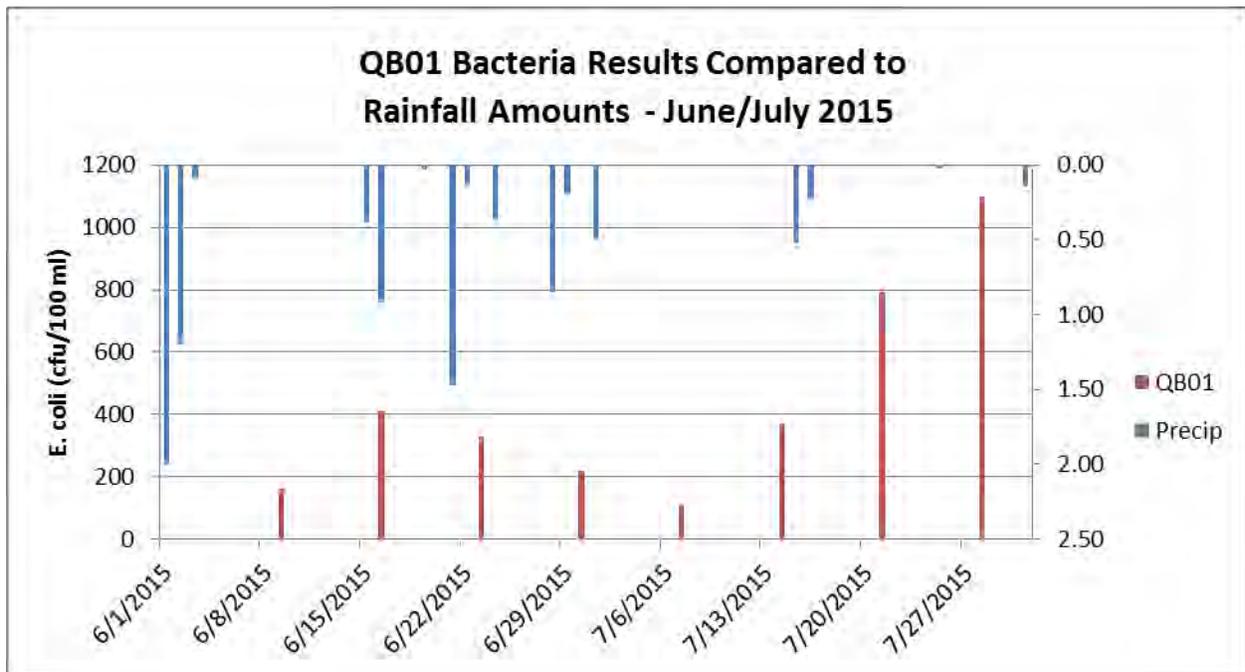
Bacteria levels in Quinatissett Brook at Ballard Road (QB01) were generally higher than those observed at other sites in the French River watershed (Table 1), and dry weather samples collected on July 21st and 28th exceeded the single sample limit (Fig. 32). Typically, dry weather bacteria spikes indicate point sources, illicit discharges or base flow-related conditions such as

septic system failures. However, there is little nearby development, so potential sources of, or contributing to, the observed bacteria levels are not immediately apparent.

Figure 32. Comparison of bacteria levels at QB01 (Quinatissett Brook at Ballard Road) to occurrence of rainfall.

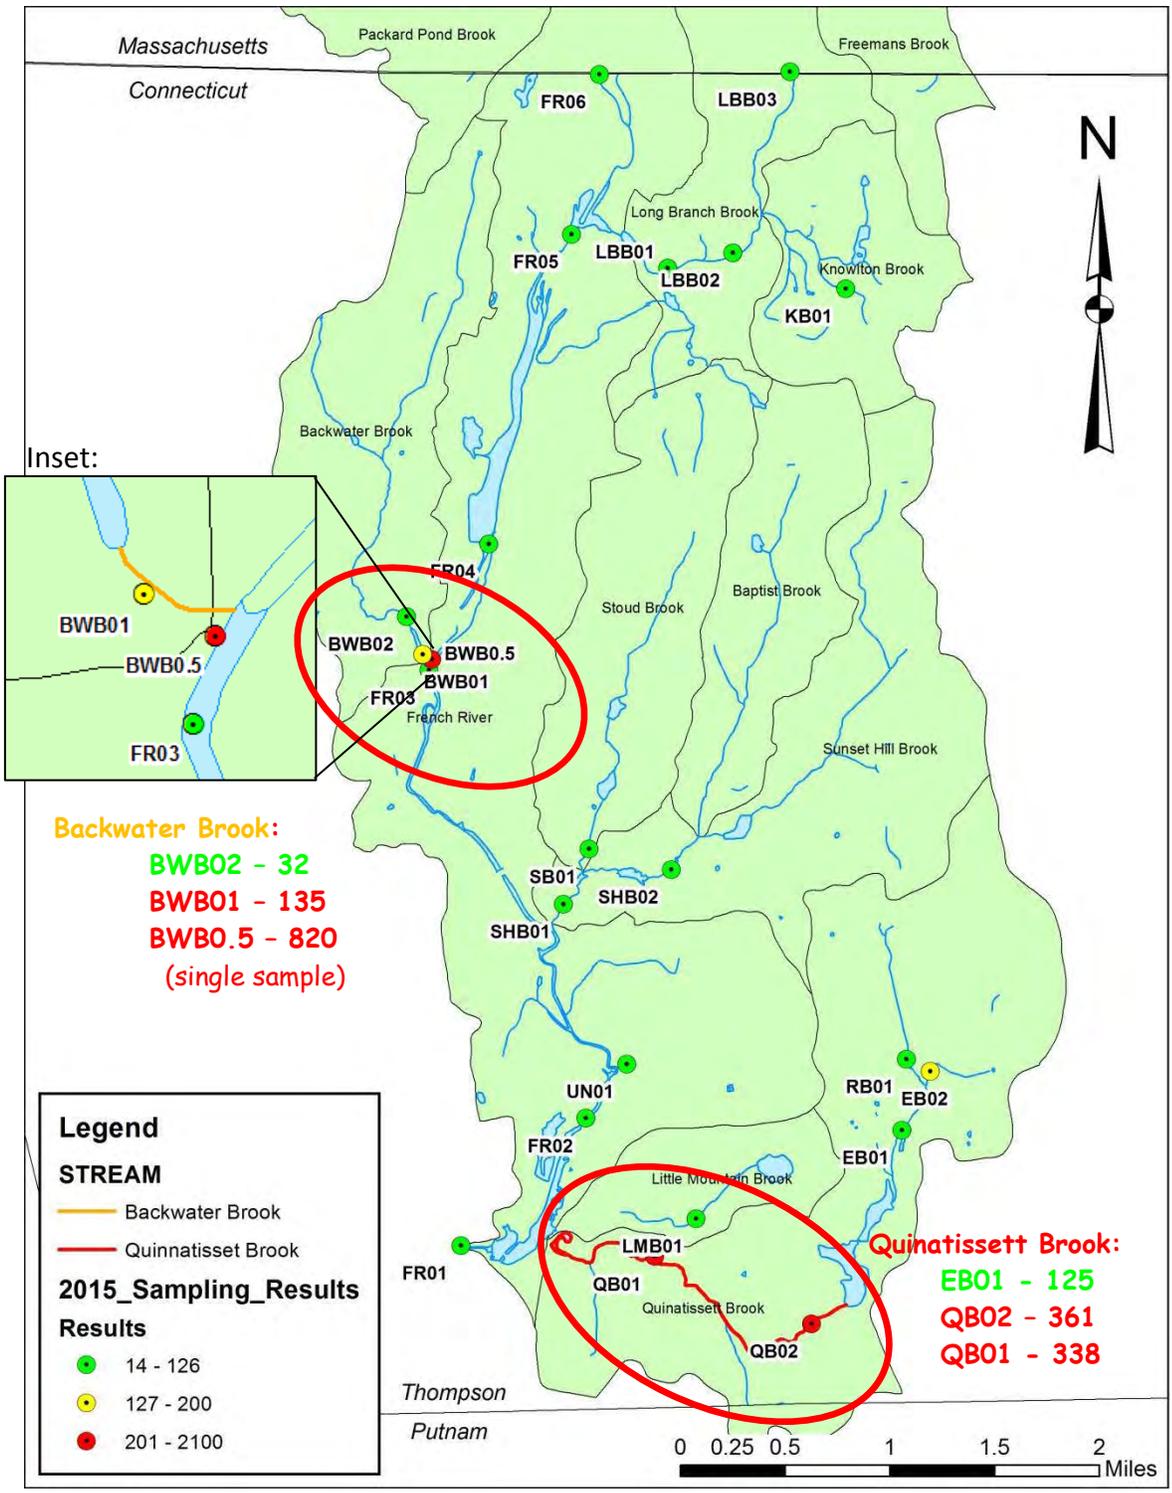
ECCD identified two stream segments where in-stream fecal bacteria levels consistently exceeded established water quality standards for both single samples and the geometric mean; Quinatissett Brook (sampling sites QB02 and QB01), from the confluence with the French River to the outlet of Reams Pond, and Backwater Brook (sampling sites BWB01 and BWB0.5), from the confluence with the French River to the outlet of Duhamel Pond (Fig. 4). ECCD reviewed the surrounding land uses in order to identify possible fecal bacteria sources (Fig. 5), and prepared a prioritized restoration list identifying possible stormwater management practices that could be implemented to improve water quality at each site (Table 2).

Figure 4. Fecal bacteria hot spots identified in the French River watershed in Thompson, CT. The inset depicts the segment of Backwater Brook (shown in orange) between Duhamel Pond and the French River that did not meet water quality standards.

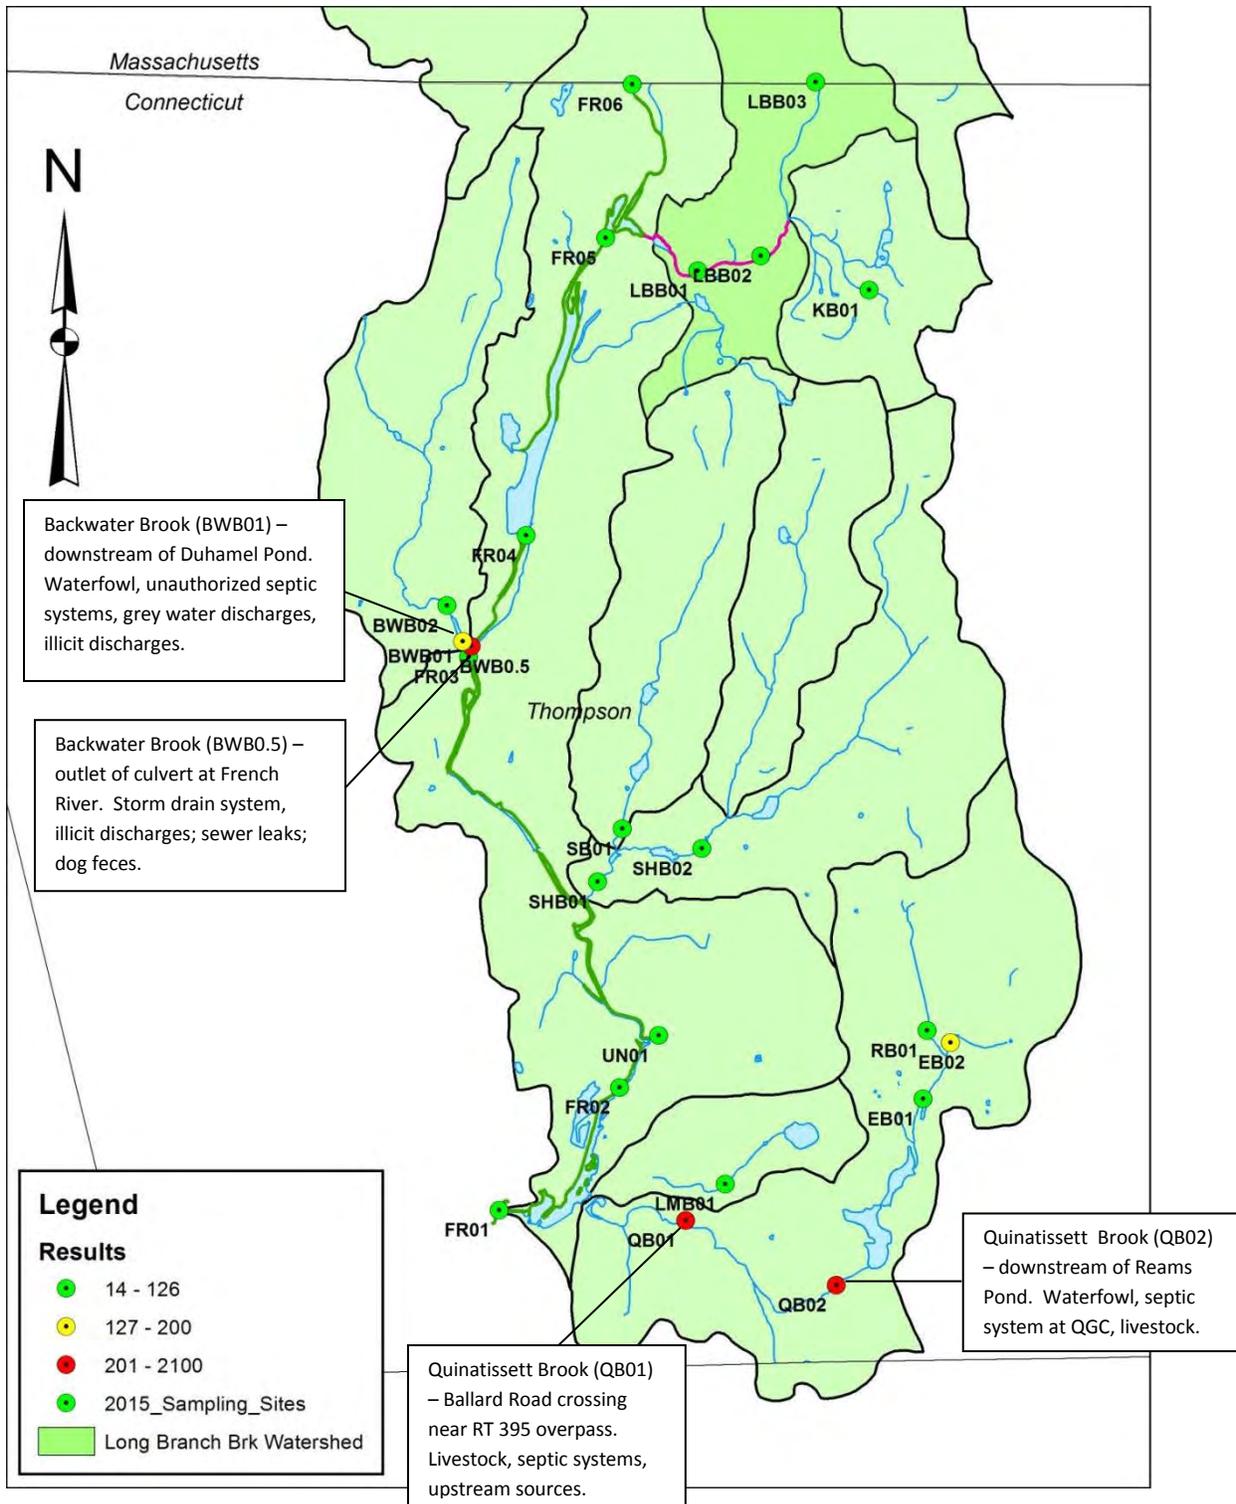
- underperforming/failing septic system at Quinatissett Golf Course;
- underperforming/failing septic systems on Robbins Road and Ballard Road;
- waterfowl at Reams Pond;
- livestock upstream of Reams Pond; and
- livestock on RT 21, Robbins Road and Ballard Road.

Figure 5. Potential fecal bacterial sources associated with the fecal bacteria hot spots identified at Backwater Brook and Quinatissett Brook in Thompson, CT.

- manage animal waste and waterfowl at Duhamel Pond;
- verify that all properties abutting Duhamel Pond are properly connected to the sanitary sewer system;
- conduct sewer main inspections/regular maintenance; verify the abandoned sewer main at the former Walker Road is not conveying waste;
- identify/verify presence of greywater discharges;
- reduce, infiltrate and/or treat stormwater runoff from surrounding developed area (roads, sidewalks, driveways, buildings, parking lots) prior to discharge to Backwater Brook and the French River;
- encourage dog owners/walkers to clean up after their pets; and
- identify and eliminate illicit discharges to the existing storm drain network.

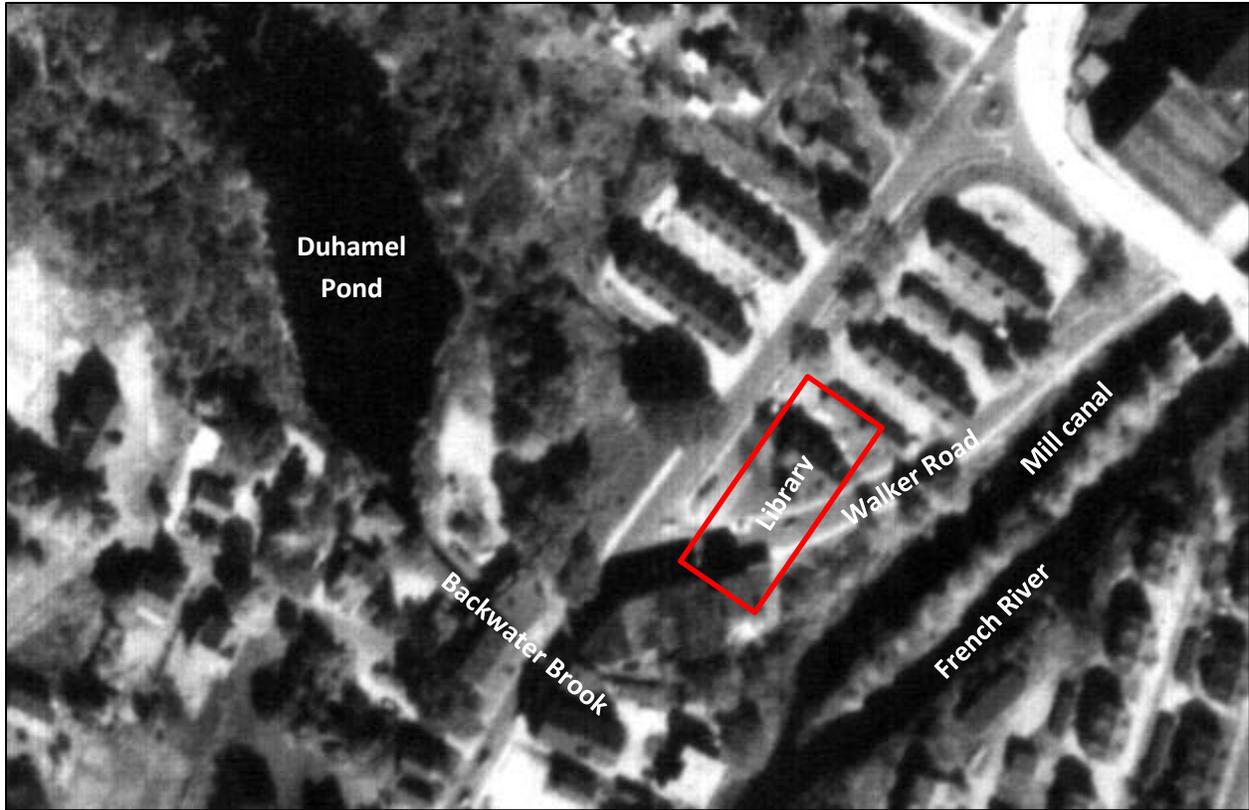
Figure 7. Aerial image of the Thompson Public Library site circa 1963, depicting previous site development (Univ. CT MAGIC Library). The location of the public library is outlined in red.
