STATE OF CONNECTICUT

THE NUCLEAR ENERGY ADVISORY COUNCIL REPORT

2010

Established Pursuant to Public Act 96-245

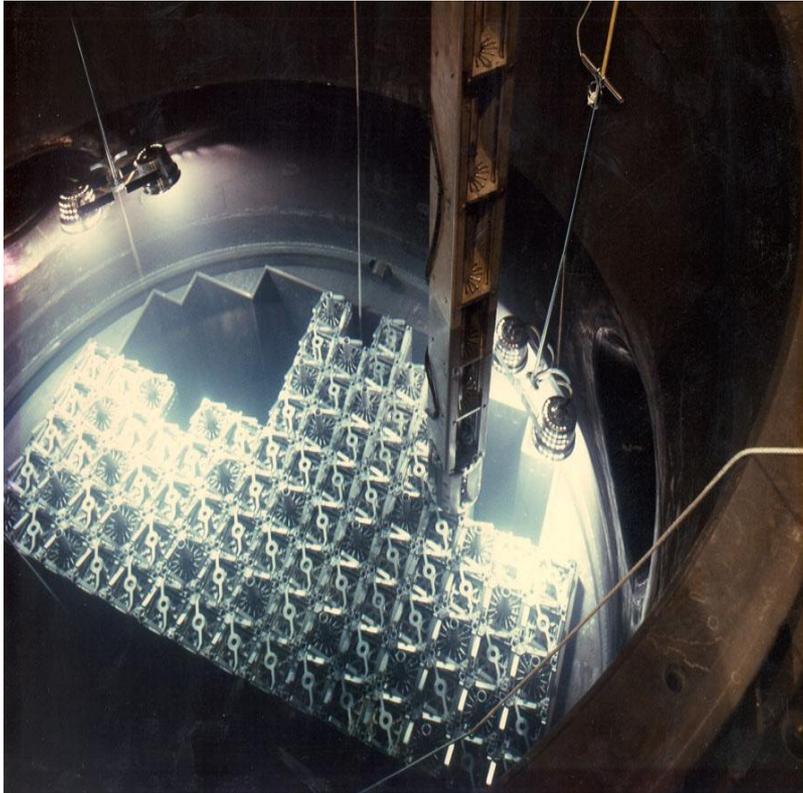
Unit 2 Fall 2009 Refueling Outage

- ❖ Major outage work
 - Variable Frequency Drives
 - Alloy 600 weld overlays
 - Service Water

- ❖ Duration - 42 days

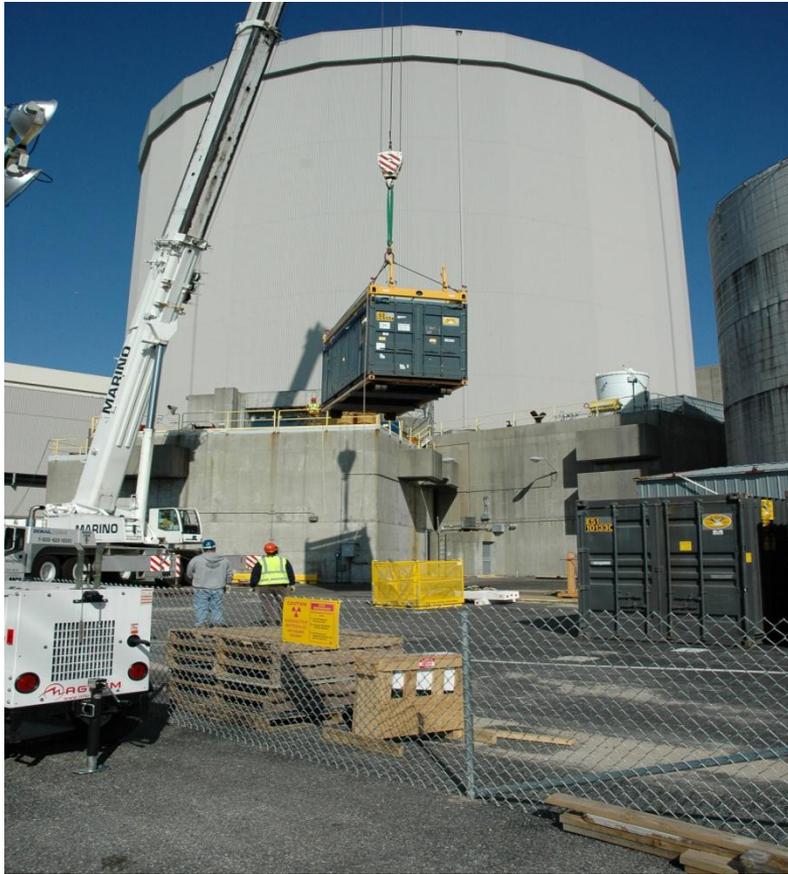
Unit 3 Spring Refueling Outage

- ❖ Major outage work
 - Variable Frequency Drives
 - Main transformer replacement
- ❖ Approximately 1,000 supplemental employees
- ❖ Successes/Challenges
- ❖ Duration - 37 days

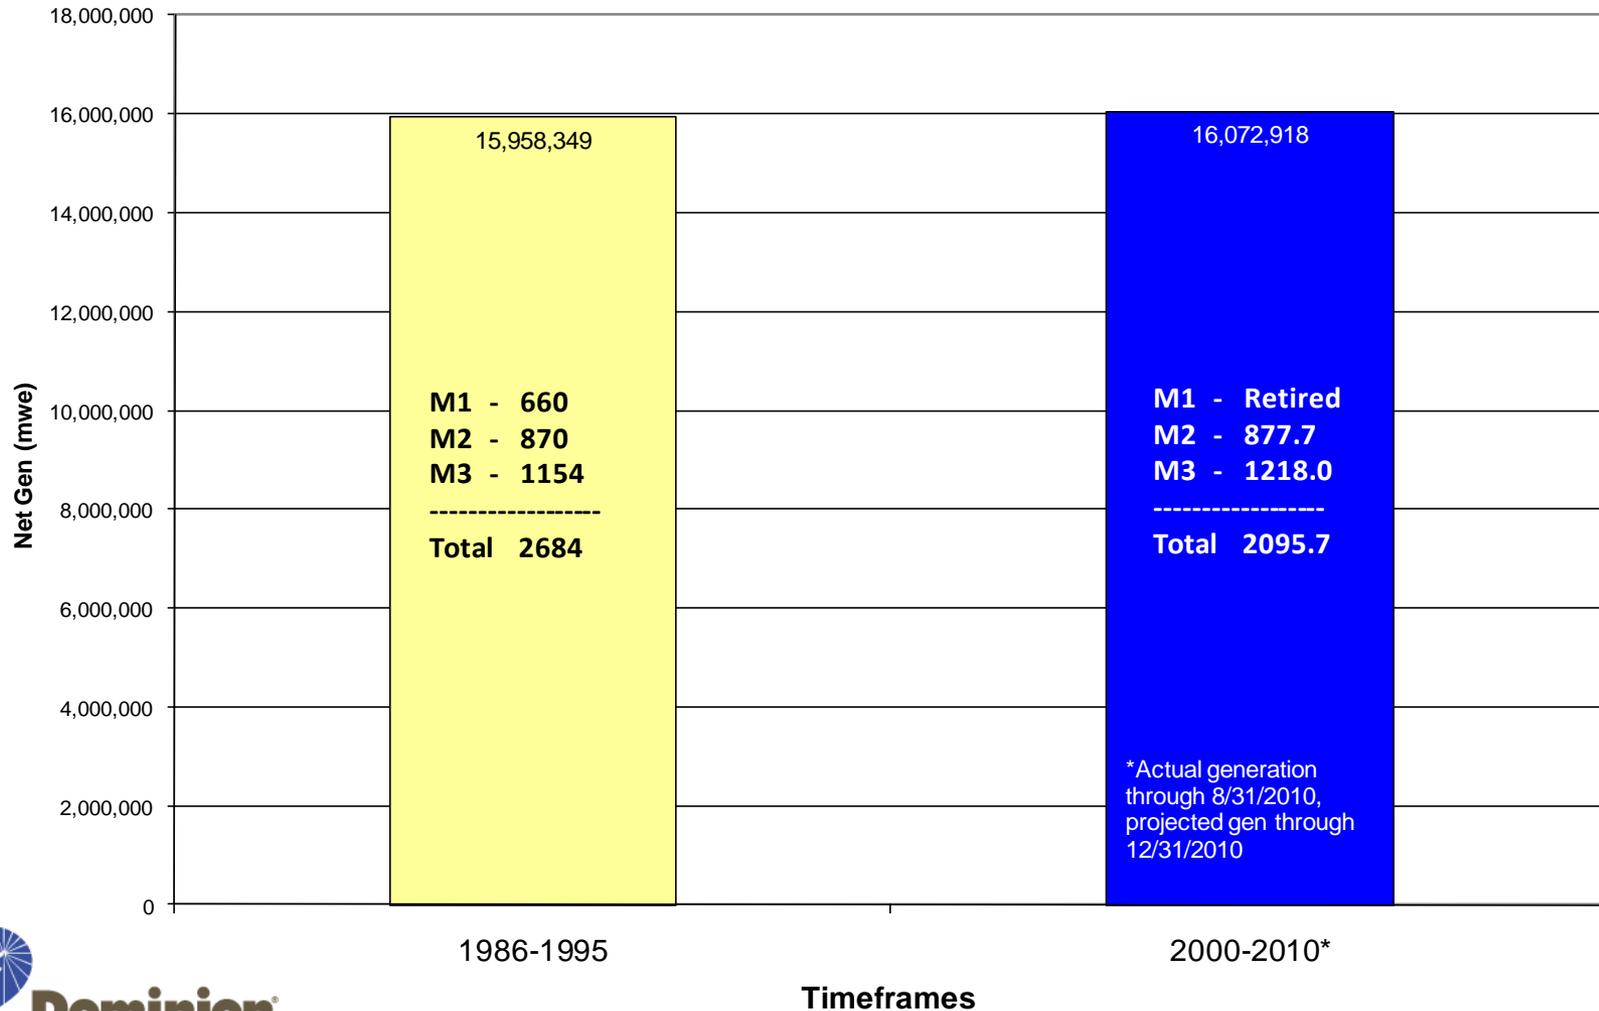
Millstone Average Net Generation

Reliability Investments are Working

Millstone Station Net Generation Comparison - Average Per Year

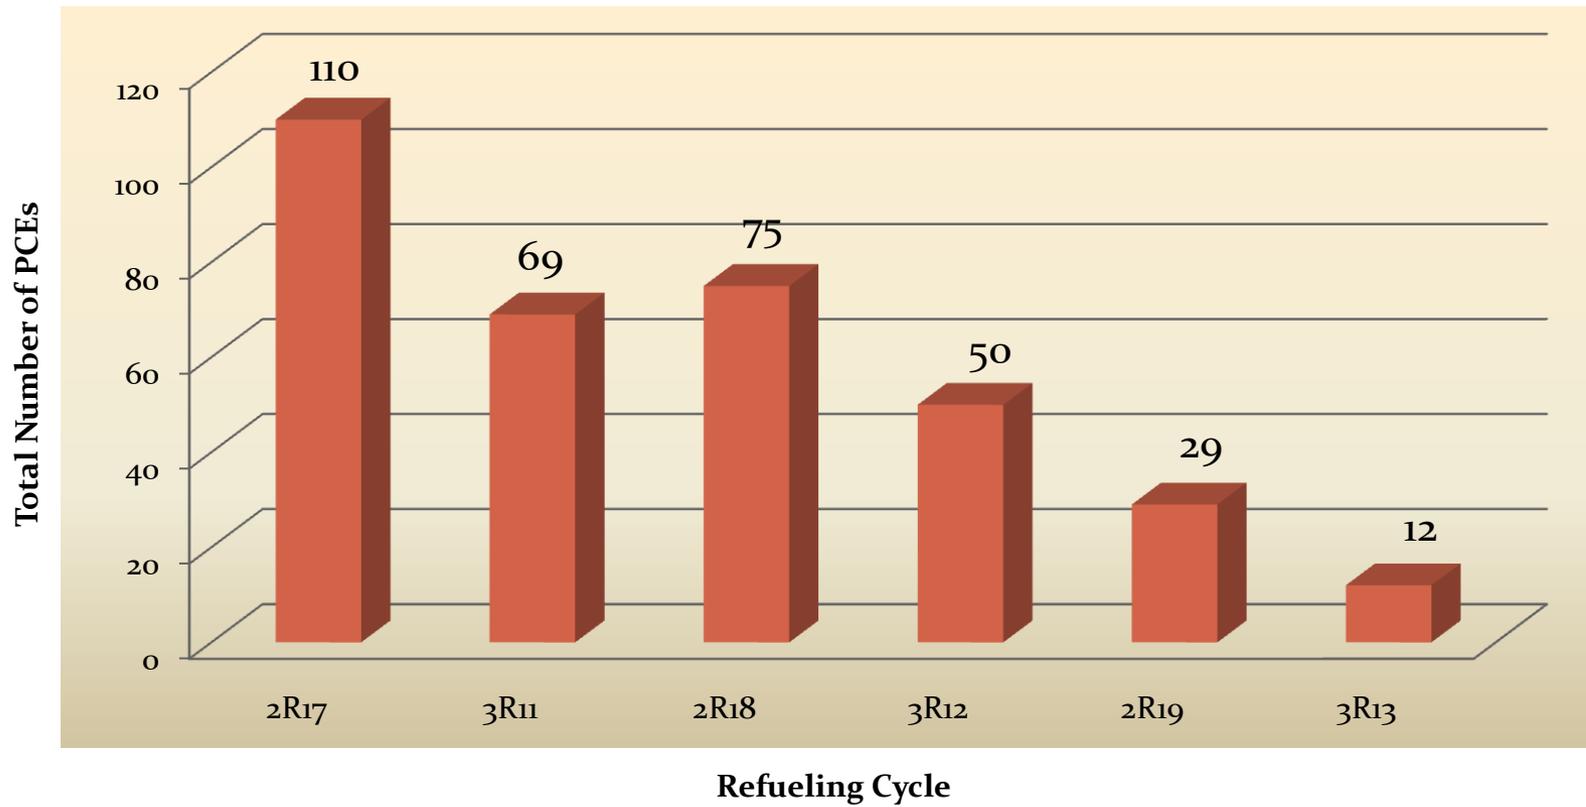
PCE Reduction Excellence

Millstone Power Station
Outage Personnel Contamination Event Trend
(Last 3 refueling cycles per Unit)
