APPENDIX - A  
Morgan Brook Watershed Management Plan  
Bacteria Sampling Results - Morgan Brook Watershed

Appendix - B  
Morgan Brook Watershed  
Section 319 Nonpoint Source Management Program  
Track Down Survey Summary Table

**WEST HILL  
POND**

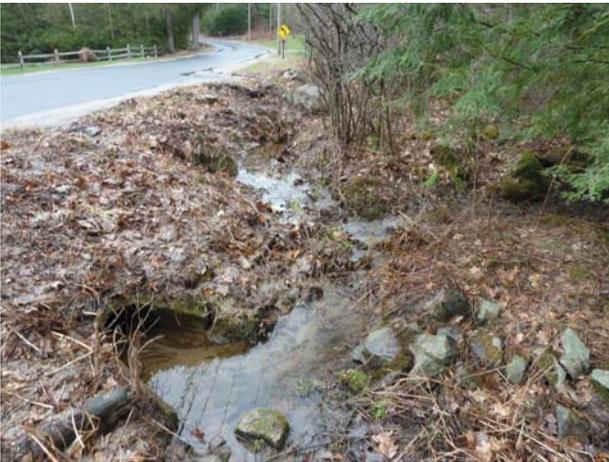
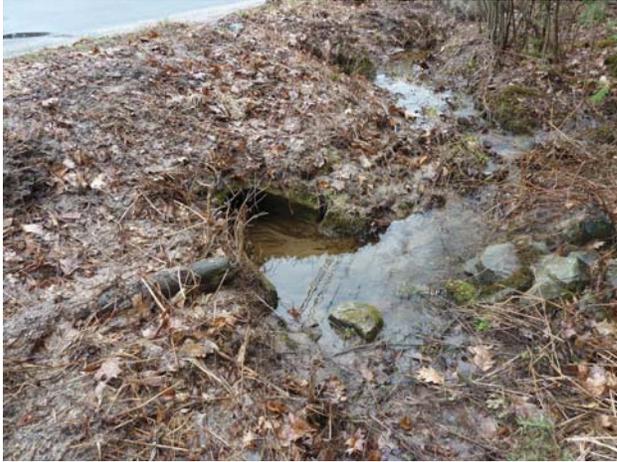
<b>CONDITION: (Evidence of...)</b> <input type="checkbox"/> Cracking/chipping/corrosion <input type="checkbox"/> Downstream scour hole <input checked="" type="checkbox"/> Sediment deposition <input type="checkbox"/> Failing embankment <input checked="" type="checkbox"/> Collected organic debris <input type="checkbox"/> Other:			<b>CULVERT SLOPE:</b> <input type="checkbox"/> Flat <input checked="" type="checkbox"/> Slight (2° – 5°) <input type="checkbox"/> Obvious (>5°)	<b>UNDERSIZED?</b> <input checked="" type="checkbox"/> No <input type="checkbox"/> Yes <input type="checkbox"/> Unsure
	<b>DAMS</b>		<b>TYPE:</b> <input type="checkbox"/> Manmade <input type="checkbox"/> Active Beaver <input type="checkbox"/> Old/Abandoned Beaver	<b>MATERIAL:</b> <input type="checkbox"/> Concrete (poured or block) <input type="checkbox"/> Dry stone <input type="checkbox"/> Mortared stone <input type="checkbox"/> Gabion <input type="checkbox"/> Other: <b>MATERIAL:</b> <input type="checkbox"/> Large woody debris <input type="checkbox"/> Small woody debris	Height: _____ (ft) Height: _____ (ft)

**NOTES/SKETCH:**  
outlet into West Hill Pond

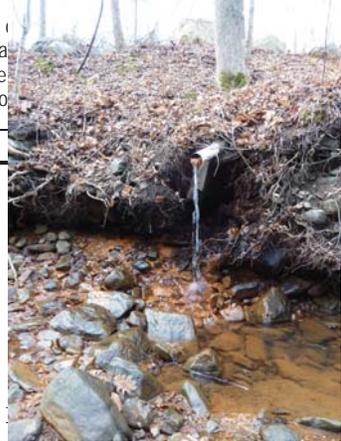
<b>SKETCH/NOTES:</b> Grease budding at pipe, Pipe discharge is within designated TROUT MGMNT AREA

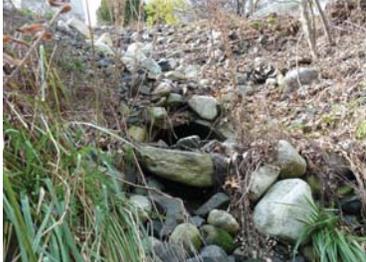
**SKETCH/NOTES:**  
Green Ridge Condo complex  
No stormwater renovation

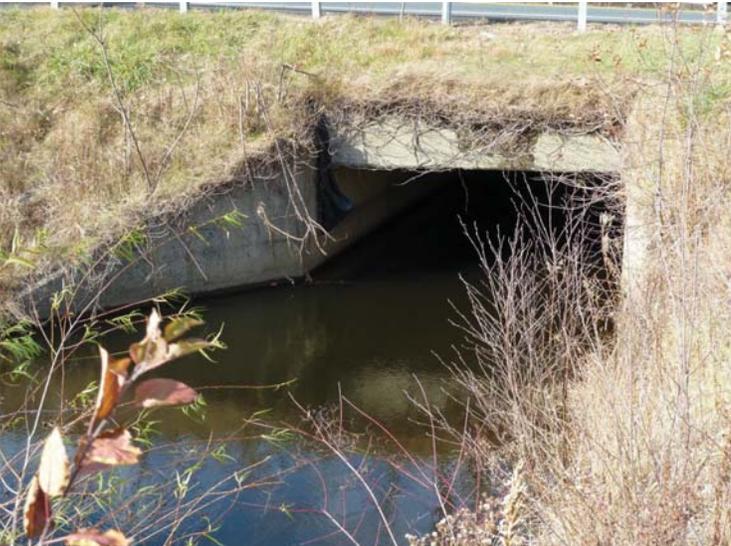
**NOTES/SKETCH:**  
Near Lombard Ford

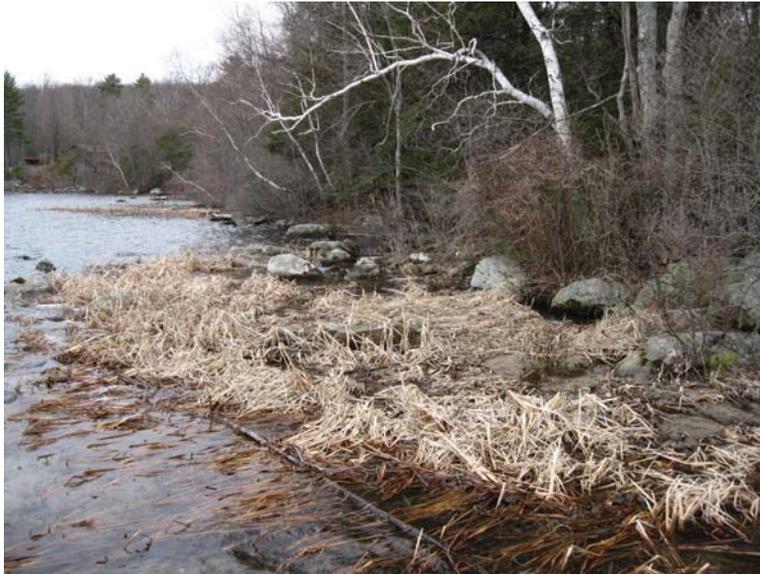
Outfall Area

Redirect parking lot runoff and create a vegetated swale along uphill side of beach area to redirect flows away from the beach.  
Use coarser sand during future beach replenishments  
Install silt fence or filtrex soxs along waters edge of beach during winter season.

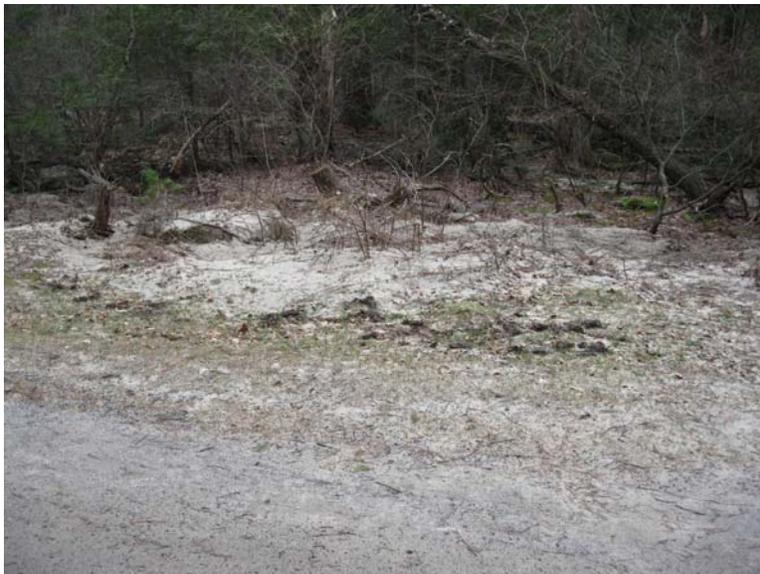
Wind Eroded Sand

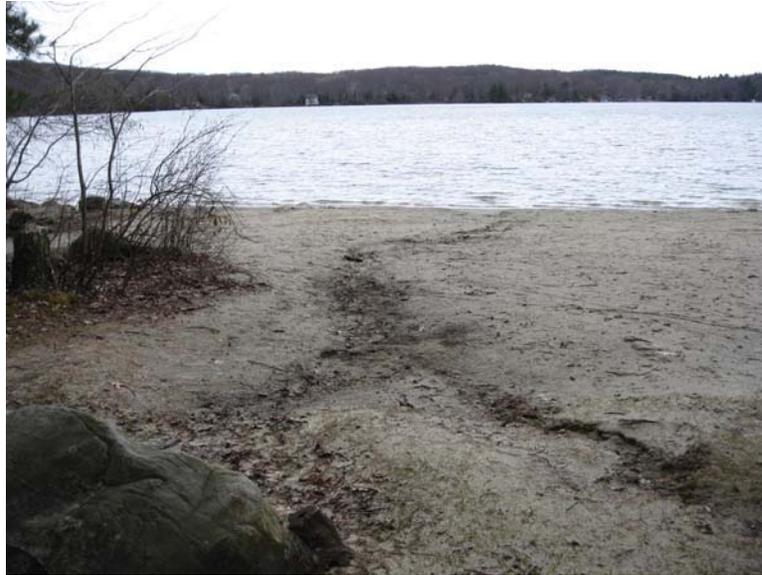
Beach Erosion

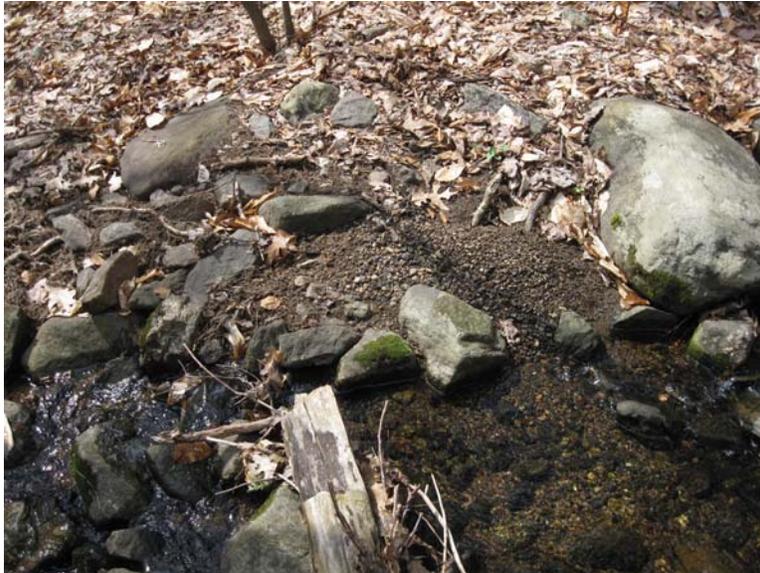
Evidence of Active Erosion that Progressively Moves Toward Pond

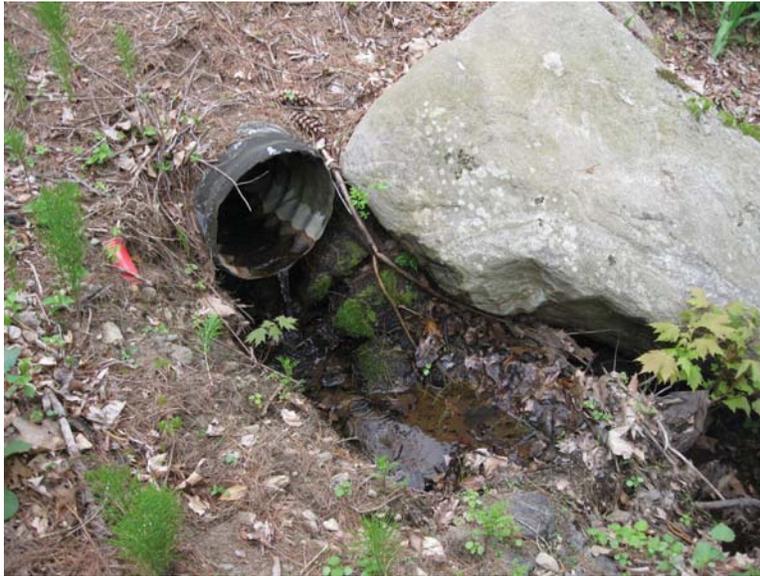
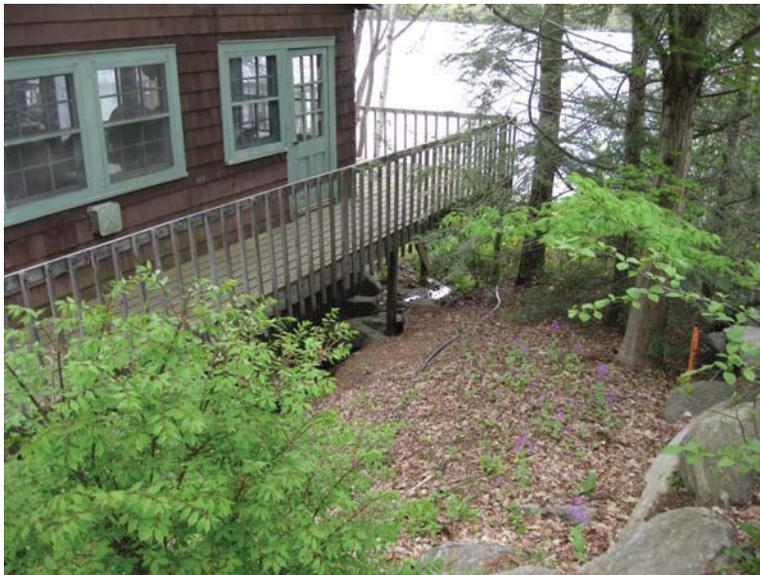
Drainage goes under existing deck & is flooding yard  
Insufficient room to create stabilized channel, Will require piping

Stabilize roadside swale with vegetation or riprap, and install deep sump catch basin or large particle separator. Due to confined space, lower discharge will need to be conveyed in pipe system to outlet. It might be possible to create a small in pond sediment basin. Remove unnecessary impervious surface.

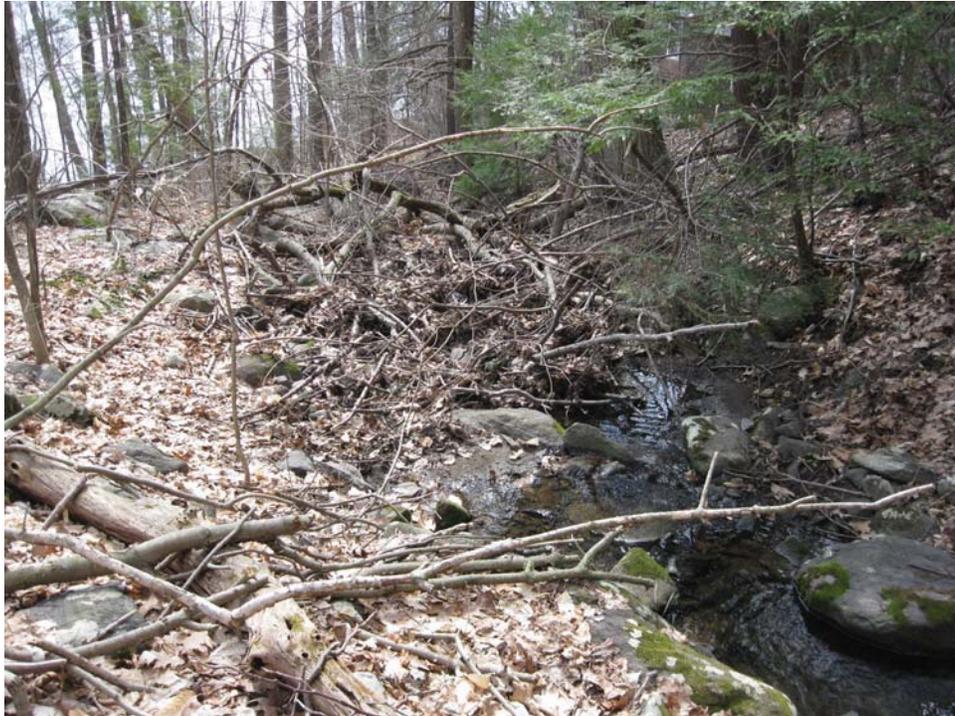
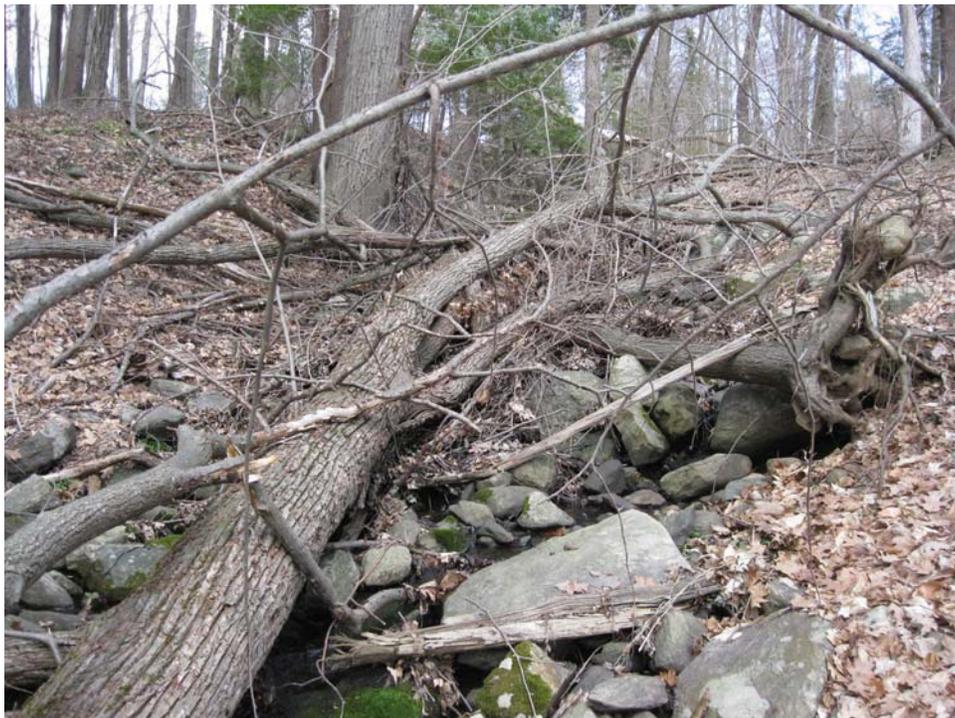
Allowing drainage channel to remain blocked by debris, creates dams and forces storm flows to create new paths, eroding material in the process

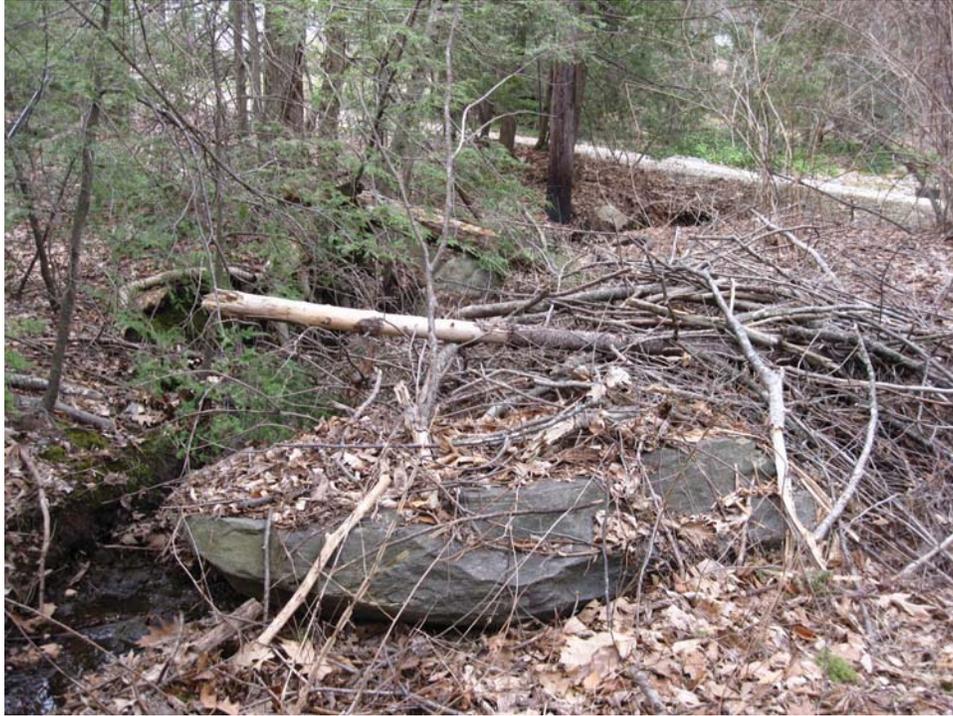
Disposal of landscaping wastes in drainage paths

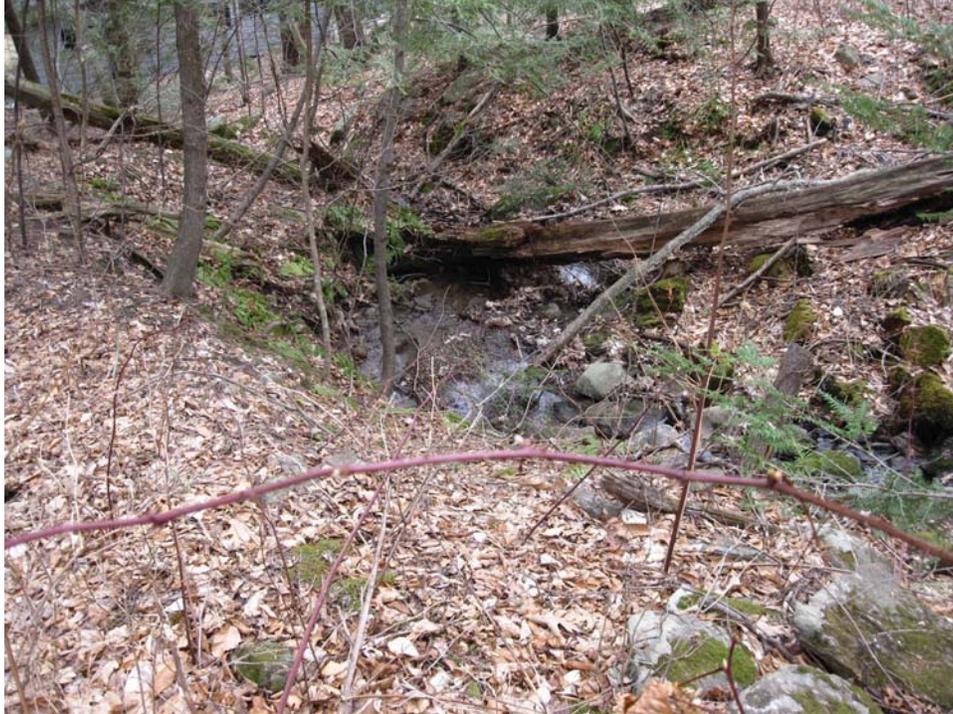
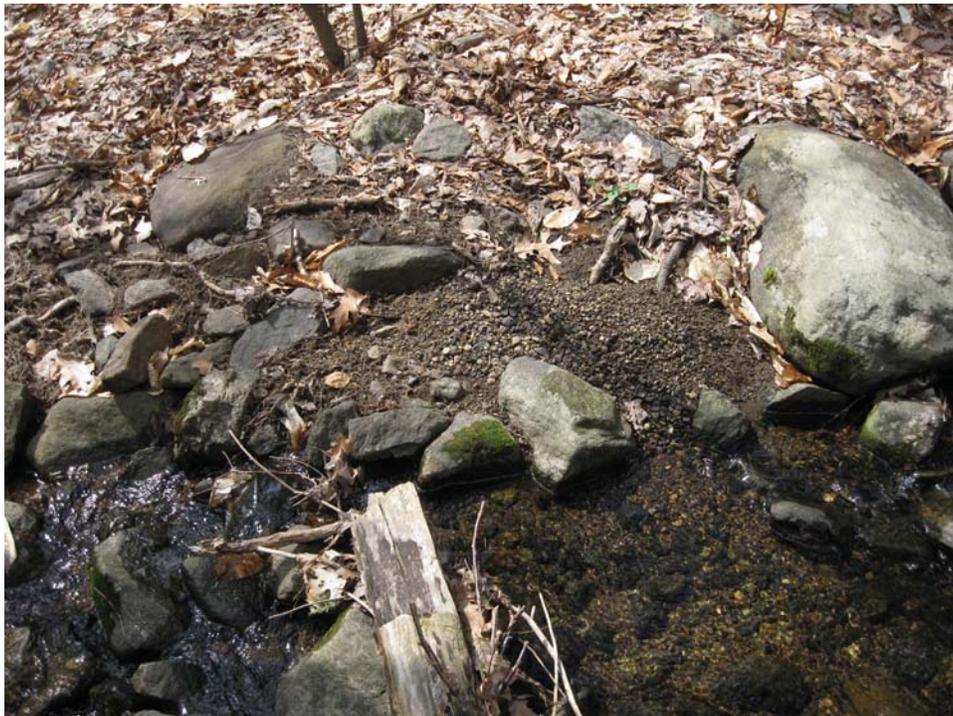
Erosion of bank material

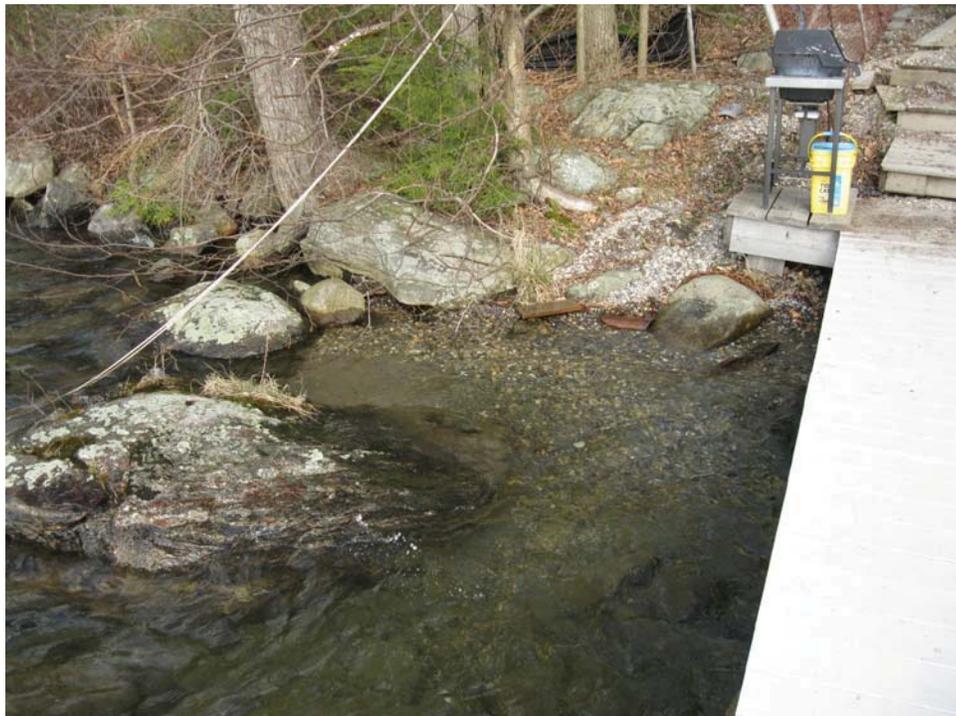
Eventually entering the Lake

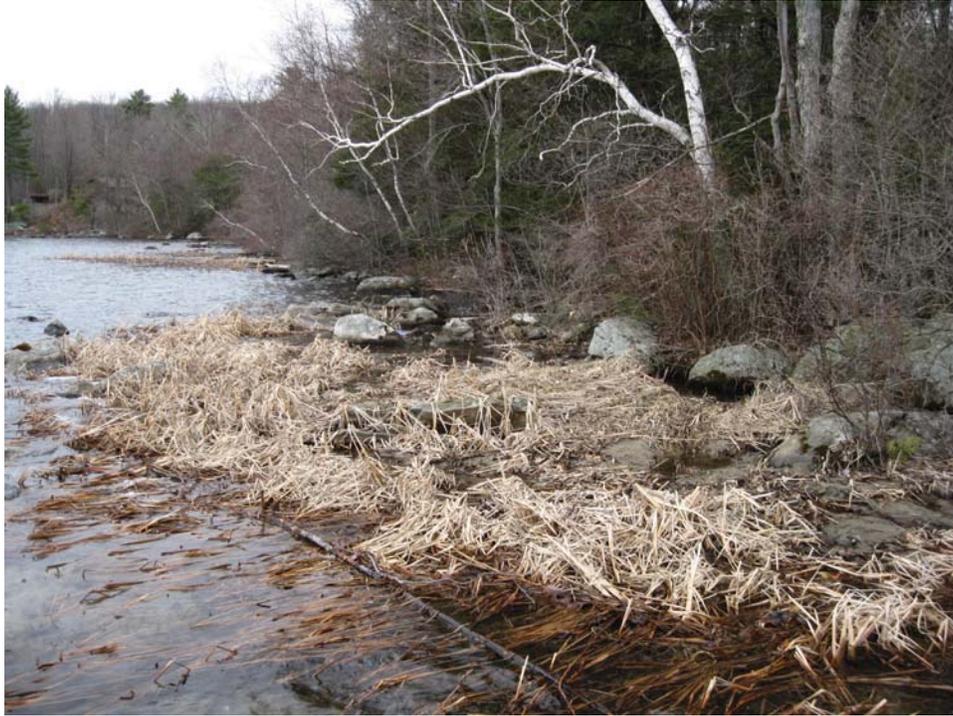
Causing infilling & vegetation growth
